# PERFORMANCE ANALYSIS OF HISTORICAL CHURCHES AND MOSQUES DURING RECENT EARTHQUAKES – SOME PERSPECTIVES ON APPLICATION OF AI/ ML SYSTEMS

Satwant Rihal <sup>(1)</sup>, Hisham Assal <sup>(2)</sup>

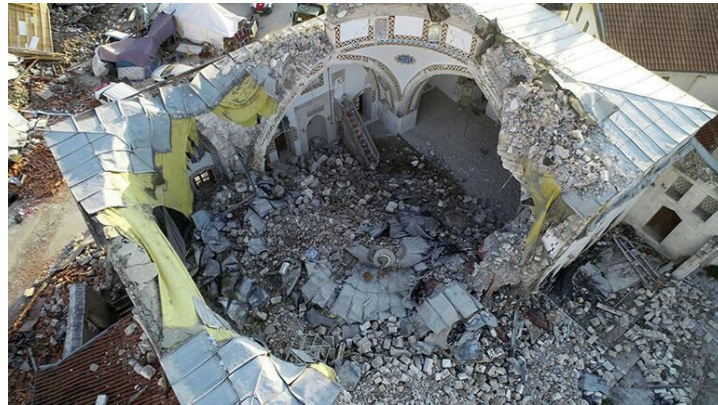
Figure 3. Habib-i-Necca Mosque one of the first mosques in Anatolia destroyed. Source: ArkeoNews (<https://arkeonews.net/>)

Severe damage and collapse of the Habib-i-Necca mosque in Anatolia is presented in Figure 2.

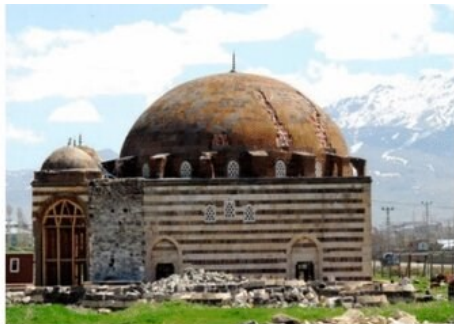
Kaya Çelebi Mosque, Van Earthquake (2011)

Some examples of the types and patterns of damage suffered by historical mosques during previous earthquakes in Turkey has been presented by Kocaman, et. al. [5]

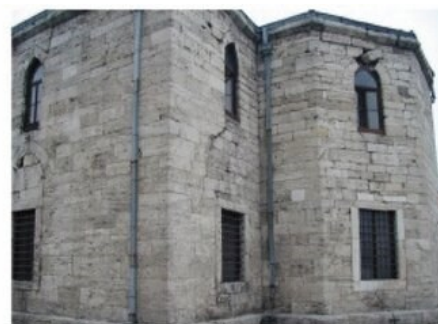
Kadı Mosque, Düzce Earthquake (1999)

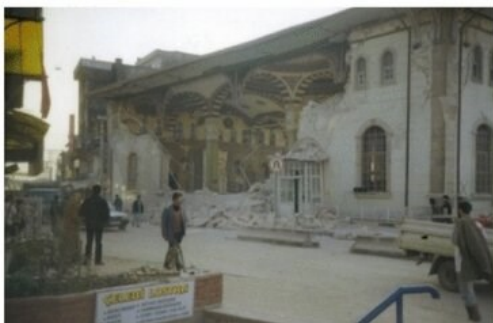
Düzce Merkez Mosque, Düzce Earthquake (1999)

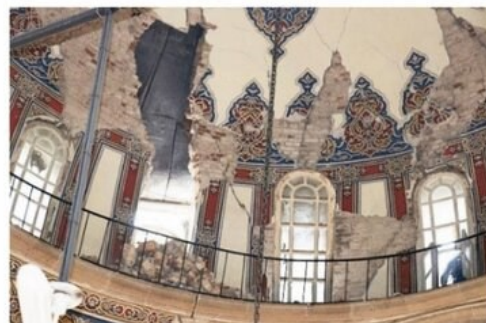
Malatya Ulu Mosque, Elazığ Earthquake (2020)

Figure 4. Examples of earthquake damage in historical mosques in Turkiye  
Source: DOI: 10.1007/s10518-023-01613-1

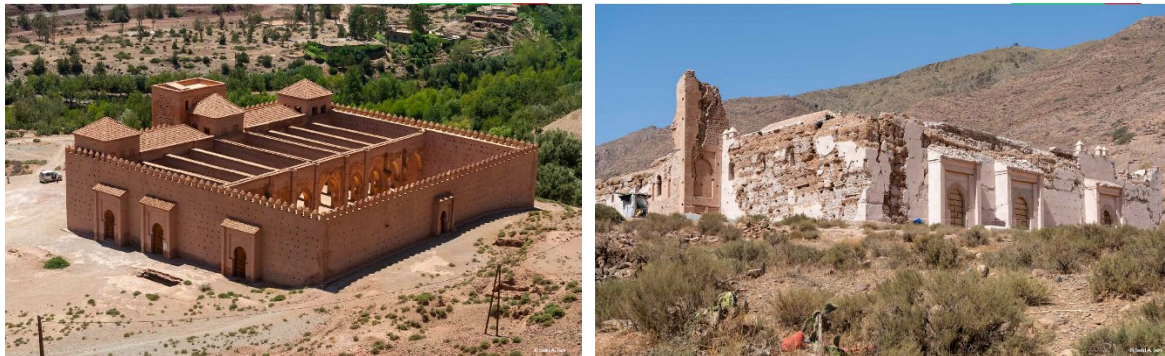
Figure 5. The Tinnel Mosque – Left: before earthquake, Right: after the earthquake

The historical Tinnel mosque, considered as a notable example of Almohad architecture, and dating back to the 12<sup>th</sup> Century, was severely damaged by the 2023 Al Houz, Morocco earthquake, while it was under restoration, as shown in Figure 4.
