# SEISMIC VULNERABILITY ASSESSMENT OF COMPLEX HISTORICAL MASONRY AGGREGATES WITH INTERACTIONS BETWEEN STRUCTURAL UNITS

*Keywords:* Historical aggregates, interactions between buildings, equivalent frame modeling, nonlinear static analyses.

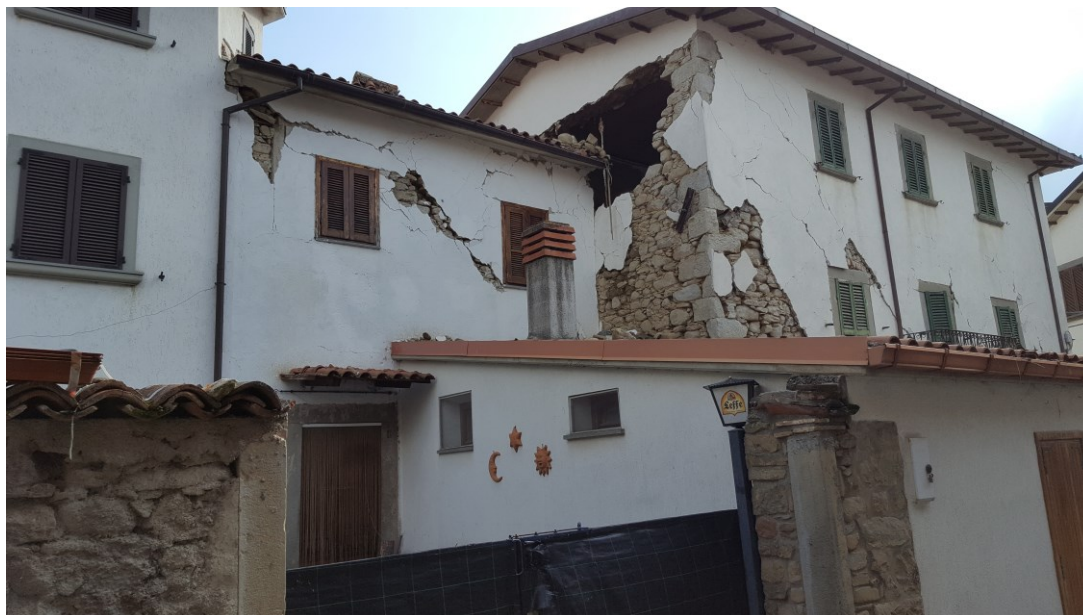
Figure 1. Local mechanism and in-plane damage in existing aggregates in Amatrice, Italy, after the 2016 Central Italy earthquake (Photo: A. Penna/G. Guerrini).

heights, and suboptimal renovations often weaken the overall structural behavior [5], thereby increasing the seismic vulnerability of these aggregates [6], as shown in Fig. 1.

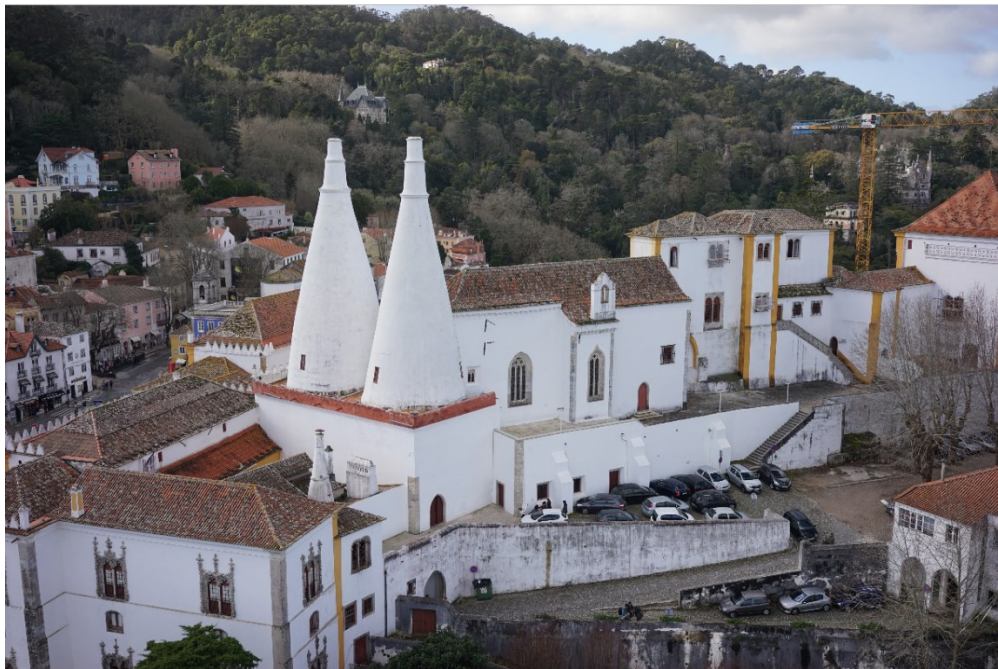
Figure 2. North Façade of the National Palace of Sintra: a) 1507 drawing by Duarte D'Armas, and b) current photo captured by the drone of IST.

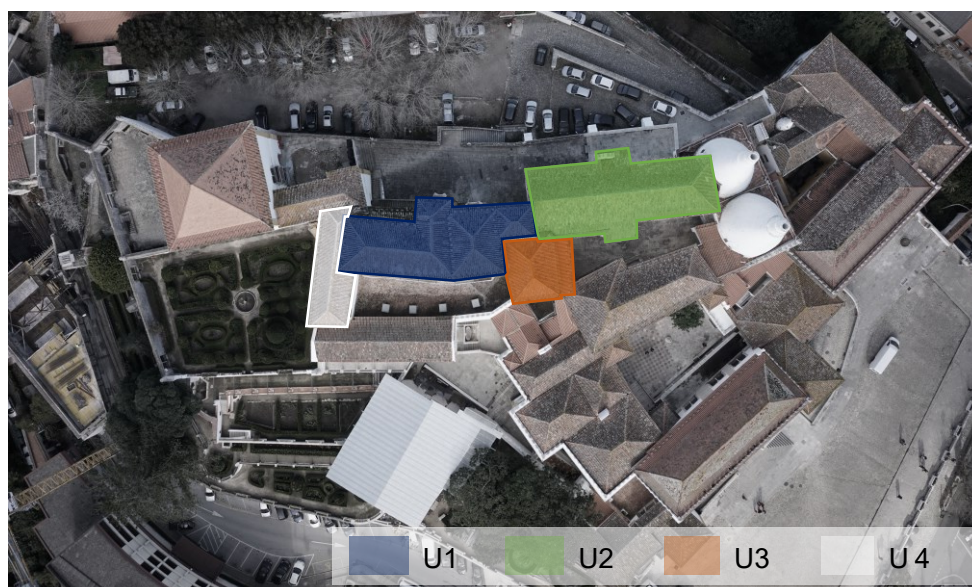
Figure 3. Case study units (Photo: IST drone)

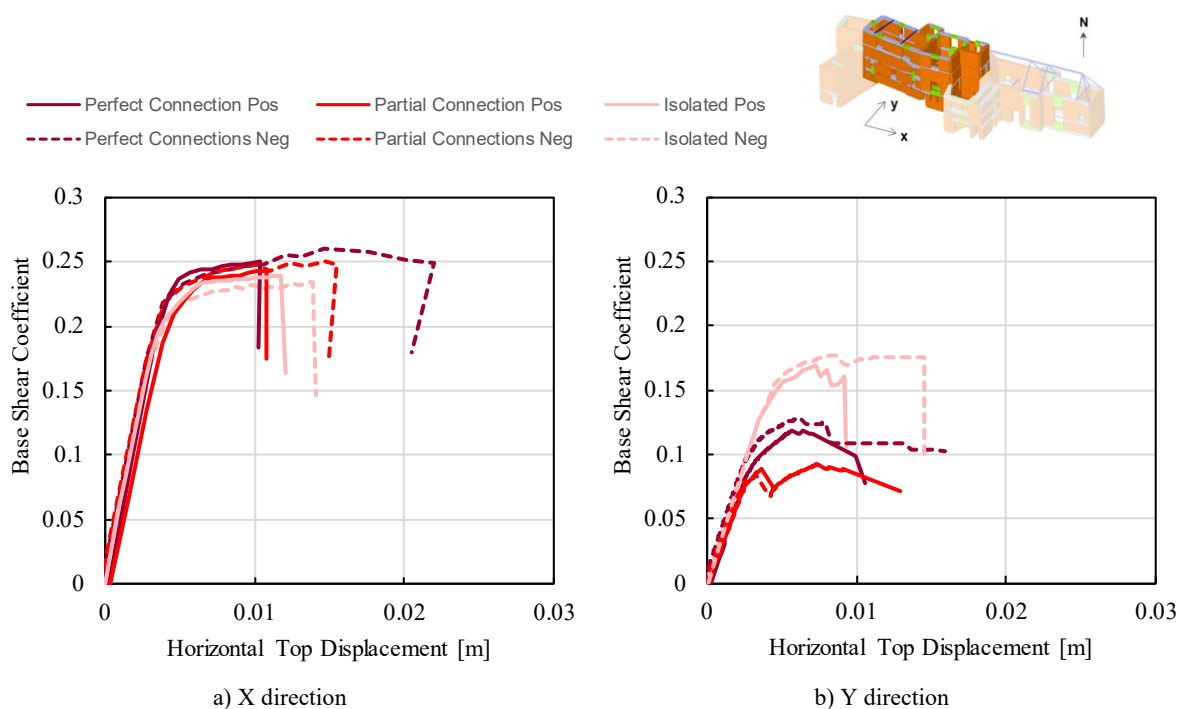
Figure 5. Pushover curves of Unit 1: a) X direction, b) Y direction, considering a uniform loading.

Nonlinear static analyses were carried out in the X direction (longitudinal) and Y direction (transverse) for a uniform loading, proportional to the mass. Fig. 5 presents the pushover curves for the three types of connections in terms of the base shear coefficient of Unit 1 versus the average top-floor horizontal

displacement of the same structural unit. The base shear coefficient was determined by calculating the ratio of the total horizontal force to the total vertical force at the base of the first floor without a supporting wall built against the bedrock. Each curve is displayed up to the ultimate displacement of Unit 1, defined as the point at which either a lateral strength reduction of at least 20% or the formation of a collapse mechanism is observed.

The pushover curves indicate that the aggregate effect does not significantly influence the behavior of Unit 1 in the longitudinal direction of the aggregate (X direction). Units 1 and 2 exhibit similar stiffness, while Units 3 and 4 have a minimal impact on the overall stiffness of Unit 1. Consequently, when subjected to loading in the X direction, the aggregate moves cohesively. In fact, regardless of the connection type, Unit 1's collapse is always governed by a soft-story mechanism in the same façade wall. This mechanism is characterized by a concentration of damage on a single floor preceding failure, resulting in a sudden loss of lateral strength. However, although the same collapse mechanism occurred for the three connection types and the global behavior is not influenced in this direction by the type of connection, not all walls presented the same behavior. For example, Fig. 6 shows the damage pattern that changes with the type of connection in a wall in the X direction shared between Unit 1 and Unit 2, named Px as identified in Fig. 4. The isolated model presents higher concentrated damage at the lower levels, while for the model with perfect connections, the damage is shared between the two buildings on the upper floors. In addition, for partial connections, the connecting elements present tensile stresses, allowing the opening of a gap between the two structural units.

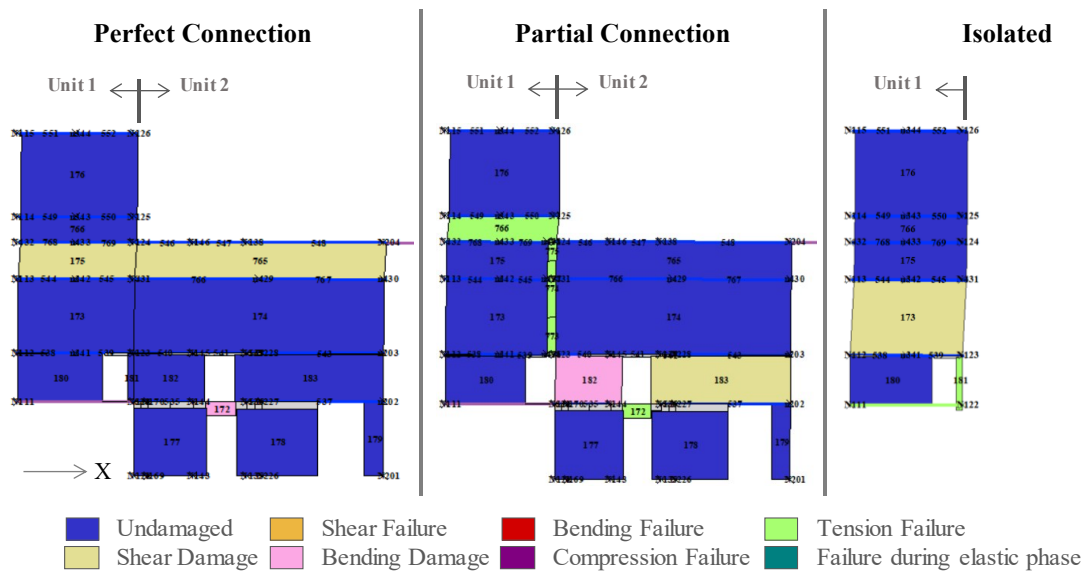
Figure 6. Damage pattern of a wall Px for a top-of-wall horizontal displacement of 0.01 m.
