BASE ISOLATION OF AN EXISTING REINFORCED CONCRETE BUILDING

Krešimir Todoric⁽¹⁾, Mario Uroš⁽²⁾

In Croatia, base isolation has not yet been used to increase the seismic safety of buildings. This paper investigates the possibility of applying base isolation system on the existing reinforced concrete frame building from the 1930s. In the paper, the building retrofitting solution with base isolation is compared with the conventional strengthening solution.

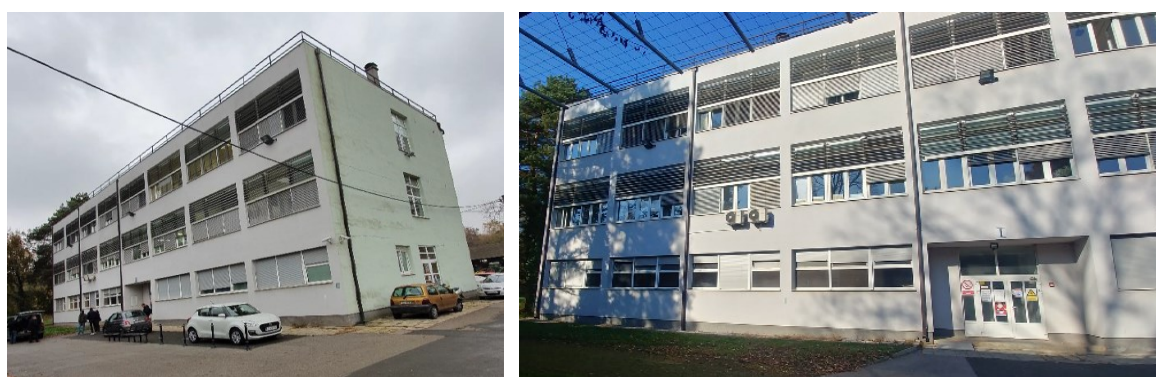
The building's floor plan dimensions are 40.50 x 16.00 m, mostly in rectangular shape, with an annex on the north side measuring 10.50 x 6.50 m. The building consists of a ground floor, first floor, second floor and attic, and the height of the building from the ground level is approximately 17.00 m. In Fig. 1 building is shown before retrofit.

Figure 1. a) South side; b) Main entrance [3]

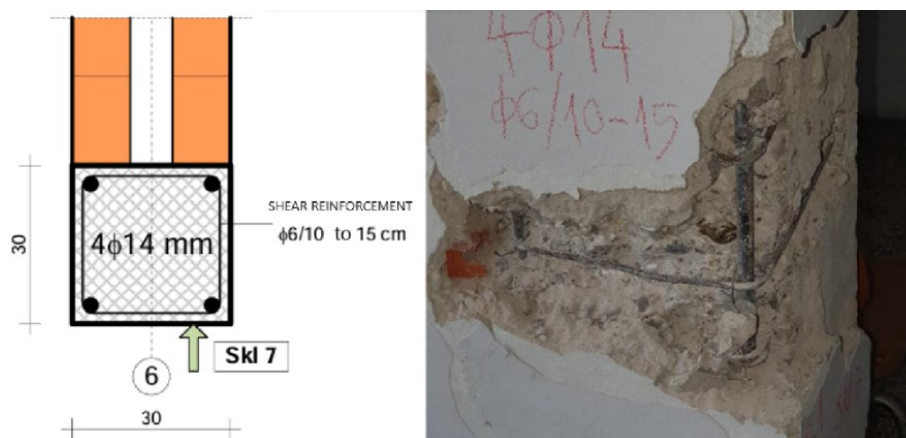
Some of the archival drawings have been preserved, but there is no data about mechanical properties of the used materials. As part of the reconstruction project, investigative work was carried out. According to the Structural investigation report of the structural testing laboratory of the Faculty of Civil Engineering [4], the shear strength of the masonry, the dimensions of the structural elements, as well as the quality of the material were determined. Concrete samples were taken by roller drilling and compressive strength testing of reinforced concrete columns was investigated on the ground floor and upper floors of the building, and non-destructive sclerometer testing was used to assess the quality of the concrete. Fig. 3 shows the reinforcement of the 30/30 cm column.

Figure 3. Reinforcement in the column [4]

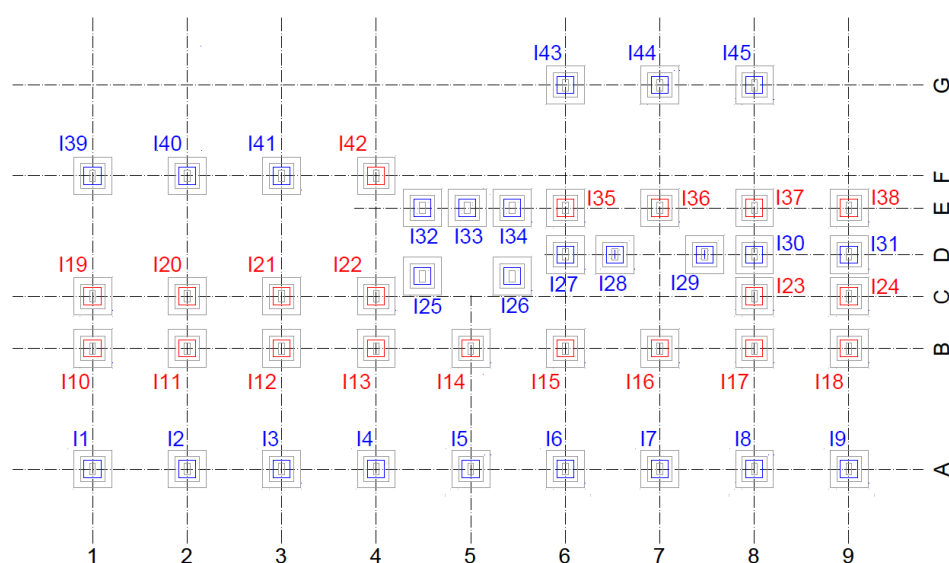
Base isolation increases the period of the structure to more than two seconds, which results in a smaller seismic force, but it is necessary to carry out the verification of the structure and the seismic force obtained after the installation of the isolators. The diagram in the Fig. 4 shows the positions of the isolators, where the two types of isolators differ depending on the force. Defined in manufacturer's data, two types of isolators used, have different horizontal stiffness, which is defined by vertical forces. As shown in Fig. 4 red positions are used to show isolators with greater vertical load, and positions colored blue show isolators with smaller vertical load.

Figure 4. Layout diagram of the base isolation

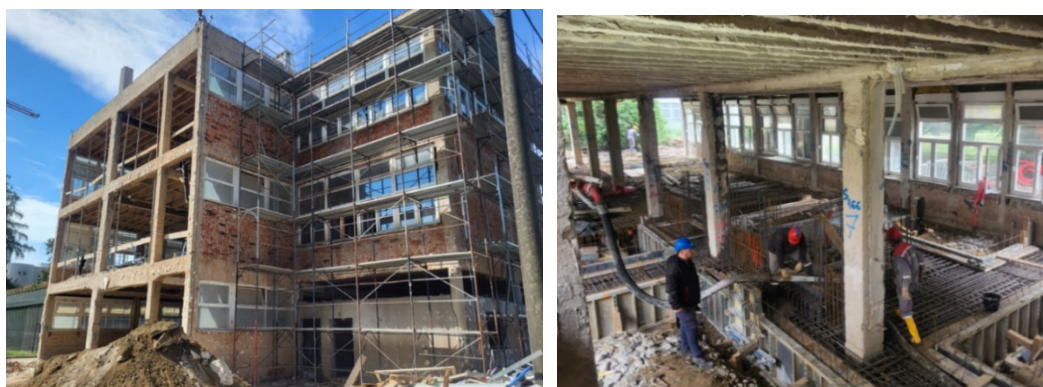
Fig. 12 shows the complexity of the intervention, during reconstruction after the earthquake using the conventional method of inserting walls. The removal of floor and wall coverings on all floors in order to be able to access the reinforcement and new elements of the structure require moving out and the need for a replacement location.

Figure 12. East facade and ground floor during renovation [8]

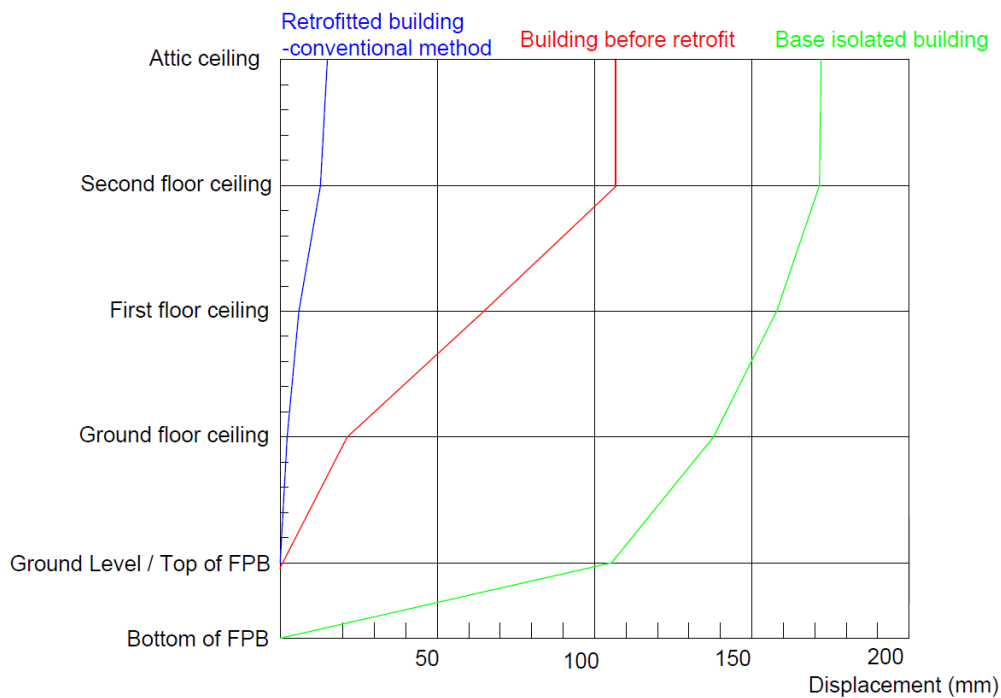
The Fig. 14 shows the structural displacements for all three models. The structure with base isolation has a large displacement in the isolator, which meets the manufacturer's allowed displacement, and the total displacement of the structure according to dynamic analysis is 17.1 centimeters, as shown in Table 4, so it is important that the building has the ability to move in all directions. Retrofitting by using conventional methods stiffens the structure, and displacements are small. When using base isolation, displacements are concentrated in the isolators.

Figure 14. Comparison of displacements

Displacement of the building before retrofit (earthquake)	10,7 cm
Displacement of the building with base isolation (earthquake) – dynamic analysis	17,1 cm
Displacement of the building after retrofitting by using conventional methods (earthquake)	1,2 cm
