Structural analysis of a Rc building failure caused by the earthquake of 26th November in Durrës, Albania

Anjeza Gjini¹, Hektor Cullufi², Princ Xhika³

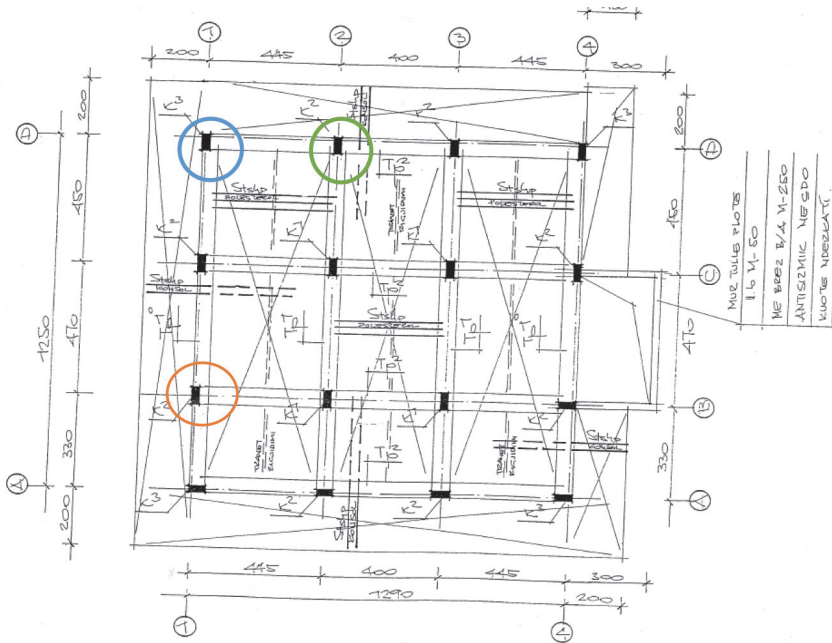
Figure 5. Layout in +3.50 m

In the table below is shown the need for reinforcement and the designed one for columns in the ground and first floor (ref. Figure 5).

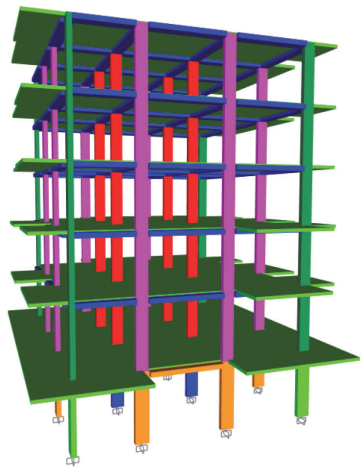
Figure 6. 3D Modelling of structure using ETABS Ultimate 19

The structure is modelled using advanced software such as ETABS Ultimate 19. This mathematical model can capture to a satisfying degree all actions on structure exerted by self-weight, imposed loads, seismic events and the effects of their combinations. The analyses are conducted using provisions from EN 1998-3 (2005) [3], 4.4.3 Multi-modal response spectrum analysis (1) P and 4.4.4.1 (1) P Nonlinear Static. Judging by the results obtained by both types of analyses it is clear that this building has major issues regarding ULS and SLS.

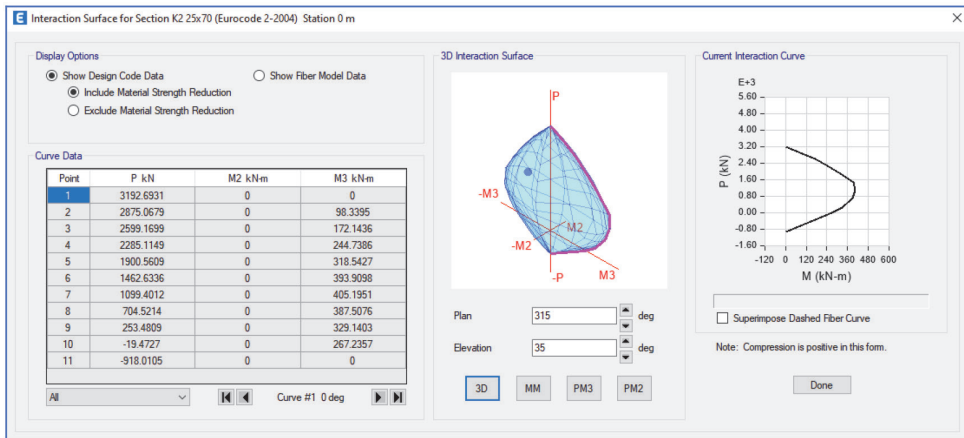
Figure 8. Typical interaction diagram for ground story column

Regarding ULS, analyses show that some of the columns in ground and first stories are overstressed, which means that the required reinforcement exceeds the maximum allowed. Furthermore, by comparing required longitudinal reinforcement of frames to the reinforcement provided by the designer, we can see that this design is insufficient and presents major structural issues (table 3). This is also demonstrated by pushover analysis results where structural capacity is smaller than structural demand by a large margin.
