## Post-earthquake mission in Durres, Albania, from science to practice

Following the M=6.4 earthquake that hit Durres in Albania on 26.11.2019, at the request of the Government of the Republic of Albania to the Government of R.N. Macedonia, in coordination with the deputy Prime Minister of the Government of R. N. Macedonia and the Director of the Bureau for Forensic Expertise of the R. N. Macedonia as operational coordinator, teams of experts were established for assistance and support to the local teams in rapid assessment on the structural safety of damaged buildings in the most affected areas. The Institute of Earthquake Engineering and Engineering Seismology – IZIS (Ss. Cyril and Methodius University in Skopje) was leading the Macedonian mission with four teams composed of 11 experts. Most of the structures that were the subject of inspection were residential, mainly constructed as reinforced concrete structure and flat-slab systems prior the year 2000. Most of these structures suffered major nonstructural damage with negligible structural damages and extensive repairable structural damages. The cause of incurred damages was inconsistent application of recent knowledge in des

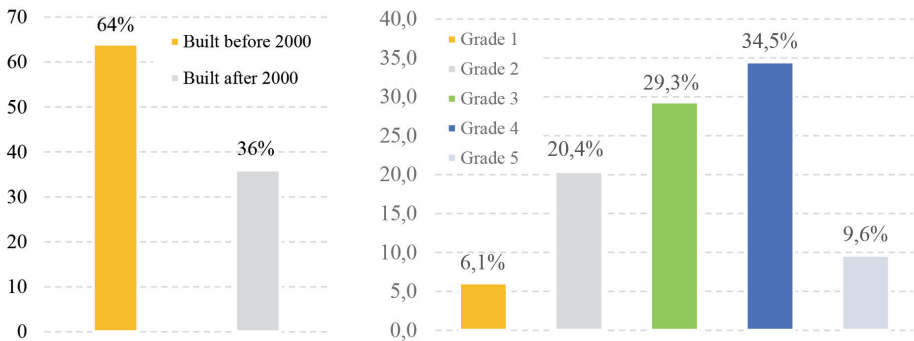
**Figure 5. Review of structures according to year of construction (left) and grades assigned to damaged structures upon inspection (right)**

Most of the inspected structures, 64 % of total number were built before 2000, meaning that they are more than 20 years old, while the remaining 36 % of the structures were built after 2000 (Figure 5 left). In accordance with this statement, it can be concluded that most of the structures are of a older date wherefore they are assumed to have been not designed in compliance with the current seismic regulations.

According to assessments made by the commissions (in accordance with Table 1), the expert teams concluded that 6.1 % of the structures suffered slight non-structural damage (Grade 1). 20.4 % of the structures account for those with moderate damage to non-structural elements. However, each third structure suffered major nonstructural damage with negligible structural damages most frequently in the form of hairline cracks in the columns (Grade 3). Almost 35 % of the structures suffered major structural damage that was mainly concentrated in the columns and 9.6 % of the total number of inspected structures were assigned grade 5, meaning that they have to be torn down (Figure 5 right). Photos of damaged structures assigned Grade 3 and Grade 4 are shown in Figures. 3 and Figure 4. More photos of structures are given in IZiIS Report 2019-73.
