Out-of-plane behaviour of loadbearing and non-structural masonry walls during recent earthquakes

Key words: loadbearing masonry, infills, earthquake damage, Albania earthquake, Croatia earthquake

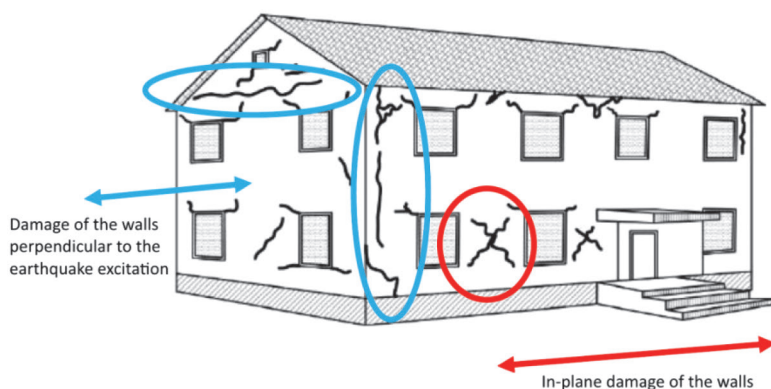
Masonry structures have a satisfactory loadbearing capacity under compression due to the action of gravity loads, but masonry is characterized by a very low tensile strength, which is often exceeded in the walls exposed to earthquakes, and results in the cracking and damage of these walls. Figure 1 shows typical earthquake-induced damage of URM structures due to the action of earthquakes in the plane of the wall and perpendicular to the wall plane (out-of-plane). Damage due to the earthquake excitation in the plane of the wall, primarily the characteristic diagonal ("X") cracks caused by exceeding the tensile strength, is marked in red in Figure 1. In addition, typical damage patterns due to the effect of the earthquake perpendicular to the plane of the wall are marked in blue in Figure 1. Vertical cracks at the joints between longitudinal and transverse walls are also common, especially in buildings with flexible floors or in cases when the walls are not adequately connected to the slab. Horizontal cracks at the top and/or in the middle of the wall height are also a consequence of the earthquake action perpendicular to the wall plane.

Figure 1. Typical damage of masonry buildings (according to [2])

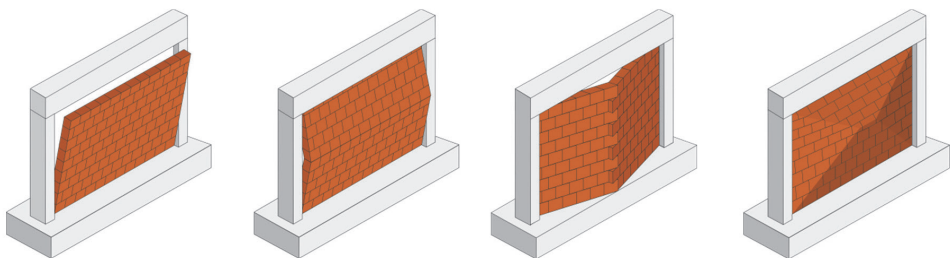
Figure 3. Failure modes of masonry infills subjected to OOP earthquake effects [3]
