Petrinja M6.2 earthquake in 2020 damaged also solid linear infrastructure: are there similar active faults in Croatia?

Tvrtko Korbar¹, Snježana Markušić², Davor Stanko³, Davorin Penava⁴

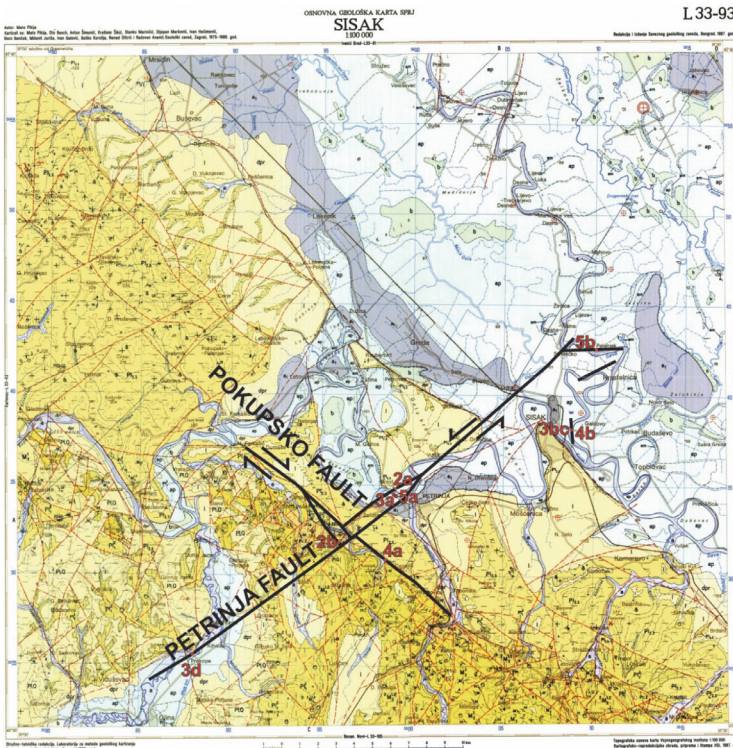
Figure 1. a) Geological map [4] showing the main activated faults (thick black lines) during the Petrinja 2020 sequence [1]. Red dots and numbers mark locations of the other Figure s.

Numerous reports in media allowed quick online research of the ground surface failures and infrastructure damage that appear along approx. 30 km long portion of sinistral NE-SW striking Petrinja Fault (Figure 1). A coseismic damage was observed in two loca-
