A job and study site: A decade of studies and interventions on ROCCA DE Terzi of Sissa

Elena Manzoni¹, Alberto Dusi²

Key words: historical structure, masonry, Parma, non-destructive Inspection, interdisciplinary studies

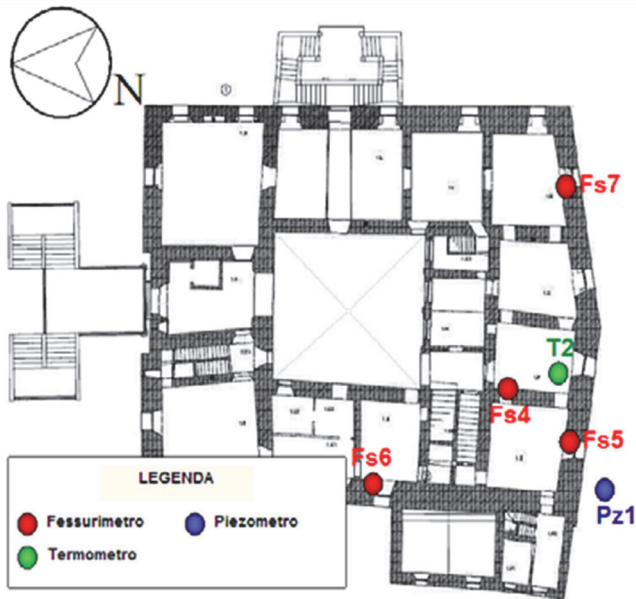
In 2011–2012 a second survey campaign was realized. Continuous monitoring of the major cracks was installed on the building. The purpose of the monitoring campaign was to verify the movement of the southwest portion of the Rocca complex, in the area surrounding the mail staircase and any movement of the vaults on the first floor. 17 tools have been installed: 14 electronic joint meters (crack meters), stroke length 50 mm, 2 thermocouples (thermometers), 1 electric pressure transducer (piezometer) and a Geologic RTU data acquisition unit which samples the electrical data every 8 hours. After 16 months, it can be concluded that the instrumentation has detected movements, although small, which indicates a mechanism is in place at the southwest angle of the Rocca. On the other hand, it is possible to say that the repeated series of seismic events in the first half of 2012 has changed the extensions and trends observed on any cracks present in the Rocca. This could be due to a change in the behavior of the structures following earthquakes.

Figure 3. Rocca of Sissa, instrument map on level 1

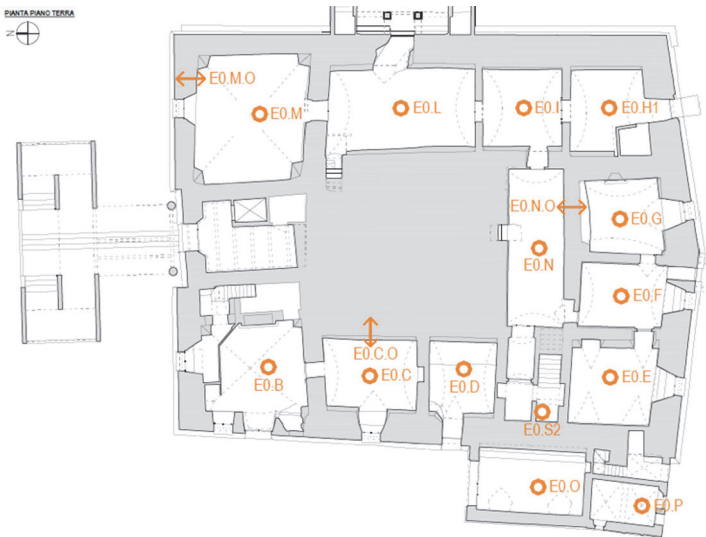
The following tests were performed: 2 tests with double flat jack in order to obtain information about the mechanical characteristics of the masonry investigated in terms of elastic modulus, 42 videoendoscopic investigations aimed at defining the textural

characteristics, the materials and the possible presence of cavities or internal cracks. The tests were carried out on some walls and all the vaults.

Figure 4. Rocca of Sissa, diagnostic map on level 1

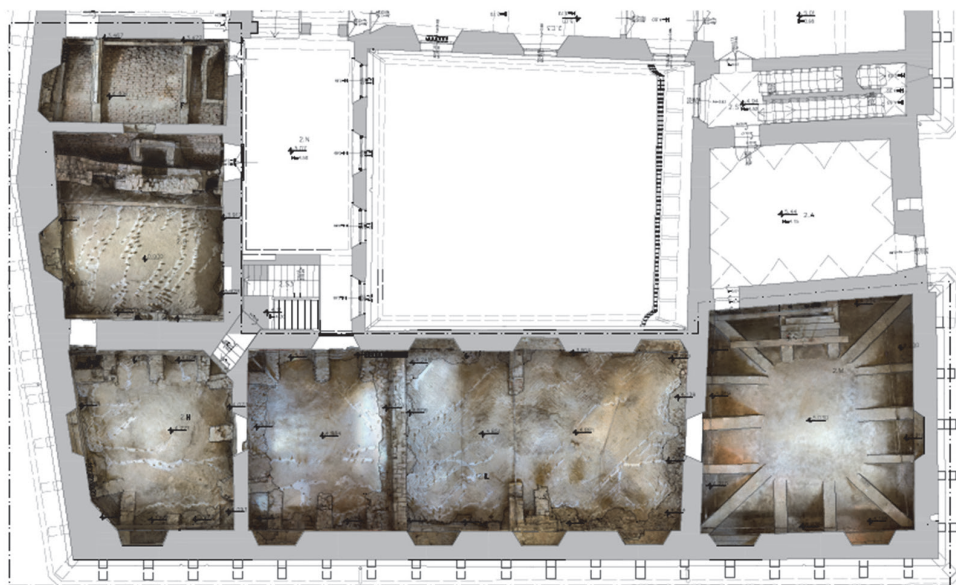
Once the floors had been removed, inspection of perimeter wall could be done. On the hidden part of the masonry, Middle age decorations were found. Moreover, numerous joints were found on the vertical wall. Diaphragm walls on vaults were found out as a strengthening technique carried out after the construction of the vault. It was clear that vault always had problems and during the centuries many times they had been the object of repairing and remodeling intervention. Stratigraphic and archaeological methods had been applied to the wall. The most impressive fact is that there is a strong lack of corner wall connections. A detailed photographic campaign and orthophotos were taken by Ianus.

The walls seem intact above the level of the floor but show numerous closings and openings below the level extrados of the vaults. Further advances in knowledge can be implemented, perhaps with the aid of a thermographic campaign. The continuous remodeling of the building is evident: windows, doors and many reopening and closure were clearly identified on the walls. Moreover, different levels of vault had found a place on the building during centuries and the presence is still shown in the small space between the extrados of the vault and the present floor. The discovery was surprising also because on the outer perimeter the appearance of the building is unitary.

Figure 12. Rocca of Sissa orthophoto vault 2nd level (Courtesy of Ianus)
