SEISMIC RETROFITTING OF SULTAN MURAT MOSQUE' CLOCK TOWER IN SKOPJE USING INNOVATIVE MATERIALS

Abstract

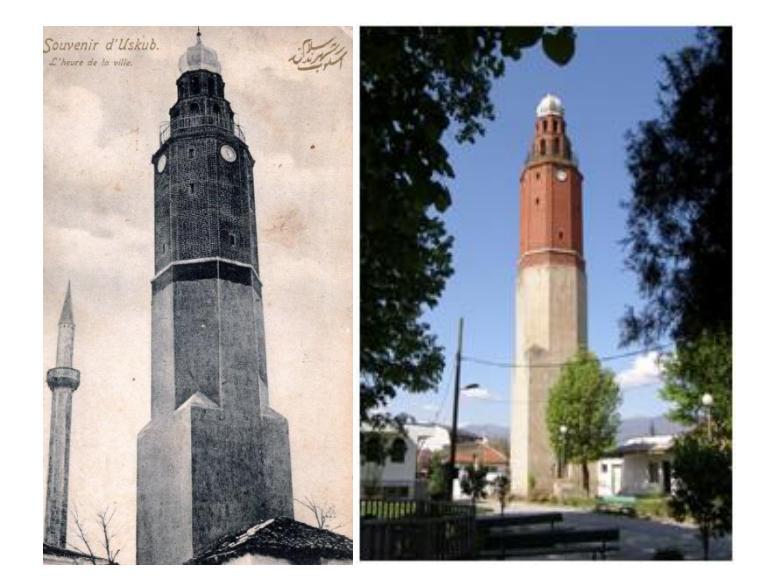
In the period after the earthquake, a report for structural strengthening was prepared. The strengthening was planned to be performed inserting reinforced concrete vertical and horizontal belt courses [2]. From the recent on-site inspection of the building, it was ascertained that the project was not implemented. Damage and cracks of the structural walls were still visible on the cleaned facade masonry as well as in the interior (Fig. 2).

Figure 1. The Sultan Murat Mosque Clock Tower (postcard from 1909) (left); Appearance in 2018 (right)

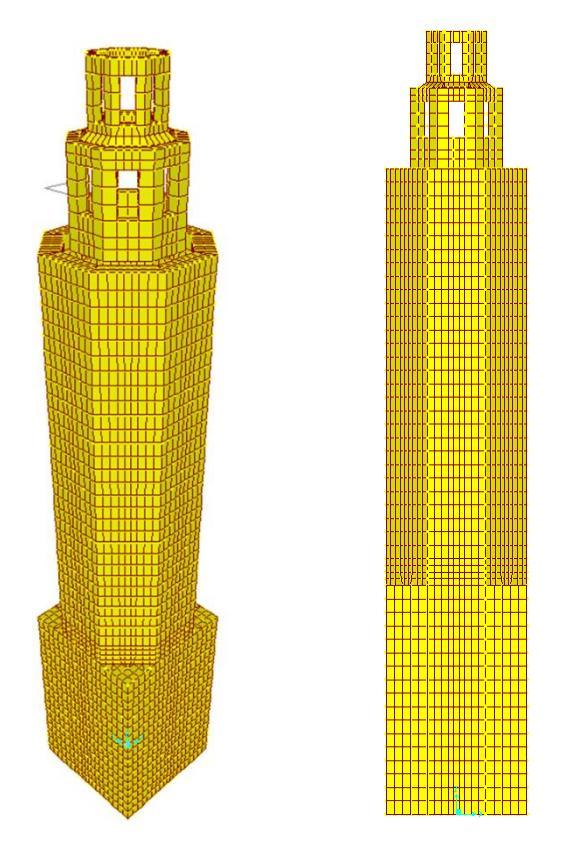
Figure 4. 3D solid finite element model of the tower

The resulting stress-deformation state indicates a sufficient capacity of stability and reliability for gravitational loads since the maximum compressive stresses are lower than the expected ultimate compressive strength of stone masonry. However, considering the maximum expected seismic impacts, tensile stresses higher than the expected tensile strength of the masonry occur in local zones, which would result in structural damage due to the expected seismic action (Fig. 6). Thus, the need for structural consolidation and strengthening was determined in order the seismic protection level to be achieved.

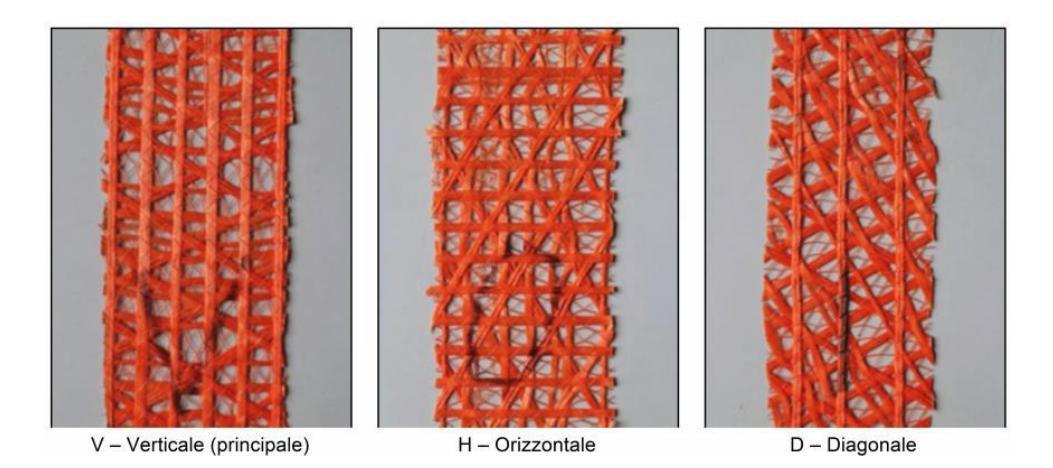
Figure 7. Used mesh of polymer-coated aramid and glass fibers

For the implementation of the strengthening system, a modern, previously experimentally verified system (ROFIX SismaCalce [5]) has been adopted, which consists of three layers: (1) a primary layer of basic hydraulic lime mortar, (2) a layer of a mesh of polymer-coated aramid and glass fibers (Fig. 7) and (3) a layer of facade lime mortar of at least 2.0 cm.

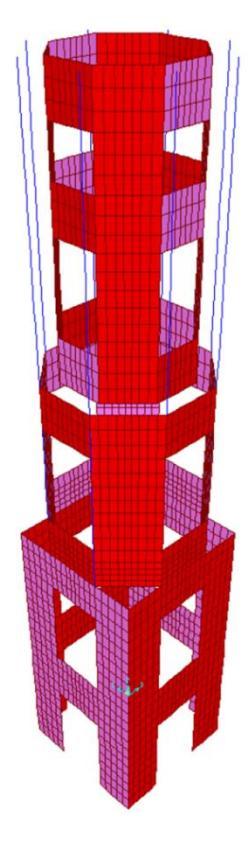
Figure 9. Numerical FEM model of the strengthening elements

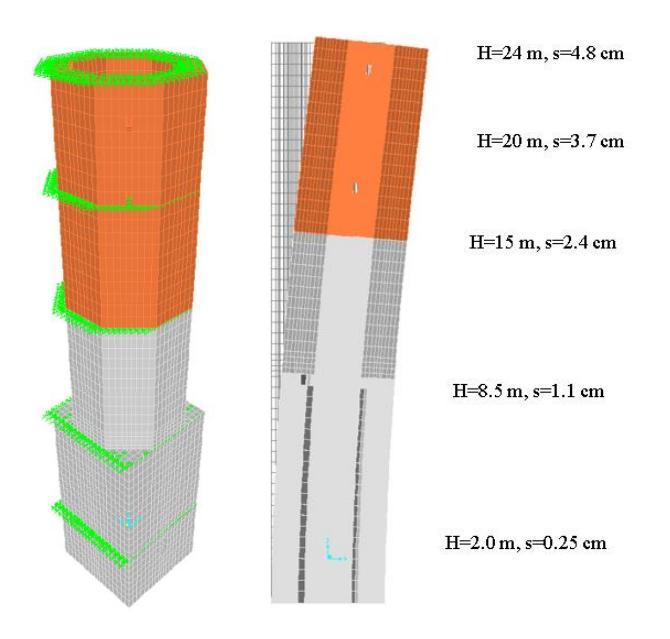
The natural periods of the retrofitted state $T_{x-x} = T_{y-y} = 0.51$ s, $T_{tor}=0.15$ s were obtained for the structure modelled in this way, which indicates a certain structural stiffening. The total displacements due to seismic force in the longitudinal and transverse direction are also reduced and within the allowed limits ($\delta_x = \delta_y = 4.8$ cm) (Fig. 10).

Figure 10. Retrofitted state - elevations of applied seismic forces (left), displacements due to the design seismic actions (right)
