THE CASE STUDY OF PRINCE RUDOLF INFANTRY BARRACKS - ASSESSMENT, MODELLING AND RECONSTRUCTION

The procedure of a detailed condition assessment of the building under heritage protection in Zagreb is presented. A detailed historical background of the case study building is shown, and observed damage and conducted in situ tests are discussed. The nonlinear static seismic analysis performed in the 3Muri software is extensively elaborated. Four different levels of reconstruction according to new Croatian law are briefly presented. Additionally, several strengthening scenarios are proposed with various strengthening techniques. The renovation of the case study building is presented through extensive photo documentation. The problems in renovations of culturally protected buildings in a specific case study are raised.

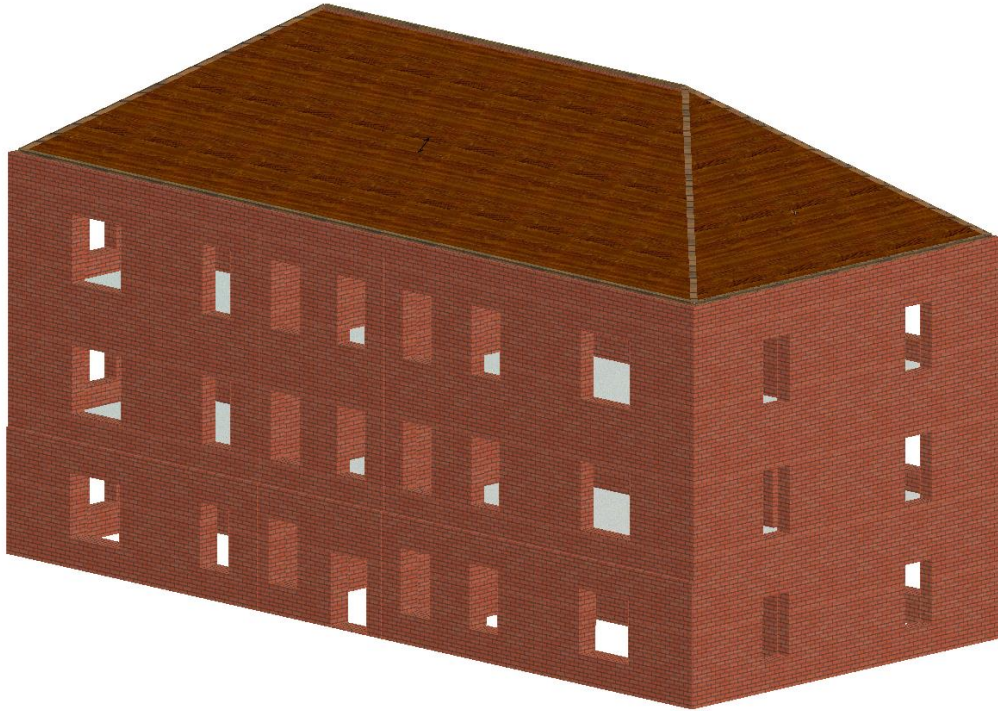
Figure 3. 3Muri model of observed building

Figure 3 shows a 3D model of the building in 3Muri. More about modelling can be found in the paper by Milić et al. [6]. Three-dimensional model with damage for the near-collapse limit state: (a) x-direction; (b) y-direction can be seen in Figure 4.
