MOST AFFECTED TYPOLOGIES FROM THE 26 NOVEMBER 2019 EARTHQUAKE

Markel Baballëku ⁽¹⁾, Rikard Luka ⁽²⁾, Klajdi Shaholli ⁽³⁾

⁽¹⁾Civil Engineering Faculty, Polytechnic University of Tirana, Albania; e-mail: markel.baballeku@fin.edu.al

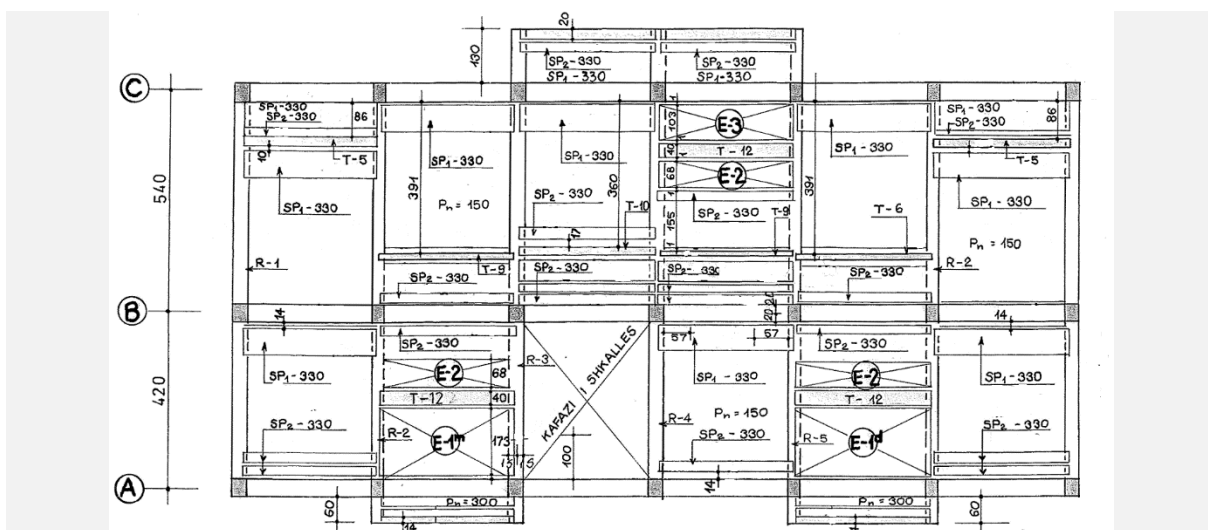
Fig. 7. Structural layout of original RC 82/2 Model (AQTN)

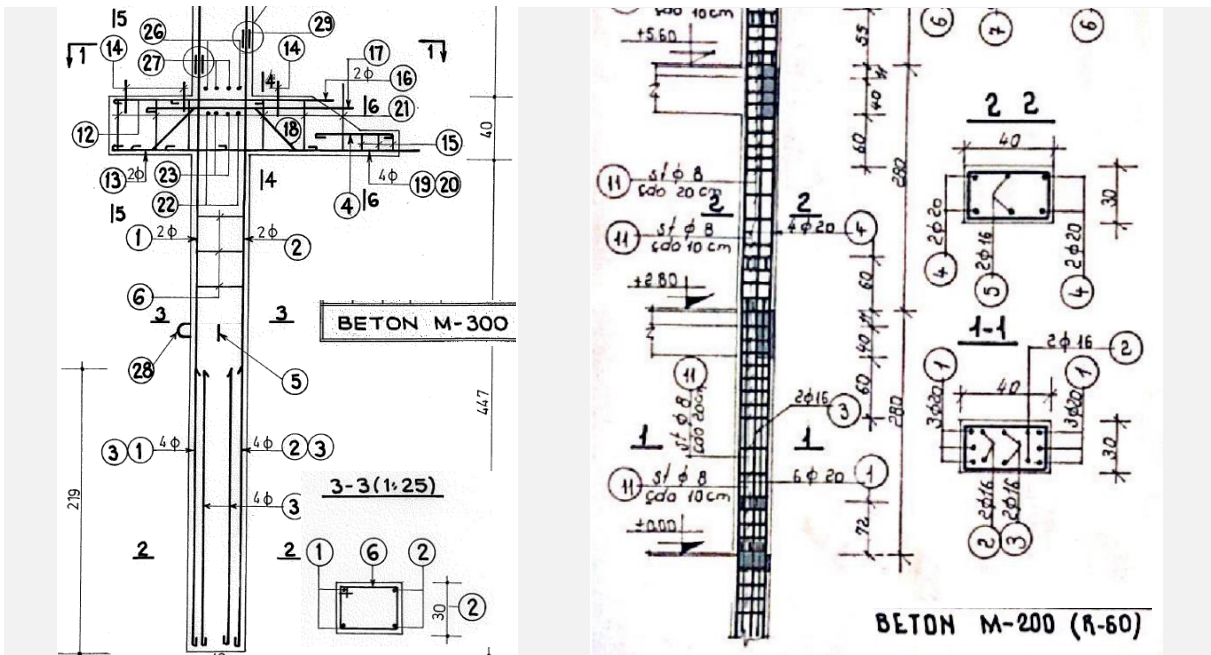
From local technical office this model was proposed to be constructed as cast-in-place RC 82/2 Model in Durrës area, initially without any change in layout, number of storeys and element dimensions. The main change was related to concrete strength and the reinforcement percentage, Fig. 8. This model is regular in plan but with irregularities in elevation due to: a-) ground floor at least 1m higher than the other floors (masonry wall under +0.00 and tie beam at top of it is not uniform and doesn't have adequate stiffness); b-) immediately reduction of columns rebar percentage (Fig. 8-b.), and, c-) often infill walls exists only partially in the ground floor – often this floor is used for services. Moreover, in some cases infill walls distributed asymmetrically in ground floor affect also the plan regularity.

Fig. 8. Column material and details: a-) Prefabricated RC Model 82/2: Concrete C25/30; Rebar 4Ø18 (less than 1%); Single hoop Ø6.5/20cm; b-) Cast-in-place RC Model 82/2: Concrete C16/20; Rebar 6Ø20+4 Ø16 (2.2%); Single hoop Ø8/10/20cm

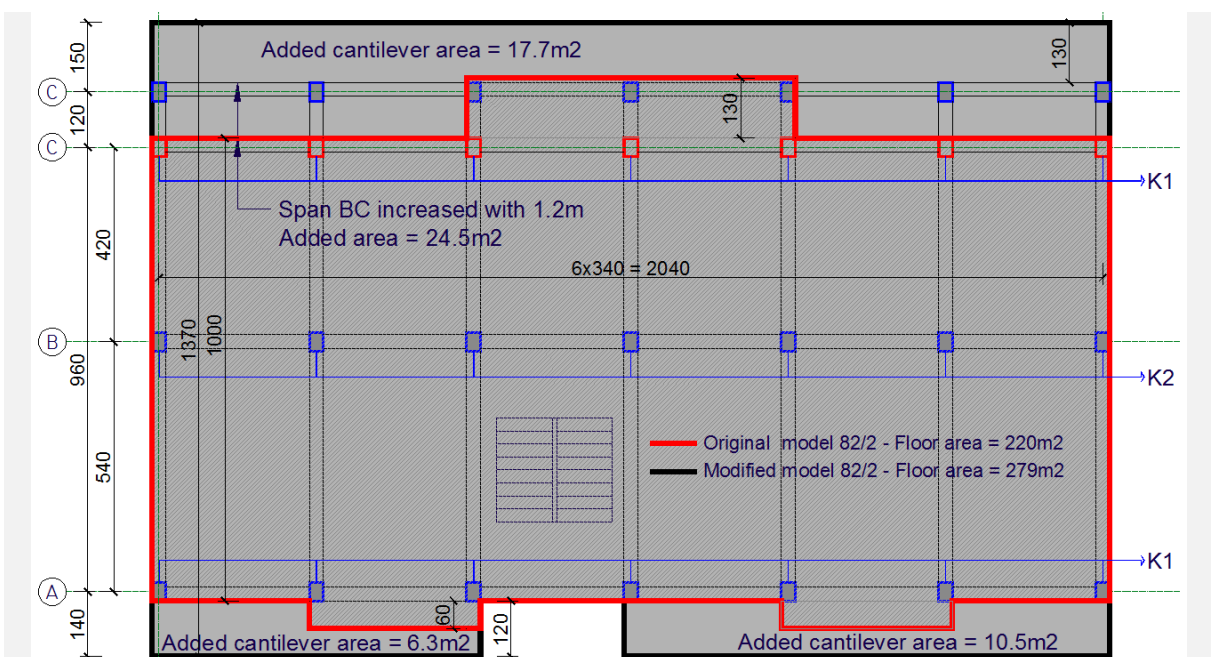
Fig. 9. Structural layout of RC Model 82/2: a-) Original model; b-) Modified model

In Fig. 9 are given layouts of two cast-in place models: Original RC 82/2 and M-RC 82/2 with the extensive changes in layout, by increasing plan area with 26.8% and in elevation by adding generally one floor. In some cases these adding volumes are followed by increasing rebar percentage (generally in beams), but in most of them the columns reinforcement remain unchanged towards original cast-in-place RC Model 82/2.
