REPAIR AND STRENGTHENING OF OLD FIRST CATEGORY BUILDING IN SKOPJE, N. MACEDONIA IN ACCORDANCE WITH IZIIS METHODOLOGY

Keywords: repair, strengthening, non-destructive tests, structural and non-structural damages, dynamic analysis

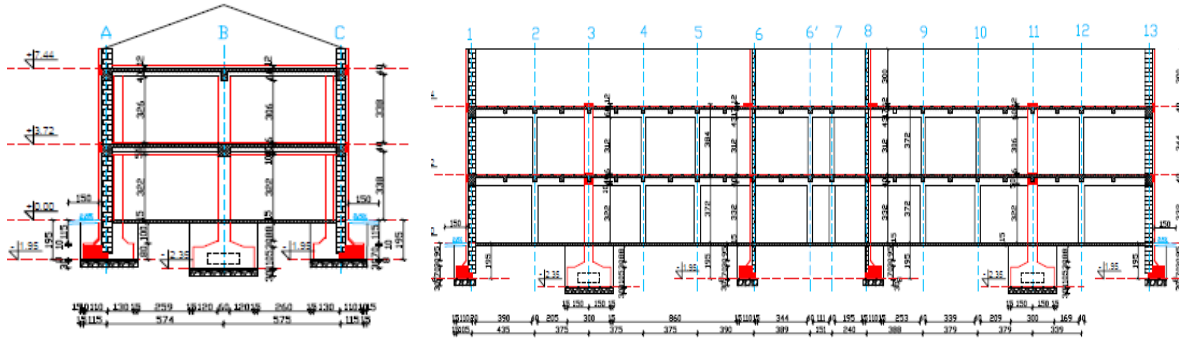
Figure 7. Cross-section of the strengthened and existing structure.

Out of a number of variant solutions, the most appropriate solution has been selected from both low-cost aspect and the aspect of satisfying the strength and deformation requirements in compliance with the valid technical regulations. The solution for strengthening of the principal structural system mainly anticipates strengthening of the structural bearing elements, walls, columns and beams, creating lines of defence against external seismic effects in both orthogonal directions (Fig. 7, Fig. 8). Repair of cracks in bearing walls and reinforced concrete elements as well as partial repair of the floor structure is done additionally. More specifically, this involves the following:

- Strengthening of the foundation structure and recommendations for drainage of atmospheric waters from the structure;
- Strengthening of the bearing walls by reinforced concrete jackets in longitudinal and transverse direction;

- Foundation of reinforced concrete jackets into own footings. The same also holds for the strengthened reinforced concrete columns;
- Inter-connection of jackets by horizontal reinforced concrete belt courses mainly along the perimeter of the structure and at the level of the floor structure over the ground floor and over the storey;

- Local repair of cracks manifested in bearing walls and reinforced concrete elements;
- Local repair of the deformed floor structure at the ground floor.

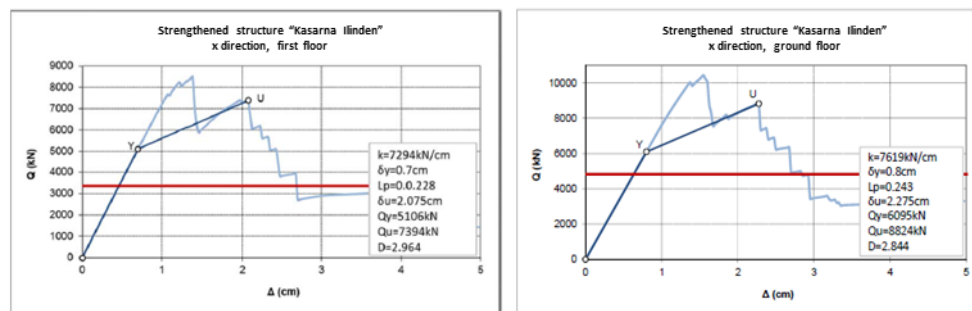
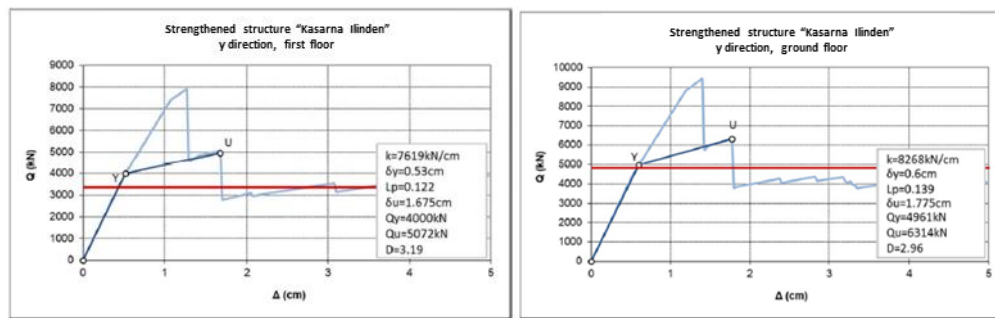
On the basis of the defined diagrams base shear-displacement and moment-curvature for every element and their transformation in diagrams force-displacement, the following floor diagrams force-deformation were defined (Fig. 8).

Figure 8. Floor diagrams force- deformation in X and Y direction (strengthened structure)

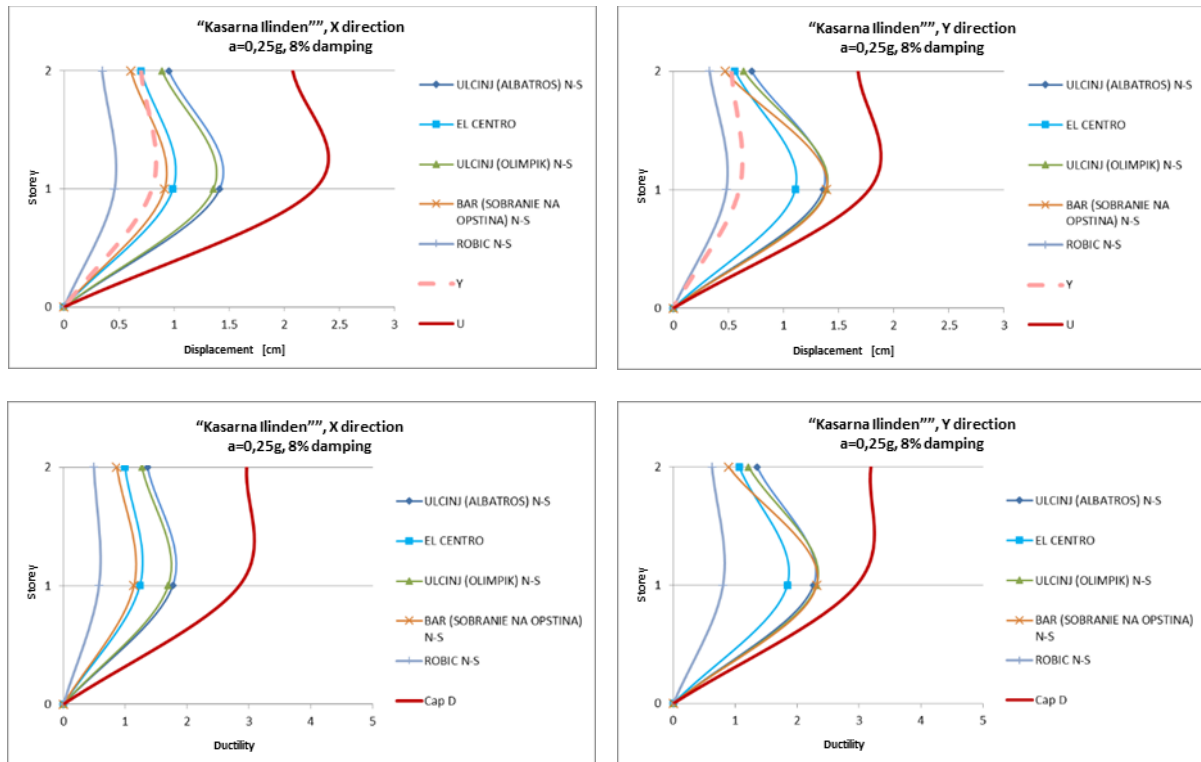
The results are shown as diagrams floor- displacement and floor- ductility (Fig. 9).

Figure 9. Diagrams floor- displacement and floor – ductility for X and Y direction

With the repair and strengthening of the structural system, a significant increase in ductility capacity and dissipation of seismic energy capability of the elements and the structural system as a whole can be noted. The dynamic response for real expected seismic actions for the location confirms that too.
