## Case studies of structural natural frequencies assessment and application in SHM and the calibration of FEM models

Davor Uglešić<sup>1</sup>, Ante Uglešić<sup>2</sup>

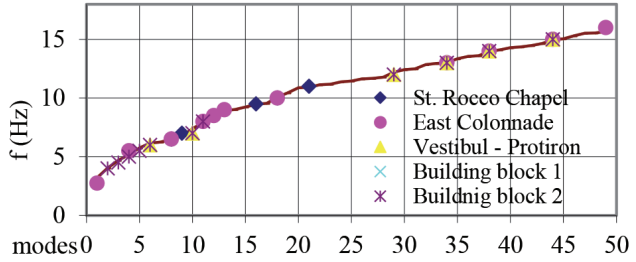
Figure 3 Comparison of frequencies

The Peristyle is the central square of the palace, surrounded by the protiron and porches. Throughout history, many buildings were constructed inside and beside the Peristyle. Some of them are still preserved on the west colonnade. The eastern colonnade was set free from the attachments in the second half of the nineteenth century. Very complex boundary conditions were given to the original structure of the Peristyle. The present aggregate consists of five parts: St. Rocco Chapel, East colonnade, Vestibule with protiron, building block 1 and building block 2 (Fig. 2). Data for natural frequencies assessment, were registered on 104 sites, for a period of 20 minutes each, and grouped in 31 verticals. The FEM model was calibrated by these results. We needed to make many changes in the FEM model to calibrate it. The results of modal analyses of the calibrated model and assessed natural frequencies are shown in the diagram (Fig. 3). By comparing the registered natural frequencies with those obtained by modal analyses, it is evident that we have a very good match. Differences generally occur in the higher tones, which is not surprising considering the very complex structure. We did not recognize the oscillations of roof and floor structures, but that was not our point of interest. In the first 14 modes, only one frequency was not recognized by measuring. A few modes are shown on Fig. 4, 5 and 6.

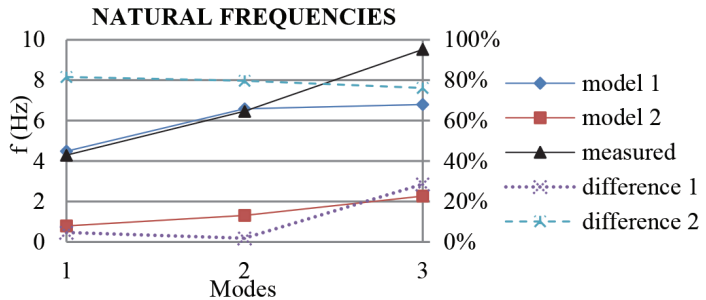
Figure 10. Comparison of natural frequencies

Within the structural safety assessment, it was necessary to determine the structure behaviour between the two options, including infill walls with or without them (Fig. 9). So two FEM models defined in accordance with these options were made on which modal analyses were conducted. The results obtained by assessment of natural frequencies showed a high degree of matching with the model with included infill walls (Fig. 10).

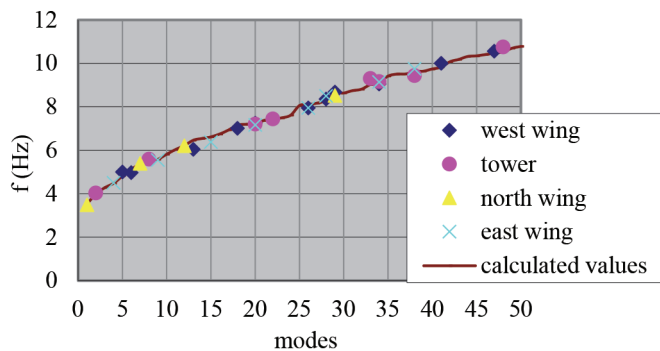
Figure 13. Comparison of calculated and measured frequencies

current layout, which includes part of the city walls with a round tower. It consists of three wings and a tower. The floor number of the building is GF +1. The walls are built of solid brick in lime mortar. Above the ground floor, there are brick vaults, above the first floor, there is a wooden structure, and the roof structure is wooden. The assessment of natural frequencies was carried out as part of extensive testing of the mechanical properties of the structure. We performed the measurements in two phases. In the first phase, we measured at 30 points. In the second phase, we performed 41 measurements. Repeated measurements in the second phase were prompted by doubts about the accuracy of the first phase. From the results of the first analysis, it was not possible to estimate the natural frequencies of the structure. The reason for this is the structure of low height and high stiffness. Similar problems appeared when natural frequencies of low-rising building schools in Canada were assessed (Tischer et al [5]). With additional analyses, results were obtained that could be used to calibrate the FEM model. Comparing the natural frequencies, we can conclude that from 50 tones obtained with modal analysis (Fig. 11 and 12) by measuring on the structure, we identified 31 of them (Fig. 13).

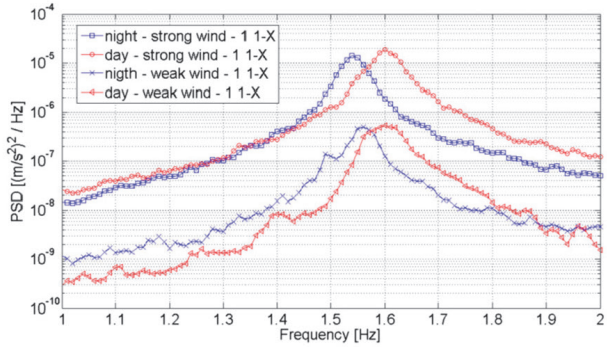
Figure 15. Changes of natural frequencies [6]

Guglia Maggiore is a carved stone bell tower structure on the roof of the cathedral in Milan. Overall, the structure extends to 40 meters in height. On Fig. 14 are marked the places where accelerometers were placed. The results of the research conducted by Busca et al [6] inter alia show the changing of natural frequencies depending on the wind speed and time of day: day or night (Fig. 15). The changes of day (high traffic) and night (low traffic) and the wind speed significantly affect the changing of natural frequencies.

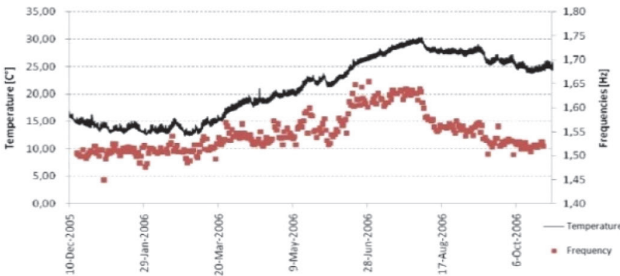
Figure 16. Changes of natural frequencies [7]

Headed by Prof Roca from Universidad Polit cnica de Catalunya [7], an extensive multi-year static (cracks, relative displacements or convergences, piers inclination, environmental parameters: temperature, relative humidity, wind direction and velocity) and dynamic monitoring of the cathedral in Mallorca was conducted. We chose the results which show changes of natural frequencies during the year due to changes in temperature (Fig. 16) and surface of multiple regression for temperature, humidity and natural frequencies (Fig. 17). These studies have shown that the temperature and relative humidity had significantly affected the dynamic properties of the building so that the values of natural frequencies changed up to 3 %.

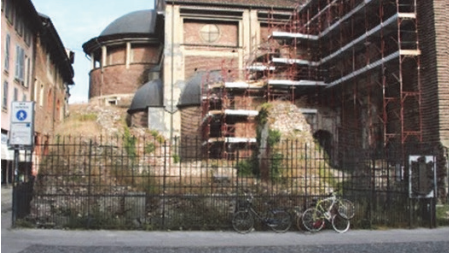
Figure 21. Remains of Torre Civica in Pavia today

- Torre Civica in Pavia, Italy (March 17<sup>th</sup> 1989) - four killed (Fig 21)
- The bell tower of St. Magdalene church in Goch, Germany (May 24<sup>th</sup> 1993)
- Cathedral of St. Nicholas in Noto, Sicily (March 13<sup>th</sup> 1996)
- Bell tower of St. George church in Pleškovec, Croatia (June 4<sup>th</sup> 2008) (Fig. 22).
