Influence of tram vibrations on earthquake damaged buildings

Ivo Haladin¹, Katarina Vranešić², Mate Ivančev³, Stjepan Lakušić⁴

Zagreb 2020 earthquake severely damaged the historic centre of the City. Most of the damage occurred on historic masonry residential buildings of which many are situated in very close vicinity to the tram track. Vibrations generated by traffic can be harmful to buildings if they have been damaged by a previous earthquake. Vibrations could attribute to propagation of existing cracks. The effect of vibration depends on many factors, and one of the most important is the distance between the track and the building. The vibrations are highest at the source and their energy loss is due to transport through the soil to the recipients, so the vibrations at the recipients can be reduced by 2 to 15 dB. In this paper, the impact of tramway induced vibrations on earthquake damaged buildings in the city of Zagreb is described. In the first step of analysis, a track segmentation was performed based on the distance between the track and damaged buildings. Each segment was assigned a score based on the risk of vibration exposure. Vibrations were measured continuously on

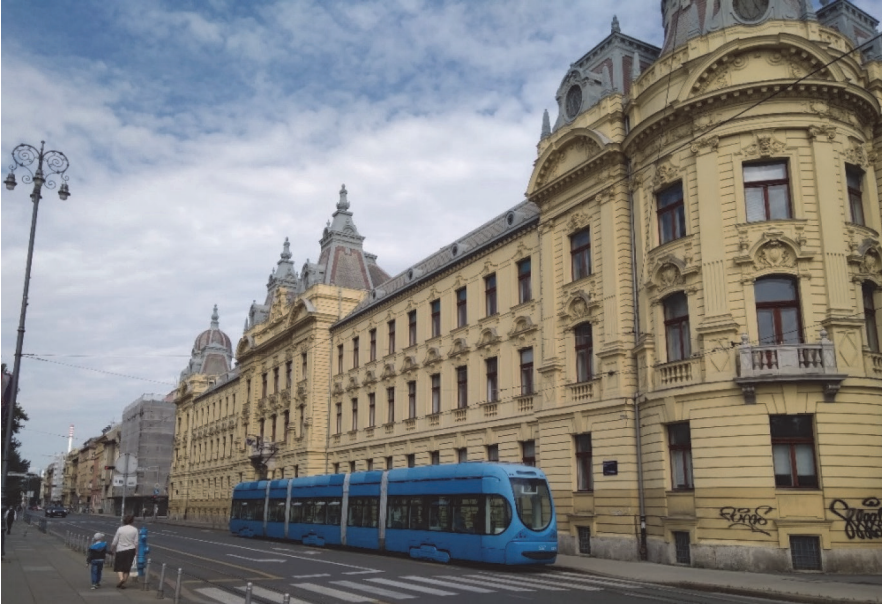
Figure 5. Tram passing in front of HŽ Infrastructure head-office building

The influence of tram traffic vibrations on earthquake-damaged buildings is a long-term process because of low-level vibrations that do not cause any immediate damage. It is only the accumulated action of a considerable number of repeated vibrations that can have an influence on masonry buildings of the type that mostly suffered damage in the earthquake that hit the city of Zagreb, as documented in [2]. Thus an initial testing of the influence of tram traffic vibrations on buildings was conducted for the purpose of conducting a long term monitoring of buildings that suffered damage in this earthquake. The testing was conducted on the HŽ Infrastructure head-office building built in 1903, which is situated at Mihanovičeva 12. As a result of the earthquake, the building suffered considerable damage to central staircase, partition walls, and load bearing walls on higher floors of the building. The building is also situated in the immediate vicinity of the tram track passing through Mihanovičeva street. The axis of the closer track is situated only 5 m away from the facade of this building.

at points MMa8 and MMa10, which are situated at the eastern corner of the building (Figure 5). Higher vibration levels were also registered at this locality (intersection with Ljudevita Gaja street) during vibration measurements in tram vehicle (Figure 4). Rail induced vibrations in HŽ Infrastructure building have also been calculated according to HRN DIN 4150 [8] for all tram types and speeds that passed in front of the building in 5 days of monitoring (more than 9500 tram passes). Peak vibration velocities recorded reached 0,67 mm/s. It is important to notice that peak vibration velocity calculated according to [8] never reached values that would be marked as harmful for sensitive buildings (2,5 mm/s).

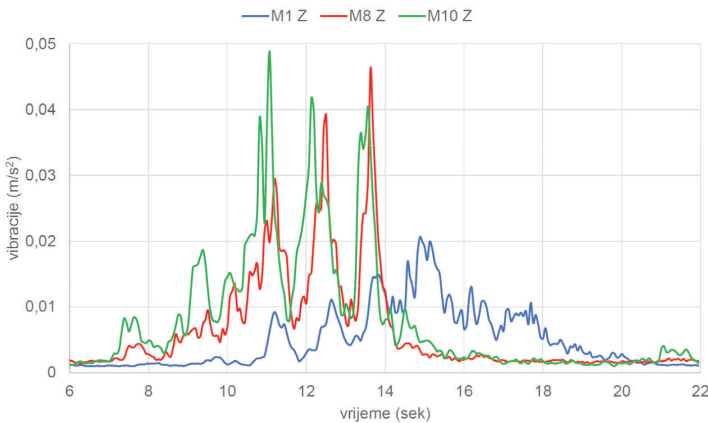
Figure 6. Vibration levels measured in vertical direction during passage of tram type TMK2200 at measuring points MMA1, MMA8, and MMA10

Some differences in vibrations generated by passage of tram vehicles were observed during preliminary investigations at some points within the building. In this respect, it is interesting to note that the highest levels of vibrations in this building were registered

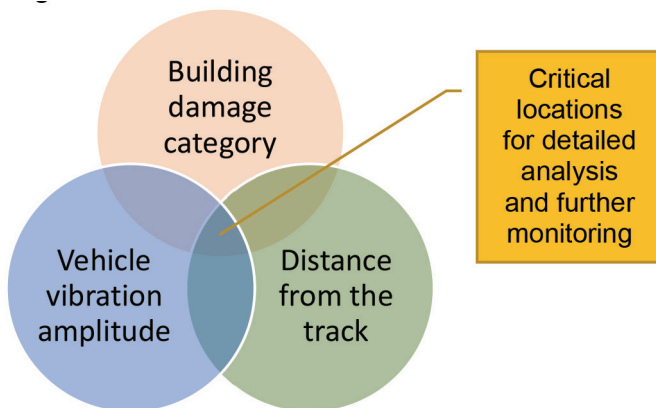
Figure 7. Detecting the most critical locations based on building damage, vehicle vibrations and distance between buildings and tram track

Although preliminary analysis on one of damaged buildings in Zagreb showed that vibrations were not harmful according to [8], other locations with different levels of vibration at source (railway track) should also be considered. Critical locations for further detailed analysis are being investigated according to criteria described in Figure 6.
