40 years after Montenegrin earthquake: lessons learned and future challenges

Nina Serdar¹, Jelena Pejovic²

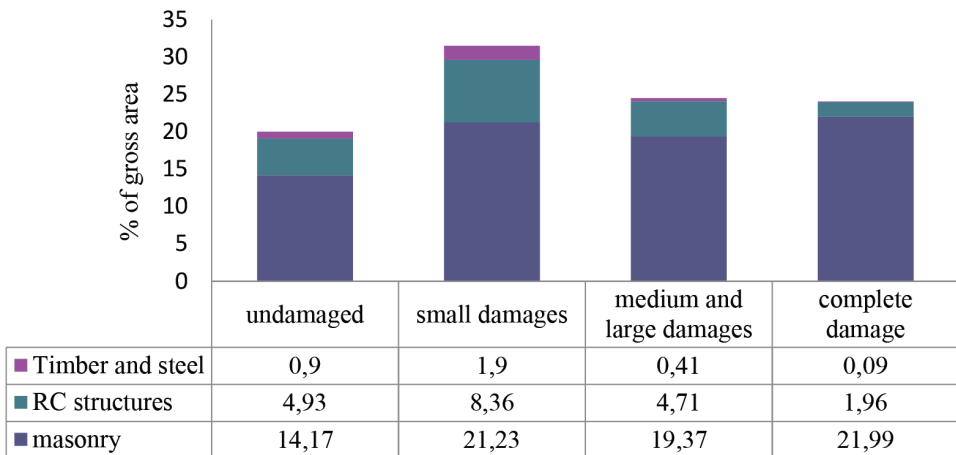
Figure 1. Damage classification according to structural type in percentage of gross area of all inspected facilities after Montenegro earthquake

of both percentage in number and gross area, were masonry structures. Fig. 1. shows the distribution of damage in percent of the total area of all investigated facilities depending on the type of structure. As much as 22 % of the area declared as complete damage is accompanied to masonry structures, while approximately 2 % were RC structures. Fig 2. shows the distribution of damage among the types of masonry structures, where it is observed that the largest damages occurred in stone masonry structures, i.e. 19.6 % of the total gross area investigated that was declared as complete damage were stone masonry structures, while as expected, much better behaviour was observed in confined masonry buildings. Among RC structures, RC frame systems proved to be the most vulnerable, see Fig 3.

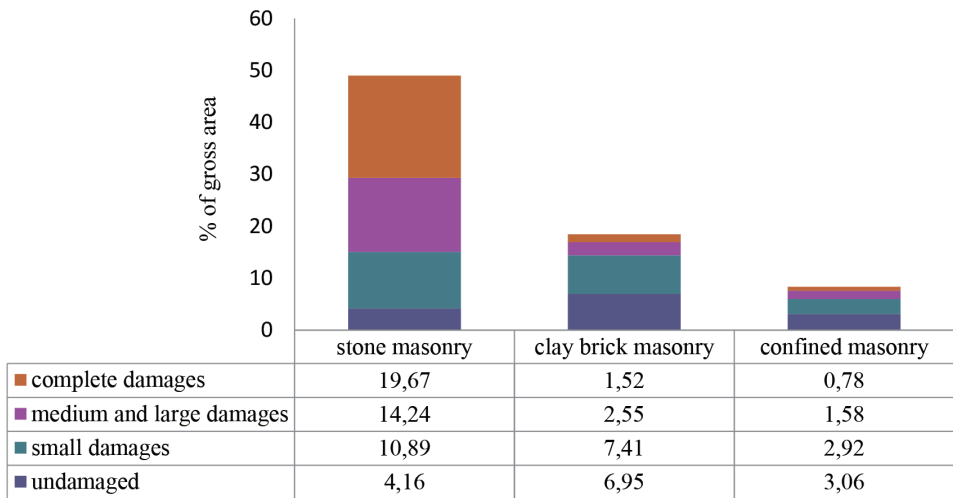
Figure 2. Distribution of damages among masonry structural systems

It was obvious that most vulnerable structures were stone masonry structures, that were heavily damaged and and the large number of this type of structures suffered complete damage. In next period of time, even for structures that have not been damaged, or had small damages, the technical condition for obtaining building permits in-

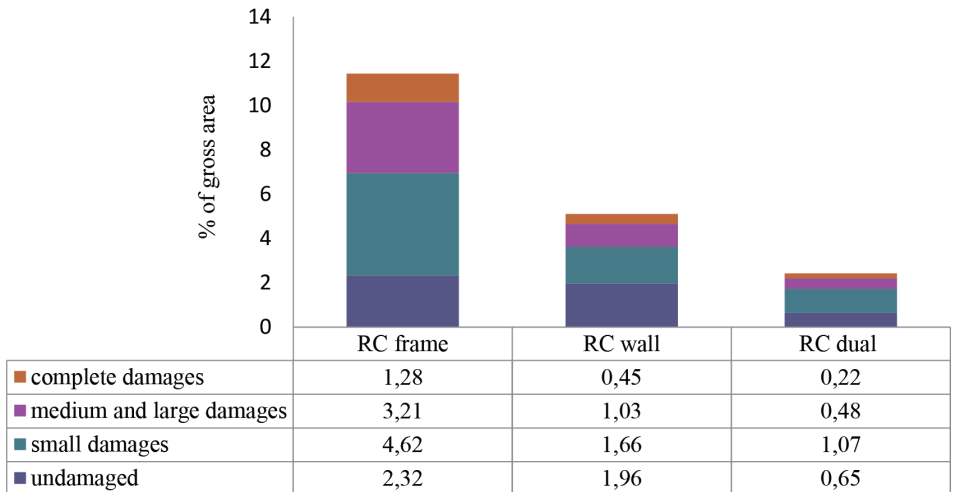
Figure 3. Distribution of damages among RC structural systems

Regarding the significant number of modern reinforced concrete structures that had collapsed, mostly hotels situated on sea coast, it was concluded that most vulnerable among them were RC frame structures. Even if those structures have not been seismically designed, it was noticed that dual or I-wall systems from same construction period, suffered less damage. The combination of soft soil characteristic and flexible RC frame structures led to resonant behaviour and severe displacements and damages.

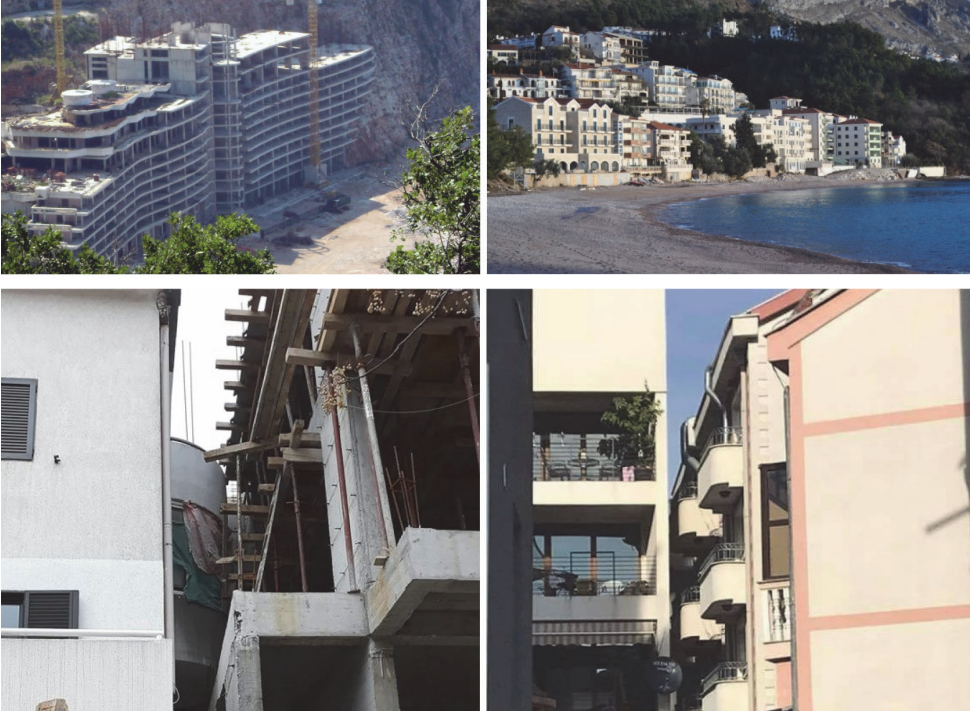
Figure 5. Uncontrolled urbanisation and construction at the Montenegrin coast, illegal construction (photo source: Montenegrin news portals)

Still, it is evident that not all planned is also executed in practise. Main omissions are most obvious at the local level. Often inadequately altered detailed urban plans of settlements or their disrespecting in practise, as well as during time developed tolerance to mass illegal construction (see Fig. 5), led to significant increase in density of population and concentration of construction in urban areas. It is easy to conclude that consequently all above led to increase of seismic risk. Perhaps the best description of the situation on site can provide the term "investor urbanism" (a term used by the domestic professionals and public), which indicates the concept policy applied in urbanism in which the financial interests of investors are often at the expense of the public interest. As the example here will be stated only several ongoing cases in Montenegro: rapid and uncontrolled development in the most attractive locations right next to the coast (see Fig. 5), urbanization of national parks, etc.
