EARTHQUAKE PERFORMANCE OF A CULTURAL HERITAGE BUILDING: THE JESUIT COLLEGE IN DUBROVNIK, CROATIA

Keywords: unreinforced masonry, cultural heritage, finite element model updating, earthquake performance assessment

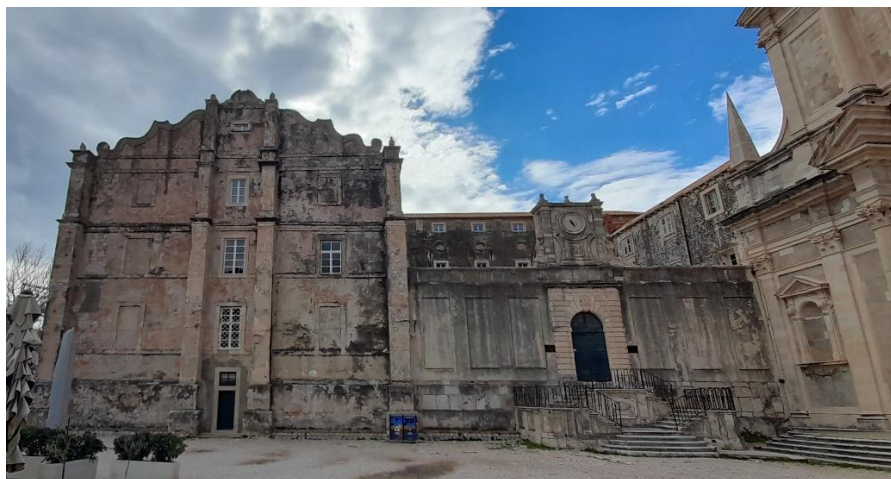
Figure 1. Episcopal Seminary Building and Classical Gymnasium, Dubrovnik, Croatia [15].

The Episcopal Seminary Building and Classical Gymnasium is one of the city's oldest educational institutes (shown in Fig. 1). The construction dates back to 1662 and was further developed over the years until 1725. The internal walls are predominantly composed of irregular stone masonry laid in lime-mortar. The deterioration of exterior walls exposes the variability in the material composition mainly attributed to the different construction stages and maintenance over the years, as shown in Fig. 2. The geometry, structural details, and damage conditions were assessed previously through a qualitative site inspection in part of the research project SeisRICHerCRO [14]. The roof structure is predominantly made of wood with no precise information available regarding the material properties. Wooden beams supporting the flexible floor system are supported on top of masonry corbels without embedment into the adjacent walls. The most important structural and architectural feature of this building is the different type of vaults supporting the floor slab. Fig. 3 shows the location of the cross and barrel vaults laid in stone masonry. In addition, the top floor also features tensile tie rods, providing additional lateral support to the parallel walls in the out-of-plane direction.

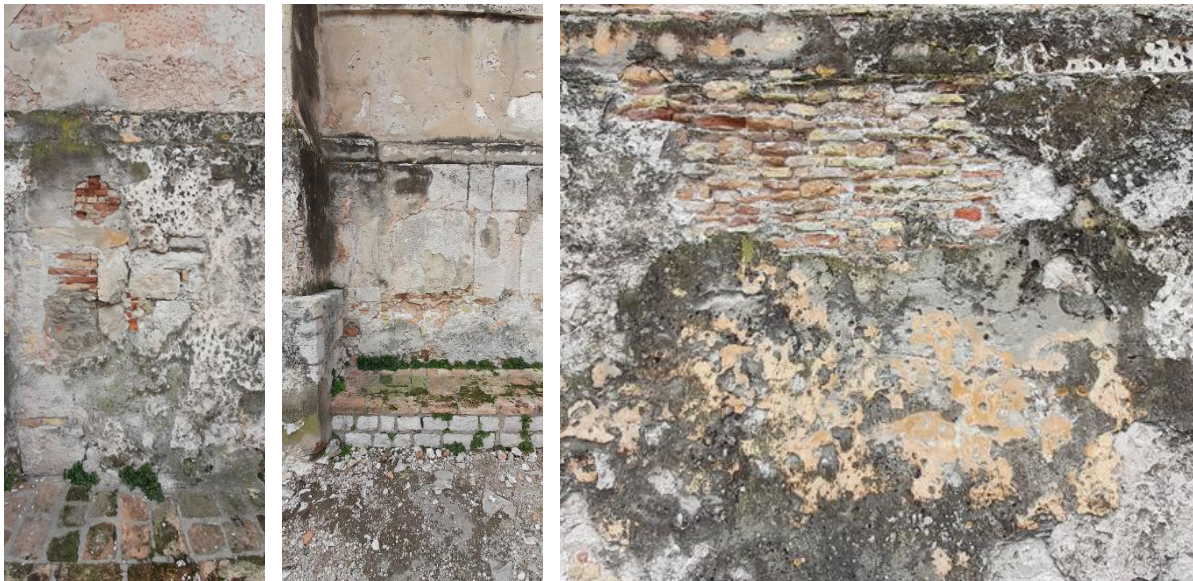
Figure 2. Materials characteristics of the external walls (composite clay bricks and stone masonry of variable sizes).

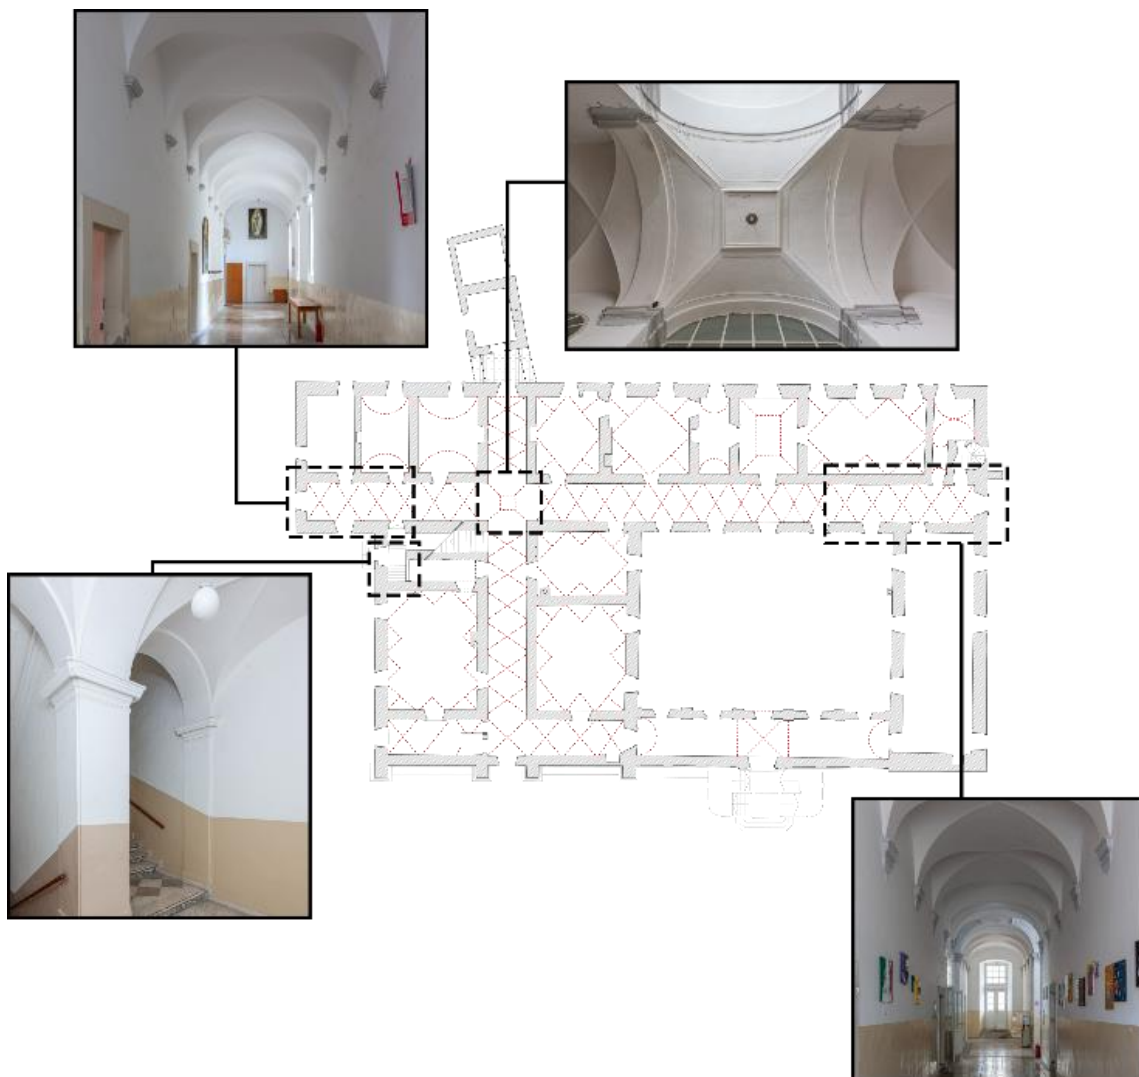
Figure 3. Location and types of different vault systems in the Jesuit College.

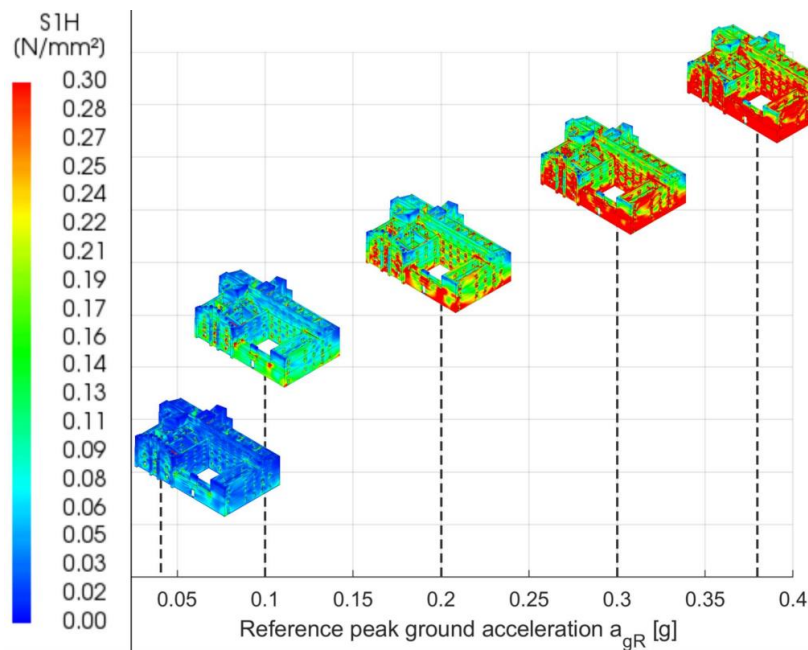
Figure 10. Progression of principal tensile stresses S_{1H} obtained using LC1 by considering different peak ground acceleration values corresponding to the seismic zones in Croatia.

The numerical model is further evaluated for increasing values of a_{gR} corresponding to different seismic zones in Croatia. Fig. 10 shows a gradual increase of tensile stresses (S1H) where, the limit $f_{t,CF}$ of 0.30MPa is exceeded. For low seismic hazard level ($a_{gR} = 0.10g$) the stresses are below the limit in practically all areas. The limit is exceeded for $a_{gR} = 0.20g$ in localized regions such as openings and critical corners.

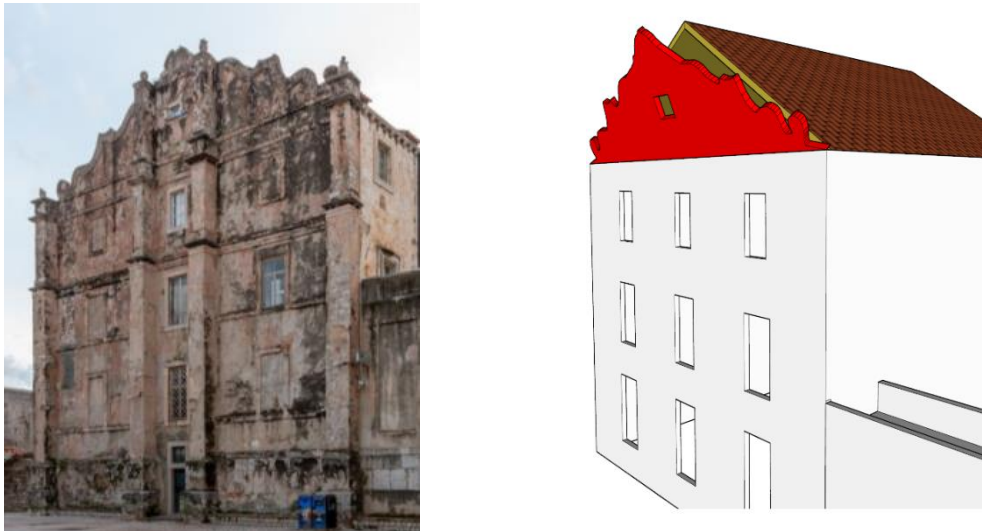
Figure 11. Description of the assumed local mechanisms LM1 and LM2. a) Clock wall; b) Gable Wall.

Fig. 11 shows the two probable local failure mechanisms i.e., LM1 and LM2 for the clock and gable walls. The local mechanism (LM1) is the overturning of the whole wall assuming no connection to the orthogonal walls. The local mechanism (LM2) indicates the overturning of the upper part of the clock wall. Fig. 12 illustrates the change in compliance factor for different levels of seismic demand. For the clock wall, the relatively smaller value of α_{eff} in case of LM1 shows that only 0.053g is needed to activate the mechanism, making the clock wall very vulnerable to OoP damages. In the gable wall, LM1 is activated at an a_{gR} of 0.144g. The Croatian NA to Eurocode 8 requires the verification of significant damage (SD) and damage limitation (DL) limit states with peak ground accelerations 0.301g and 0.156g respectively [18]. The small values of compliance factor for both limit states indicate the high vulnerability of the clock and gable wall.
