SEISMIC BEHAVIOUR OF BEAM-COLUMN JOINT IN R/C FRAMES AND STRENGTHENING WITH FRP

Keywords: beam-column joint, moment-resisting frame, seismic behavior, strengthening, FEM analysis

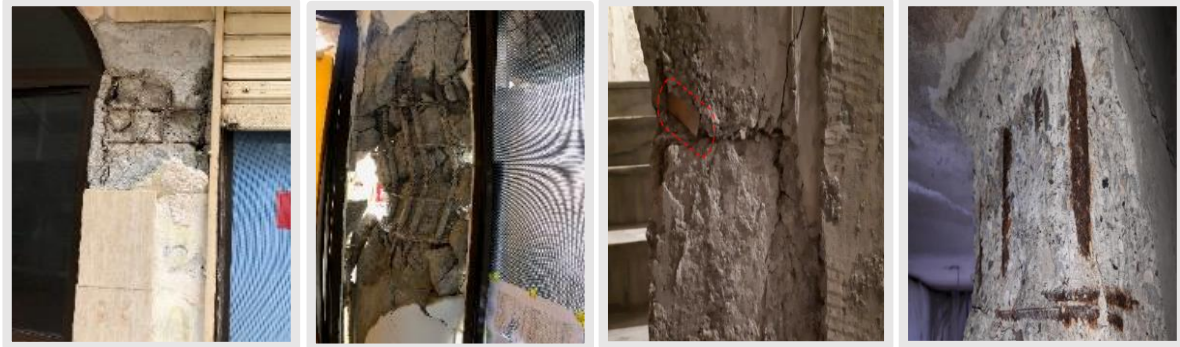
Fig. 5. Plastic hinge at the columns of multi stories building, inadequate materials and other deficiencies.

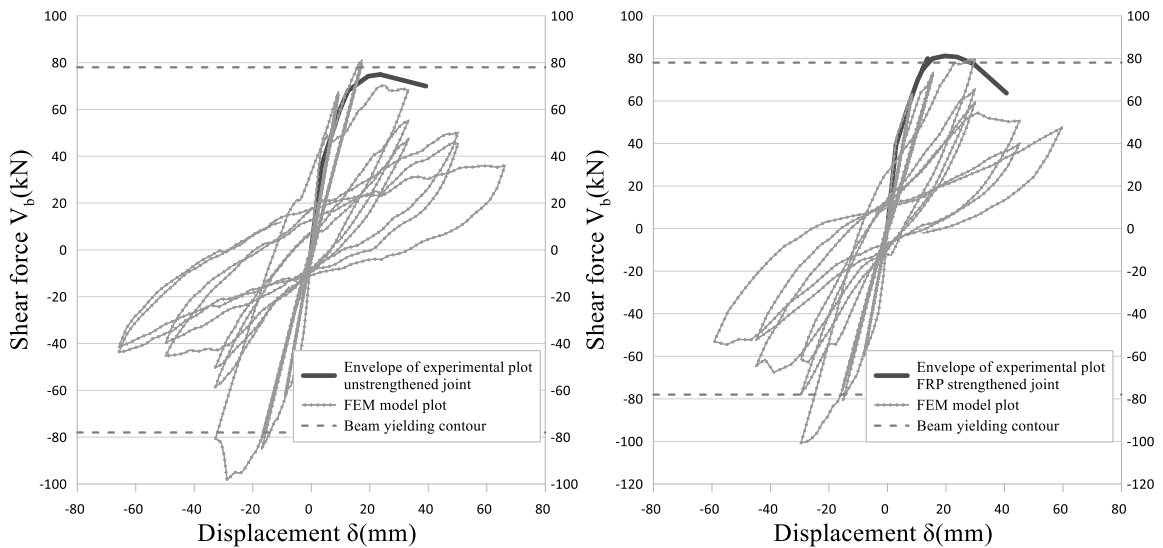
Fig. 8. Shear-drift response of tested joints: (a) envelope of unstrengthened joint vs FEM model plot; (b) first cycle envelope of FRP strengthened joint vs FEM model.

FE analysis of joints under cyclic incremental loading is conducted in reference to the control joint. Material constitutive laws and bond slip parameters of FRP are determined through an iterative process. Iteratively the procedure for obtaining a new bond slip function of FRP is progressively repeated until an acceptable adjustment of the load-displacement diagram is achieved where the percentage of error is achieved.

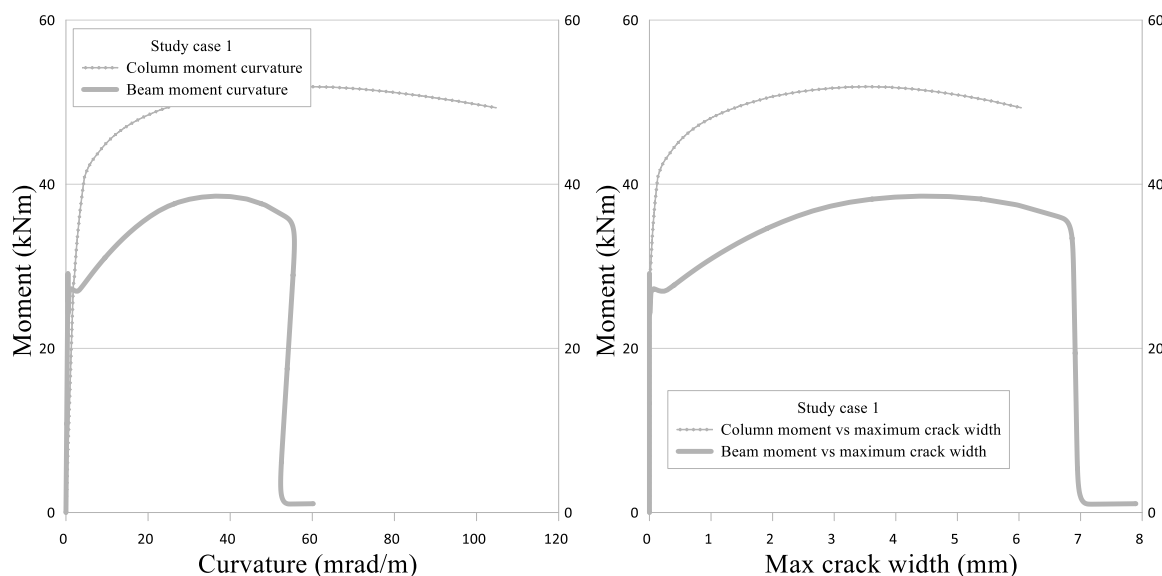
Fig. 8. (a) Beam and column moment-curvature diagram; and (b) Moment-max crack width diagram.

In the first study case, the column moment yield point exceeds the maximum moment resistance of the beam, meeting the criteria for satisfaction as per the Eurocode 8 standards. A comparison of the diagrams from all study cases allows us to infer that favorable material properties significantly impact the behaviour of the beam/column system. At the same time, the reinforcing measures exert a more significant influence on the joint's response.

The moment-curvature diagram depicts the correlation between the bending moment (M) and curvature (Φ) of the beam/column, with a characteristic shape observed in all study cases. This diagram serves as a tool to evaluate the stiffness of the beam/column, its ultimate strength, load-deflection behaviour, and design considerations. The vertical axis represents the bending moment, while the horizontal axis indicates the curvature (mrad/m). Additionally, the moment-max crack width diagram represents the element's behaviour, where the inertia moment, stiffness, and other parameters decrease as the crack width increases.

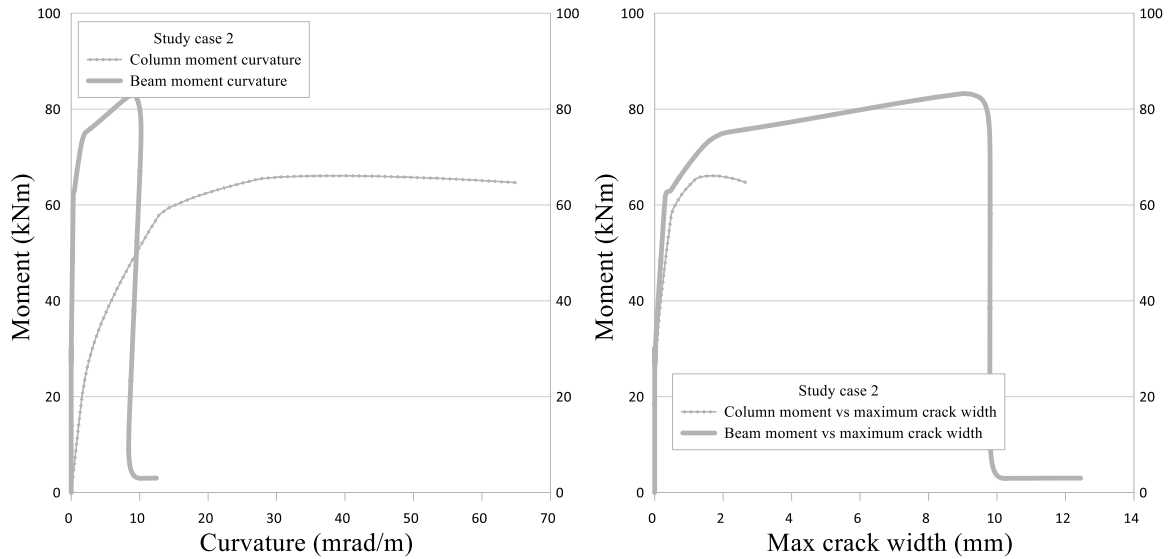
Fig. 10. (a)Beam and column moment-curvature diagram; and (b)Moment-max crack width diagram.

The diagram above demonstrates that the column moment yield point is significantly lower than the maximum moment resistance of the beam. Despite the joint possessing moderate detailing, its response is unsatisfactory.

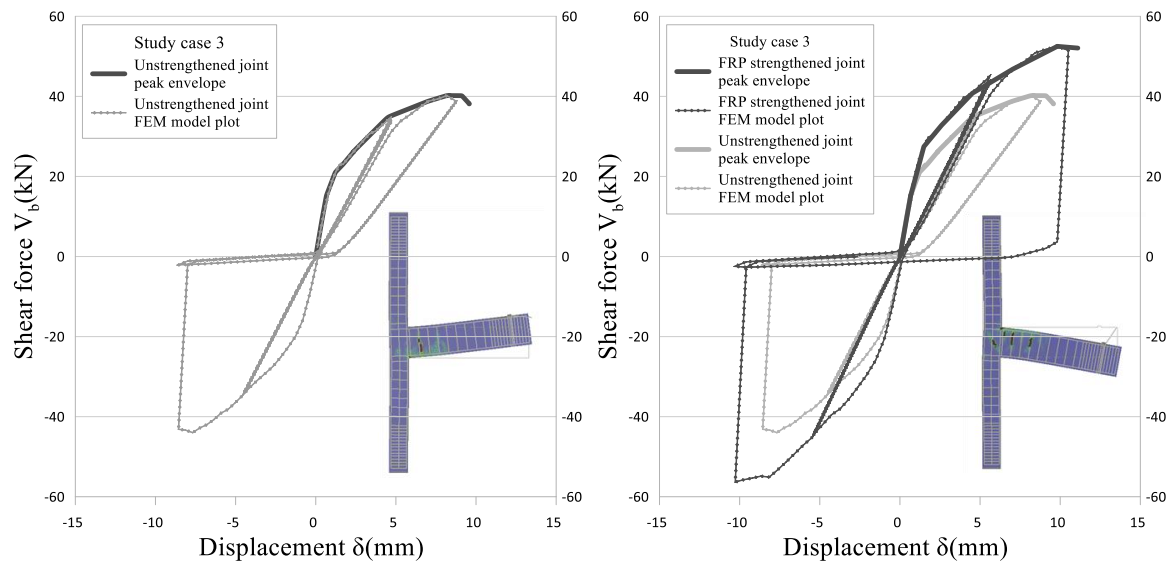
Fig. 13. Joint shear-drift response of analyzed joints: (a) FEM model plot and peak to peak envelope of unstrengthened joint; and (b) FRP strengthened vs unstrengthened joint
