# CUSTOMIZED SEISMIC SCREENING TOWARD SUSTAINABLE PUBLIC BUILDINGS ENERGY EFFICIENCY

## Abstract

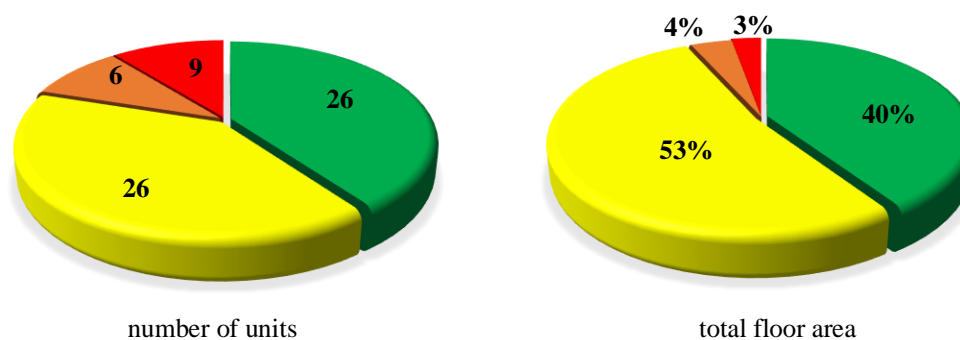
Figure 2. Distribution of medical facilities according to IZIIS' methodology

However, implementing IZIIS' extended and upgraded methodology, (steps 2, 3 4) which gives the possibility to take into account and reconsider the in-situ situation of each of the structural unit, confirmed with the site inspection and nondestructive measurement, as well as the elaborated acceptable level of risk from the deficiencies to meet the current seismic code, results in significantly different building categorization, (Fig. 2). Due to these reconsideration, vast majority of the structural units are categorized with lower seismic risk by at least one level, although there is one structural unit which turned in "red" from "orange" since it was seriously damaged.
