2nd Croatian Conference on Earthquake Engineering

Conference Proceedings

2nd Croatian Conference on Earthquake Engineering – 2CroCEE

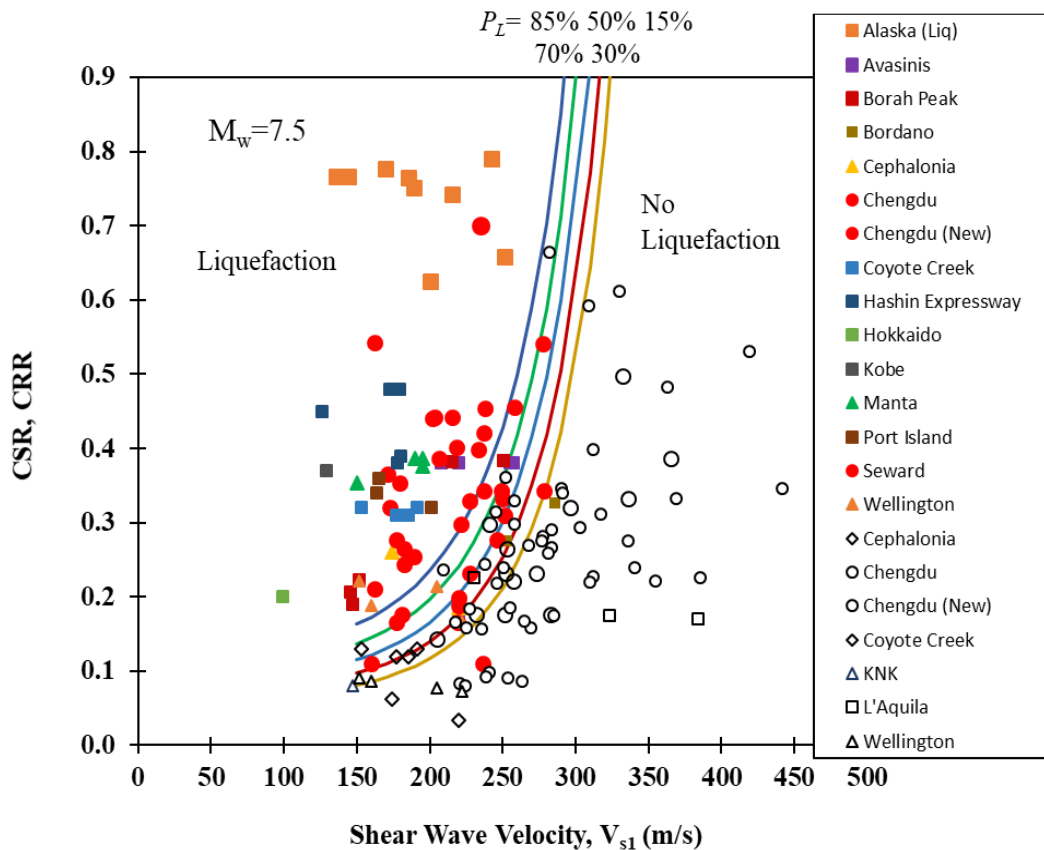
Figure 2. Plot of CRR vs. V_{s1} for a M_w 7.5 earthquake with various probabilities of liquefaction based on expanded V_s -based database collected by Rollins et al. [56]

where P_L is the probability of liquefaction expressed as a fraction. If a given probability and M_w of 7.5 is used in Eq. 9, a plot of CRR vs. V_{s1} can be produced for a given probability. Fig. 2 provides a plot of CRR vs. N'_{120} for M_w 7.5 for various P_L values proposed by Rollins et al. [56].

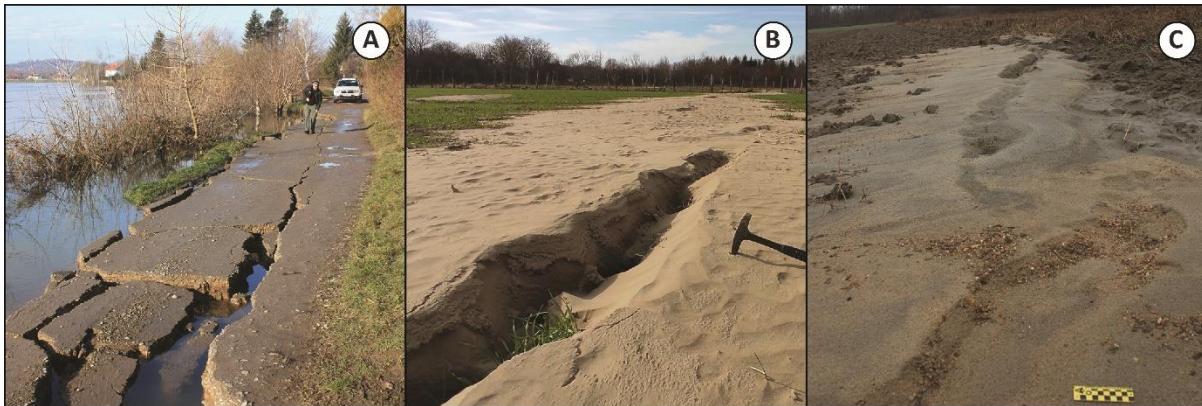
Figure 2. Examples of liquefaction following the Petrinja earthquake (modified after [2]): a) lateral spreading along Kupa river embankment at Letovanic; b) crack with sand ejecta in the alluvial plain of the Sava river; and c) sand and gravel ejecta of different provenance with the presence of shells close to the Kupa river.

An European team of researchers (geologists and engineers), in tight collaboration with the Croatian Geological Survey, performed field reconnaissance campaigns with the aim of providing a detailed identification and characterization of the primary and secondary geological and geotechnical coseismic effects induced by the Croatian earthquakes [2]. To improve the understanding of the liquefaction phenomena [3], the Working Group integrated the data collected directly in the field with those from a remote survey by drone aerial photos acquired immediately following the earthquakes. This process allowed for the collection of the liquefaction record with the highest possible completeness both in terms of pattern and distribution of the phenomena. The data set includes several detailed case studies typified by the following characteristics: (a) liquefaction occurring on alluvial plain sites (Kupa, Sava and Glina rivers); (b) ejecta consisting of sand and/or gravel locally associated with shells and armoured mud balls; (c) lateral spreading phenomena along roads and river embankments; (d) sand ejecta of different grain size and composition, even at the same site; and (e) sand and/or gravel ejecta developed along fault traces.

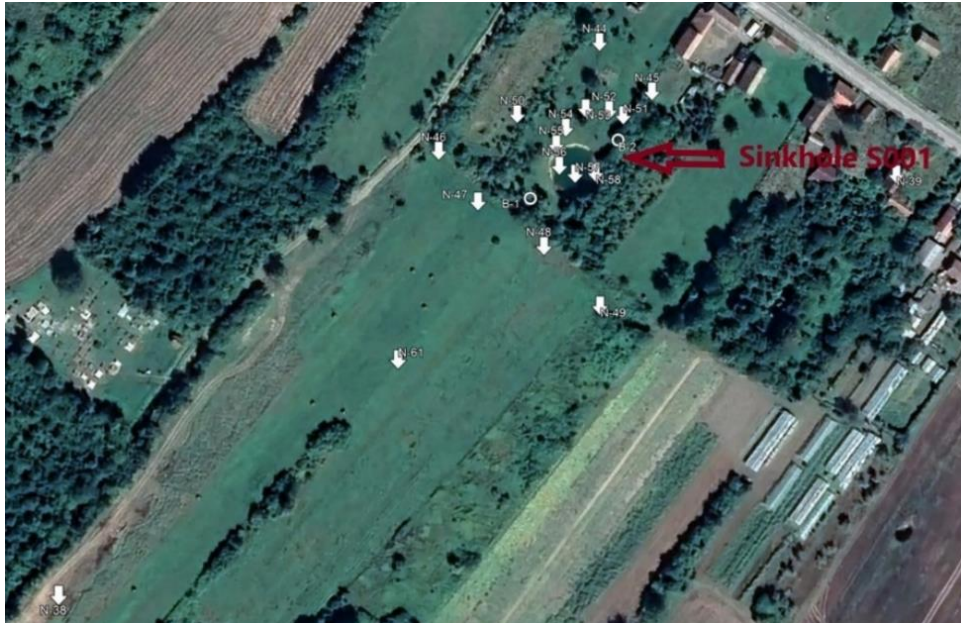
Figure 3. Sinkhole S001 and nanometrics measurement locations (modified from [1])

An initial assessment of the nanometrics data is performed for positions N-38, 44 through 48, 50 through 53, 55 through 59, and N-61 to evaluate overall HVSR frequencies and information on depths of strong impedance contrasts. The analysis is performed for data from nanometrics measurements around the area of S001, the measurement locations are show in Fig. 3.

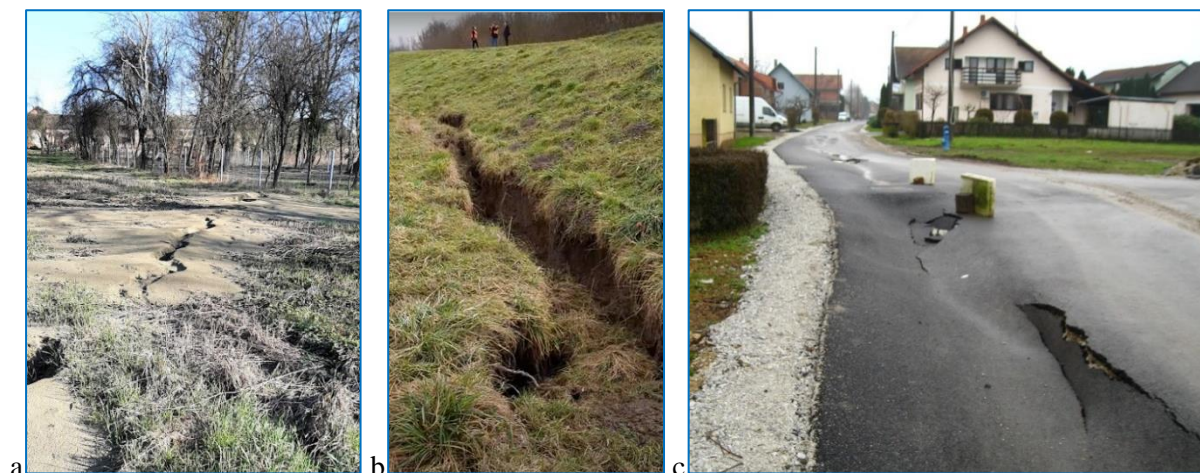
Figure 1. Examples of liquefaction in Petrinja earthquake: a) ejecta in the field in Hrastelnica, b) cracks in the levee in Sisak along the Sava river (Galdovo), c) subsidence of the road in Petrinja (Drenčinina)

The Petrinja earthquake in year 2020 [2] showed a vast array of various manifestations of liquefaction illustrating thus and reminding the citizens and engineers of Croatia that this phenomenon is to be taken in account seriously. An overview of geotechnical damages caused by Petrinja earthquake is given in the report led by Tomac and Zlatović for GEER [3]. The three characteristic damages caused by liquefaction are shown in Figure 1: a) liquefaction occurred in many fields in the area, and it was rather vast in the area of Hrastelnica; b) some of the levees protecting the area from the waters of the Kupa and Sava rivers got mostly longitudinal cracks due to liquefaction and lateral spreading as is seen here on the section in Galdovo; c) liquefaction in the villages caused cracking in several houses in the area, as well as subsidence of roads like one in this photograph and many of the wells in the area were filled with sandy soil.

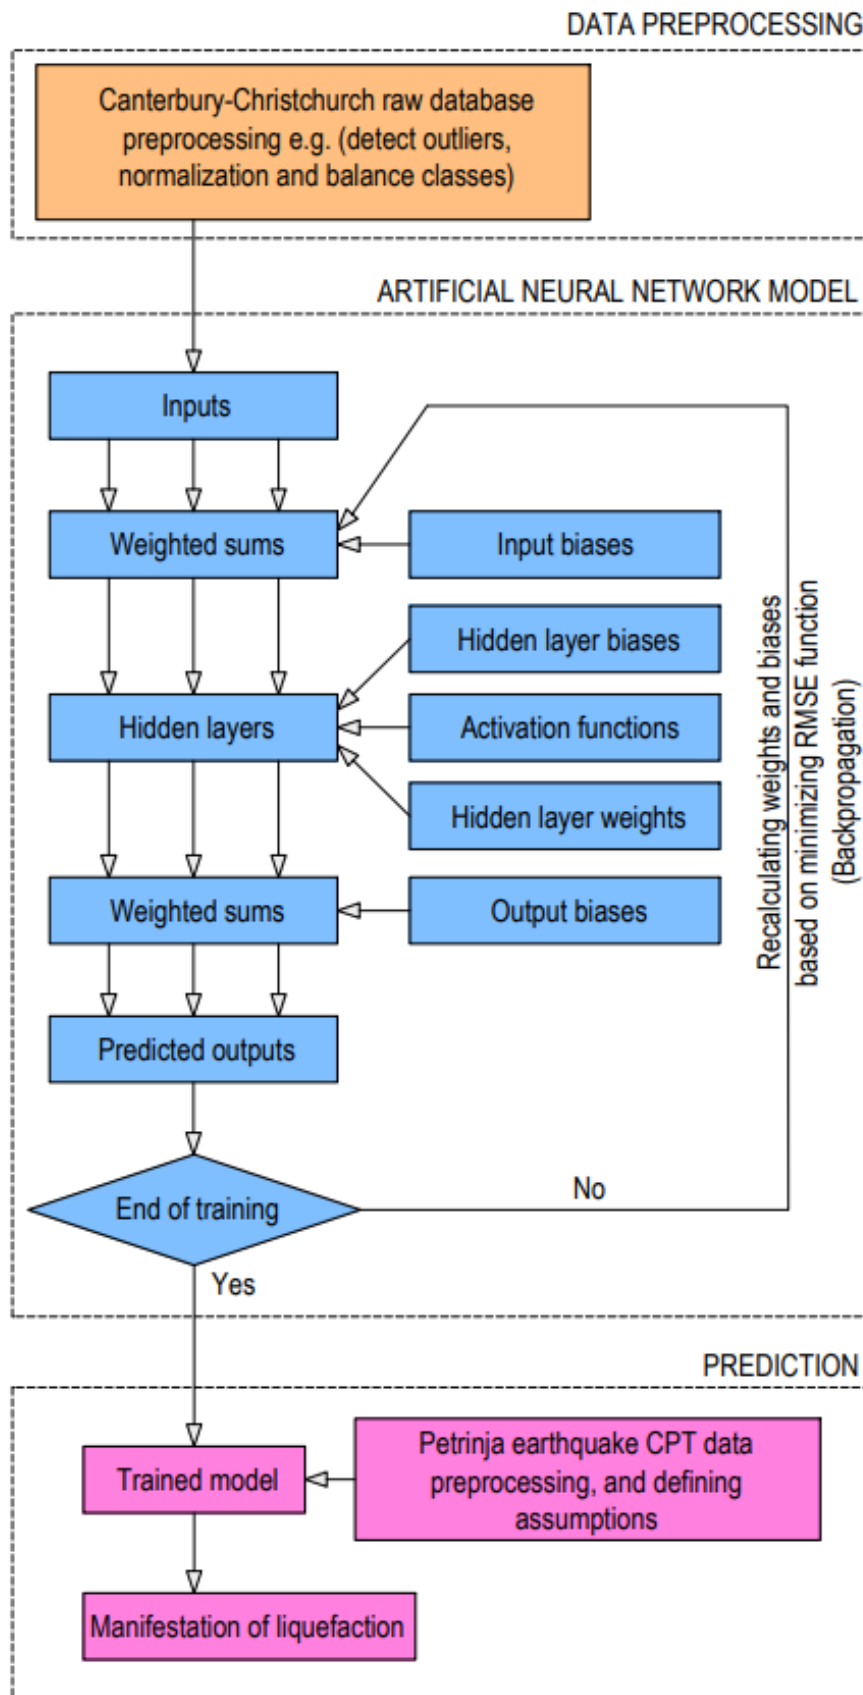
Figure 6. The three main steps of the development and application of the Artificial Neural Network

An overview of the main steps of the proces are shown in Figure 6. Pretprocessing was done on the Canterbury case-history dataset to obtain inputs for the 5 models of Artificial Neural Networks, and then on the data from Petrinja area, the developed models were used to predict liquefaction manifestation, i.e. its probability.

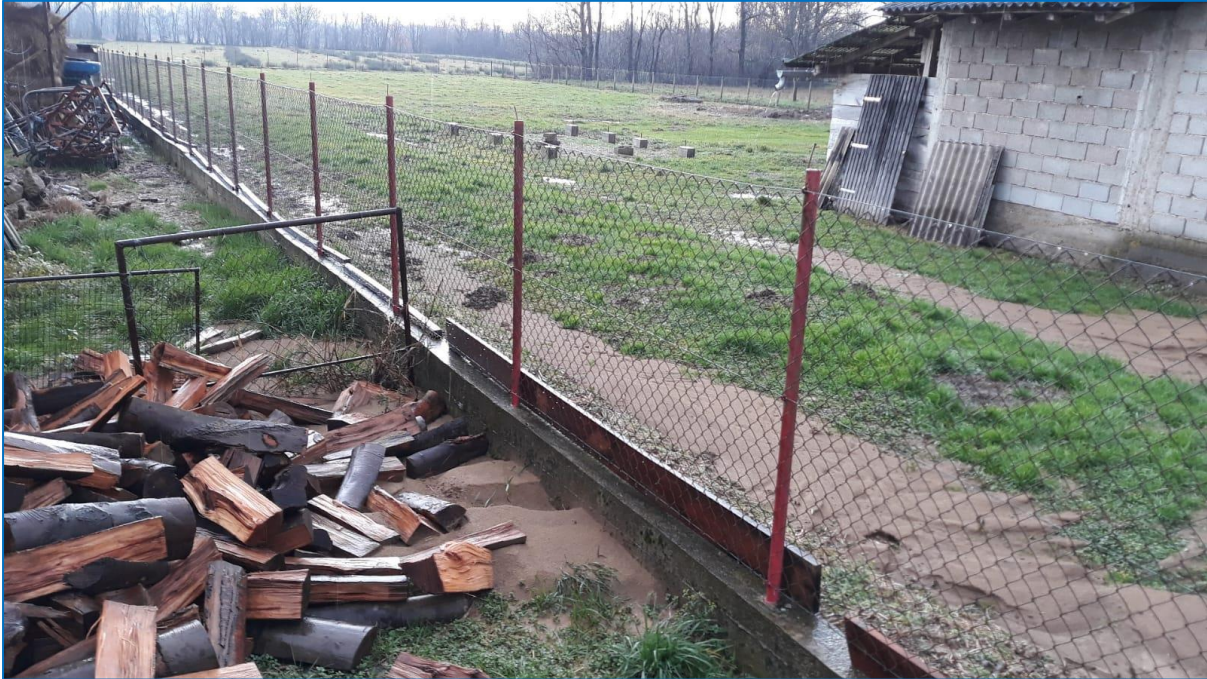
Figure 7. One of many evidences of liquefaction in Brest Pokupski (Photo already published [2]).

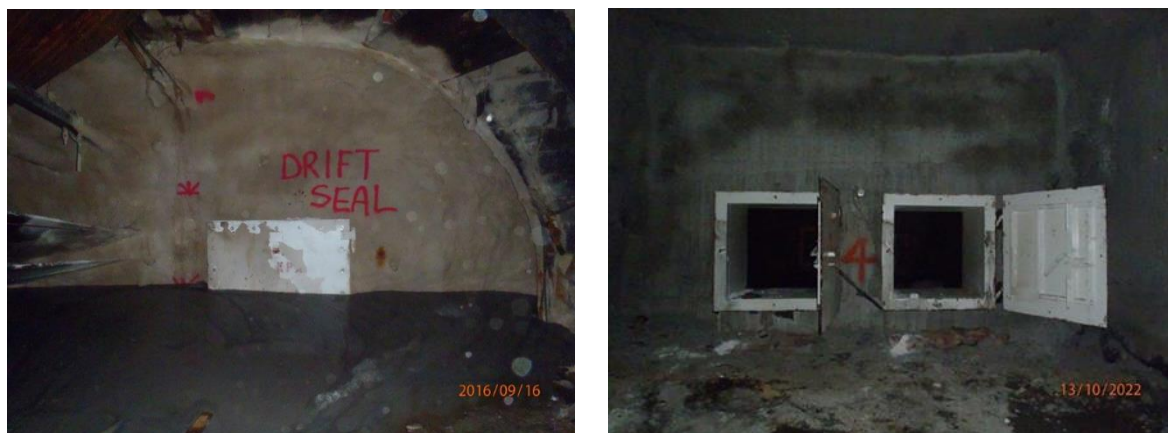
Figure 1. a) Drift seal built of concrete, b) Tunnel seal with doors

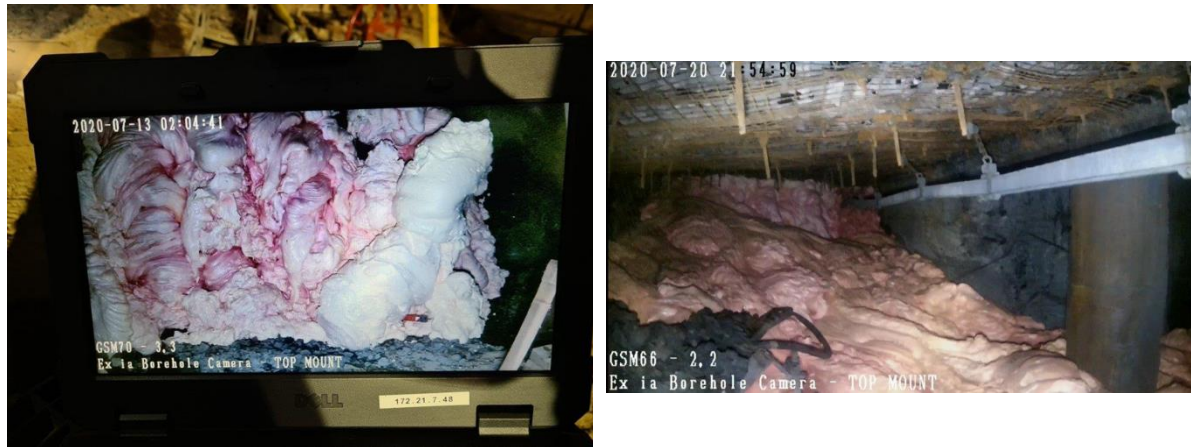
Figure 2. Tunnel seal – Rocsil foam

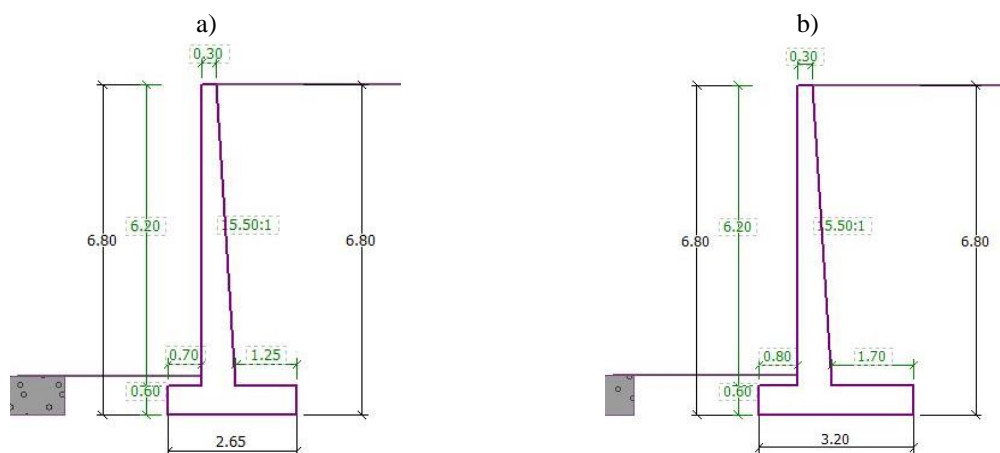
Fig. 2: Obtained foundation width for the wall $H=6.0m$ according to: a) MKS, b) EC 7-1

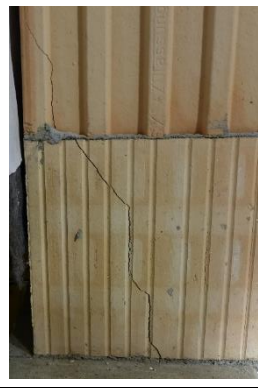
<p>Cracks in the bricks at $F_{MAX,OOP}$</p>
---	---	---

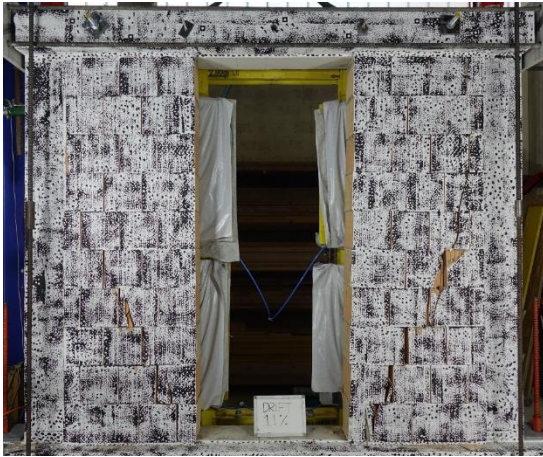
Figure 5. Damage to masonry infill at 1.1 % of in-plane drift

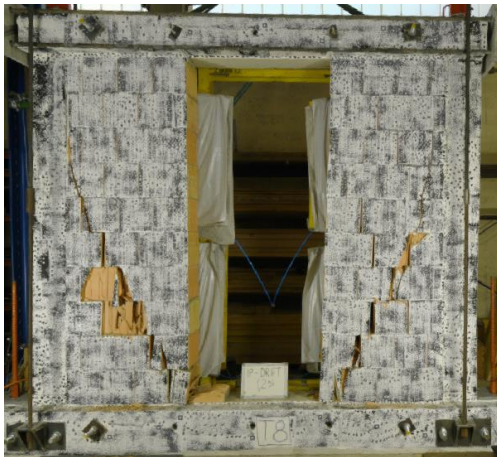
Figure 7. Damage to masonry infill at 1.2 % of in-plane drift

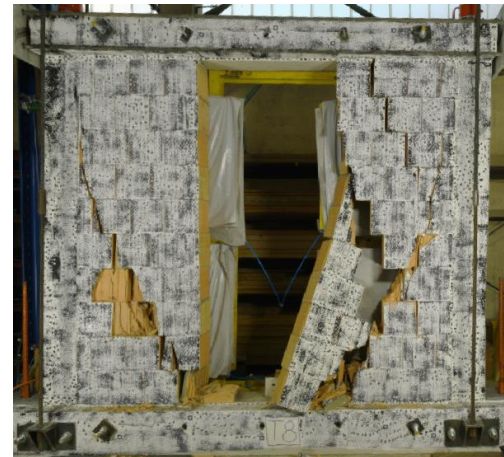
Figure 8. Collapse of masonry infill at 1.6 % of in-plane drift

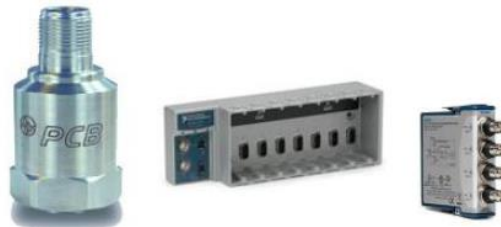
Fig. 1. Piezotronics PCB Accelerometer Model 393B12 (left), DAQ-9178 NI Data Acquisition System Module (middle) and NI 9234 Board (right)

The dynamic characteristics have been determined by measurements of ambient vibrations. The equipment with an acquisition system that was used to take the measurements, is sensitive accelerometers that have recorded the acceleration at certain points on the bridge. In this case PCB Piezotronics devices, model 393B12, manufactured by National Instruments with a sensitivity of 10,000 mV and a range of up to 4.9 m/sec², with a size of 0.5g (Fig. 1 left) were used. Data acquisition was performed with the acquisition system - module NI cDAQ-9178 and 4 NI 9234 boards (Fig. 1, middle and Fig. 2). The recorded acceleration measurements are expressed in "Earth acceleration - g" (9.81 m/sec²).

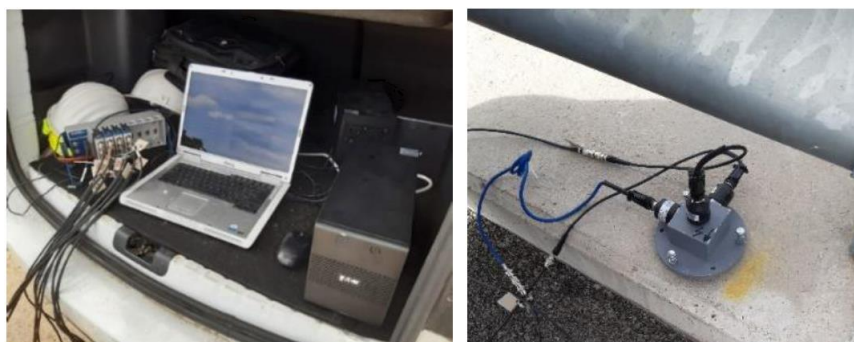
Fig. 2. Field monitoring equipment (left), three-way accelerometer (right)

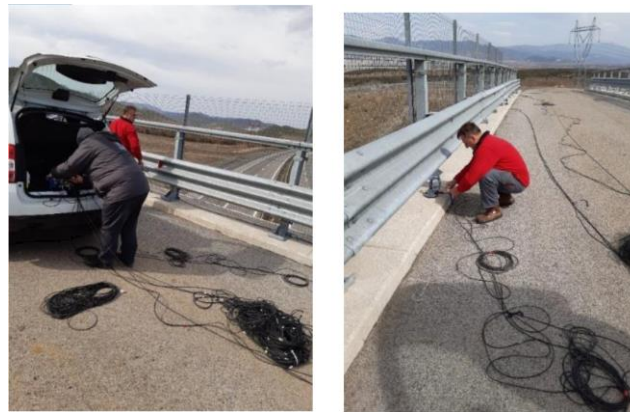
Fig. 3. Acquisition System (left) and Accelerometer Configuration (right)

The measurements were carried out using a sampling rate of 2.048 Hz. In total, 15 accelerometers were used with various measurement locations and directions. The measurement system configuration is shown in Fig. 3.

During the measurements, the sensors were placed in the different points of the bridge: in the middle of the bays and above the piers. During all measurements, one accelerometer was located in a reference point in order to enable the comparison of the amplitudes of the other sensors with the reference points for defining the tonal forms of vibration. These measurements cover a frequency range from 0 to 40 Hz, where the first resonant frequencies are found. The processing of the record was carried out by applying a fast Fourier transformation so that it was possible to define the frequency composition of the registered vibration from which the natural frequencies of the objects could be identified.

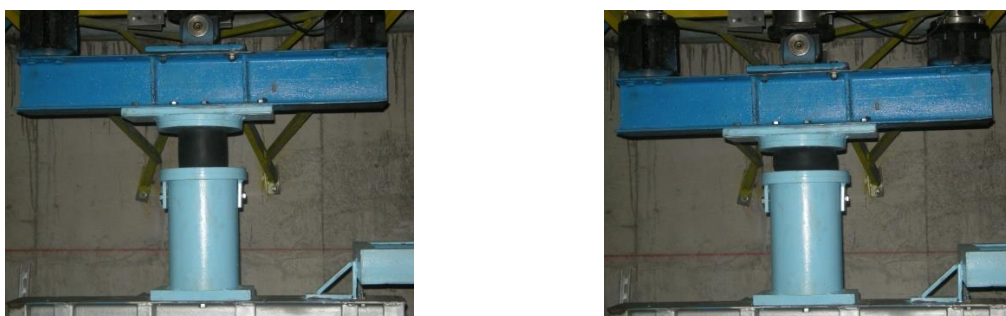
Figure 6. Experimental test set-up used for testing of the model prototypes of RB displacement control devices under simulated cyclic loads with increasing displacement amplitudes.

An extensive testing program was conducted [24]. It included realization of specifically programmed cyclic tests of the constructed prototype models of RB devices. Presented in this paper are the representative results obtained from the realized extensive experimental tests of rubber buffer prototype models. The key functioning targets of the displacement limiting RB devices are: (1) enabling physical limitation of maximum relative displacements of seismic isolation devices; (2) achieving the predefined physical limitation of the relative displacements by properly avoiding the so called “hard” structural impact; and, (3) providing efficient protection of seismic isolation (SI) and energy dissipation (ED) devices by assured limitation of relative displacements.

To achieve all the stated goals, prototype models of RB devices were designed and manufactured in the form of cylindrical rubber (pads) buffers cast by use of rubber characterized by four different values of hardness measured in shores, H40, H50, H60 and H70. To obtain comparative experimental results, two experimental test specimens of each type of RB devices, amounting to a total of eight specimens, were constructed.

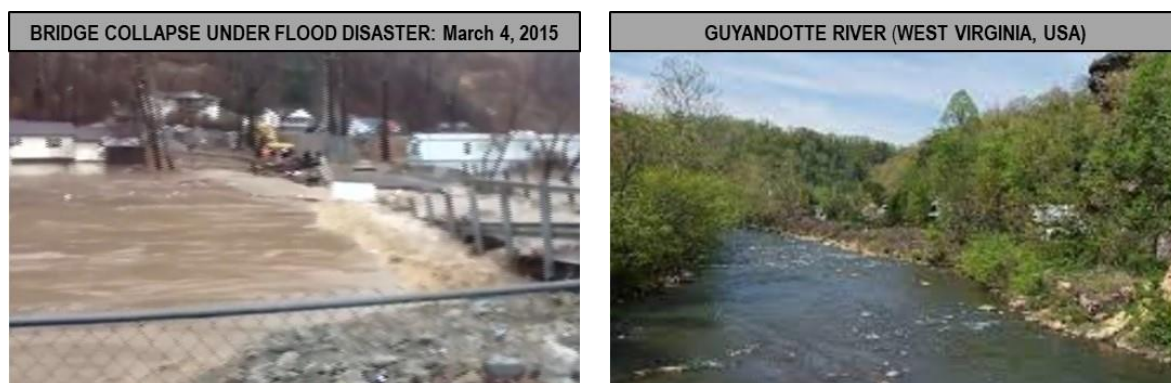
Figure 11. Typical loading of bridges under flood disasters: Collapse of the Guyandotte river bridge under flood, March 4, 2015 (left) and common water level of Guyandotte river in West Virginia, USA (right).

The observed severe destructions of bridge superstructures resulted from inappropriate protection measures in many cases, Fig. 11. The presented investigations were directed toward development of a new system to enable successful bridge protection against strong earthquakes and severe flood disasters. The presently created combined EFP system possesses an advanced capability for successful protection of bridges exposed to strong earthquakes. This was confirmed with the conducted original seismic tests of the constructed large-scale EFP bridge prototype model.

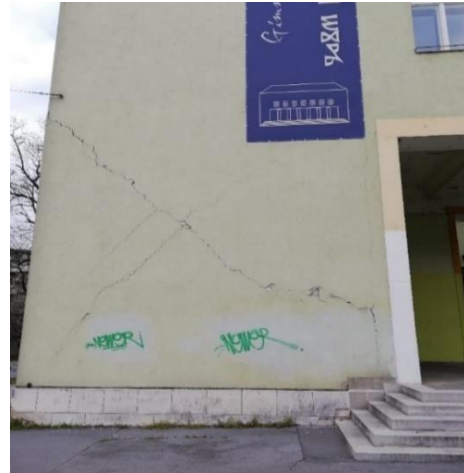
Figure 2. Typical damage on the load-bearing wall

During the investigation work, a visual inspection of the building was carried out and damage was observed on the load-bearing walls and partitions of the ground floor and the first floor. Some characteristic damage can be seen in Figure 2.

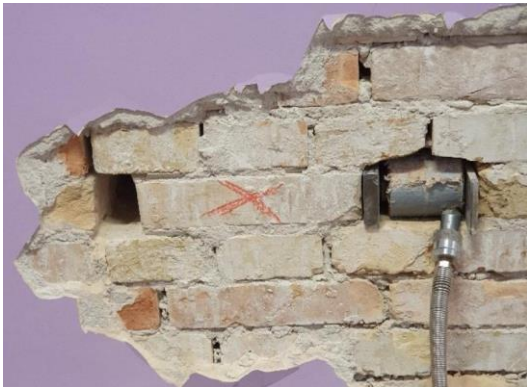
Figure 3. Masonry shear strength testing

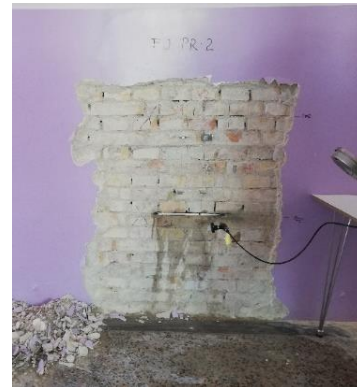
Figure 4. The determination of the existing compressive stress in the masonry

The determination of the existing compressive stress in the masonry is conducted using single *flat jacks*, Figure 4, [5]. The compressive stress in the masonry is partially relieved by removing the mortar from the bed joint. The stress is then compensated by inserting the flat jack into the opening until the initial state of stress and strain is established, which is controlled by measuring the displacement perpendicular to the opening. It should be noted that the stress obtained in this test is an average value of the stress in the part of the wall near the opening, i.e. it can be assumed that the stress is representative for the entire wall only if the wall is completely homogeneous and if the load is not eccentric. The test was conducted

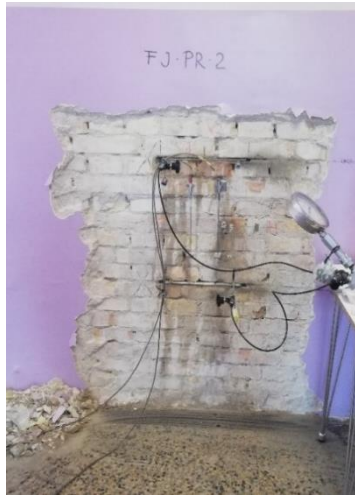
Figure 5. Elasticity modulus test

Two flat jacks connected to a single hydraulic pump must be used in order to determine the stress-strain dependence of masonry. The test is performed in the same location where the vertical compressive stress test was performed, creating another hole above the existing one (used to determine vertical pressure), Figure 5. Flat jacks are inserted into parallel horizontal openings in the masonry and the compressive stress is applied by locally applying pressure to the jacks. Devices for measuring strain are placed in between flat jacks, and the stress and strain values are measured simultaneously, which enables the determination of the modulus of elasticity, Table 2.

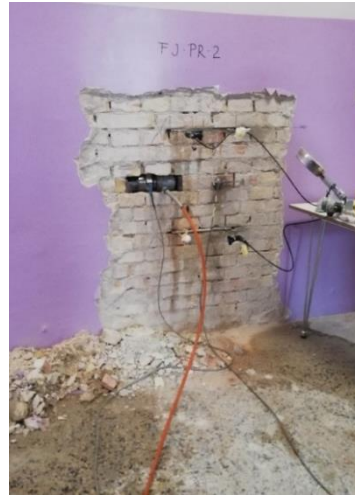
Figure 6. The shear strength of masonry without compressive stress

The shear strength of masonry without compressive stress f_{V0} was also determined experimentally using flat jacks at 3 measuring points, Table 2. In this method the compressive stress σ_0 in the masonry is checked during the shear test, Figure 6. During the test, the coefficient of friction μ is also determined. The shear strength of the masonry without compressive stress f_{V0} can be expressed as follows:

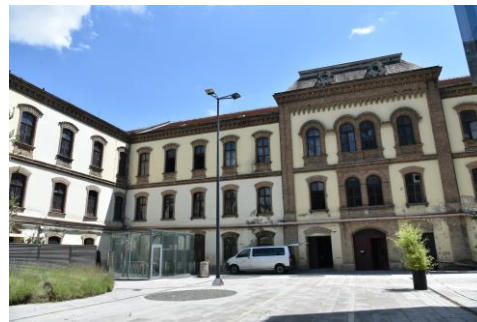
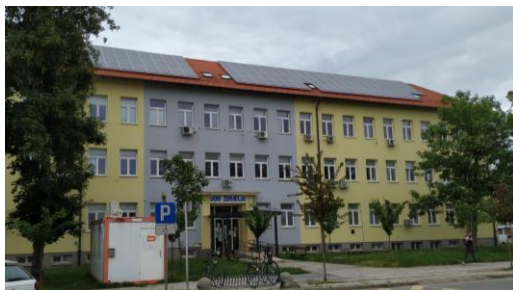
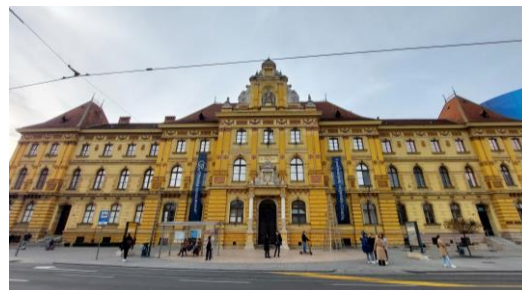
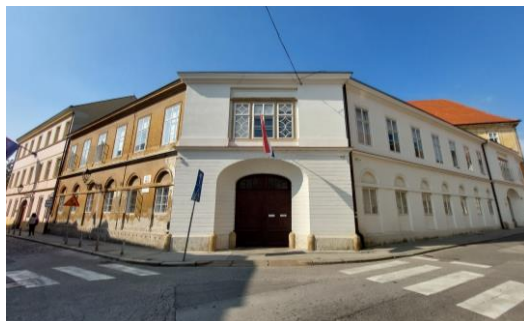
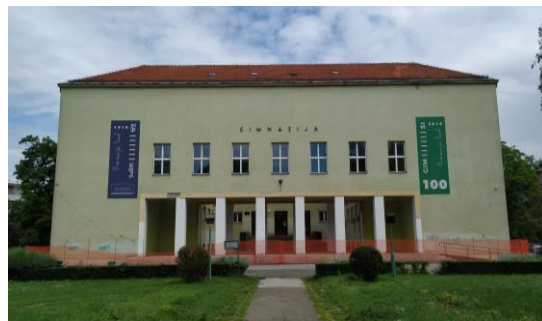
Figure 1. Case study buildings.

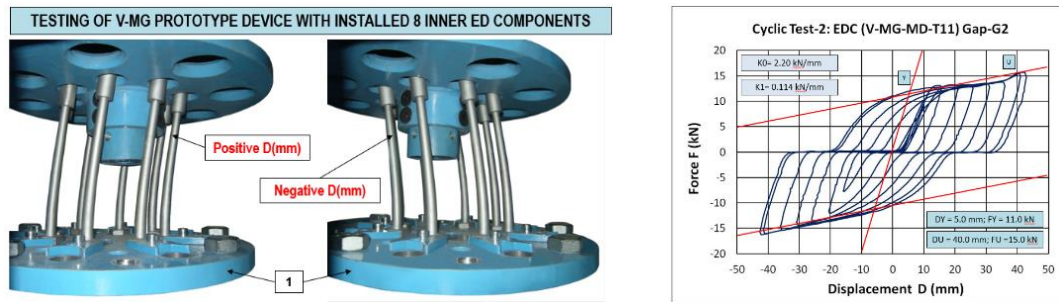
Figure 2. Cyclic testing of V-MG-ED devices (left) and Performance of EDC with simulated gap-G2 (right)

2) Testing of prototype models under cyclic loads: Within the frames of experimental testing of produced model prototypes of V-MG energy dissipation components, an experimental program has been carried out. Each individual V-MG component has been tested twice. First test-1, representing original test, was conducted to define hysteretic response of V-MG component under the initial conditions. Second test-2, representing repeated test was performed to get an insight into the hysteretic response of the model that has already been tested.

(c) Activating plate with holes: On the upper side of V-MG device, metal plate with thickness $d=20.0$ mm is constructed with openings with different diameters distributed along two concentric circles. The inner 8 openings are constructed with diameter $d_3=34.0$ mm. Having standard top cylinders with

diameter of $d=24.0$ mm, a gap of $G1=5.0$ mm was provided in all directions. However, the external 8 openings are constructed with diameter $d4=60.0$ mm. Having top cylinders with diameter of $d0=24.0$ mm, a gap of $G2=18.0$ mm was obtained in all directions. The upper metal plate is fixed to the central stiff body for which is assured strong connection to the superstructure of the large-scale bridge model. With presented original structure of V-MG device, activation of the inner ED components will start after relative displacement becomes larger than 5 mm in all directions. If relative displacement exceeds 18.0 mm, then activation of all ED components located on the external concentric circle takes place.

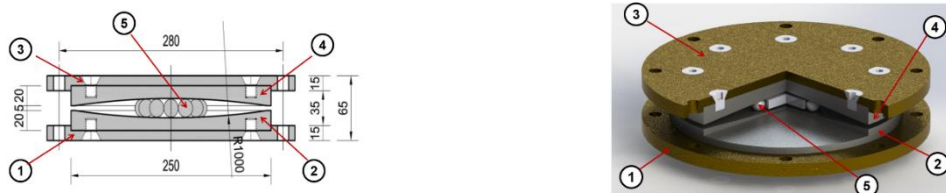
The seismic isolation (SI) system used within the USI-V-MG bridge model was assembled by the use of prototype models of double spherical rolling seismic bearing (DSRSB) devices having two large-radius spherical surfaces (Fig. 4), which were originally designed for the purposes of the planned various experimental investigation phases [5].

Figure 4. Prototype of designed, constructed and tested DSRSB devices: (1) Cross-section with geometrical properties and (2) Device view with characteristic cross-section (*Commonly re-used prototype*)

The design of such device was conditioned by several requirements: to provide the sufficient bearing capacity for vertical loads; to provide the sufficient displacement capacity; to have radii of curvatures of the spherical surfaces adequate to achieve the targeted period of vibration; to have a sliding surface generating minimal friction and to have a central rolling part providing minimum reactive friction force. The resulting device is shown in Fig. 4. The lower (2) and upper (4) spherical plates were constructed of a hard inox polished to a mirror shine, providing durability and very low friction. Its diameter was 250mm, while the radii of the spherical surfaces were 1000mm. Both plates were fixed to the lower (1) and upper (3) steel end plates with diameter of 310mm. The inserted central rolling part (5) was constructed in the form of a ring of twelve balls with a diameter of 18mm, distributed uniformly along the circle around cylindrical slider and spaced with their opposite centres at 74mm. From the response, it is clear that the device has a sufficient capacity for horizontal deformation, amounting to over 45mm and that the shape of the hysteretic loops forms a skewed rectangle, which leads to its representation with bilinear model, Fig. 5.

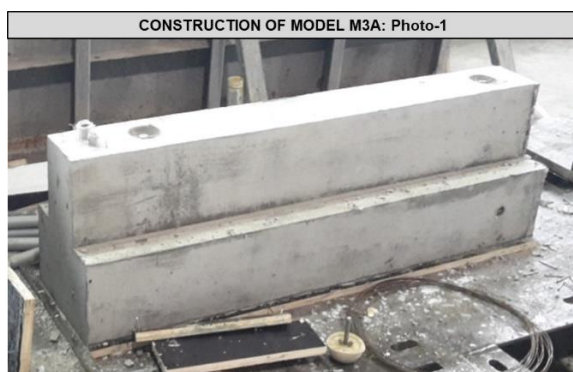
Fig. 3. Construction of model-M3A: Segment of the precast RC floor beam.

The construction of the experimental model M3-A was done completely in factory conditions and with identically high quality as that of the prototype. Fig. 3 shows a view of the constructed RC floor beam, whereas Fig. 4 provides a view of the concreted segment of the RC column with the RC corbel. From the presented figures, it could be concluded that the applied technology of construction of the experimental model M3-A was identical to the original technology that was applied in the construction of the prototype connection. Actually, the applied procedure provided all the needed prerequisites for obtaining experimental results of high quality and reliability for specific practical or research objectives.

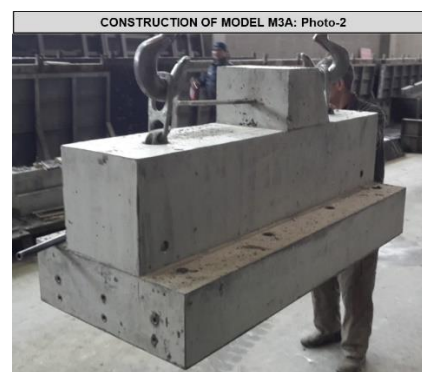
Fig. 4. Construction of model-M3A: Segment of the precast RC column.

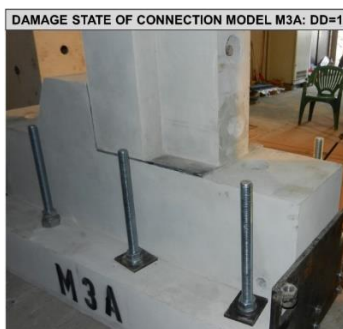
Fig. 7. Damage degree of model M3-A: Initial stage characterized by DD=1.

In the course of realization of the experimental testing of model M3-A, the development of the characteristic phases of damage to the structural connection was successfully monitored. For presentation of the damage degree, a scale for identification of the damage degree from 1 to 5 (DD = 1, 2, 3, 4, 5) was used. If there is no damage, the state is indicated by DD=1, while the state of failure is indicated by DD=5. States DD=2,3, 4 represent interim states characterized by consecutively increased damage degree. The states of occurred phases of damage are demonstrated in two characteristic figures, namely, Fig. 7 and Fig. 8 that show DD=1 and DD=5, respectively.

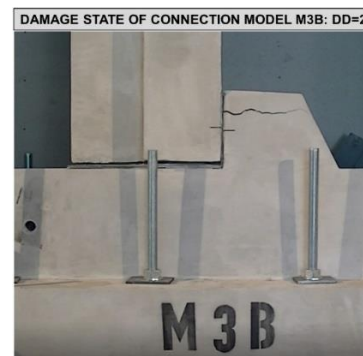
Fig. 12. Damage degree of model M3-B: Typical stage characterized by DD=2.

- In the course of realization of the experimental testing of model M3-B, the development of the characteristic phases of damage to the structural connection was successfully and continuously monitored. The states of occurred phases of damage are demonstrated in four characteristic figures, namely, Fig. 11, Fig. 12, Fig. 13 and Fig. 14 that show DD=1, DD=2, DD=3 and DD=4, respectively.

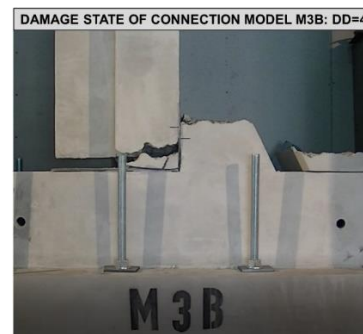
Fig. 14. Damage degree of model M3-B: Typical stage characterized by DD=4.

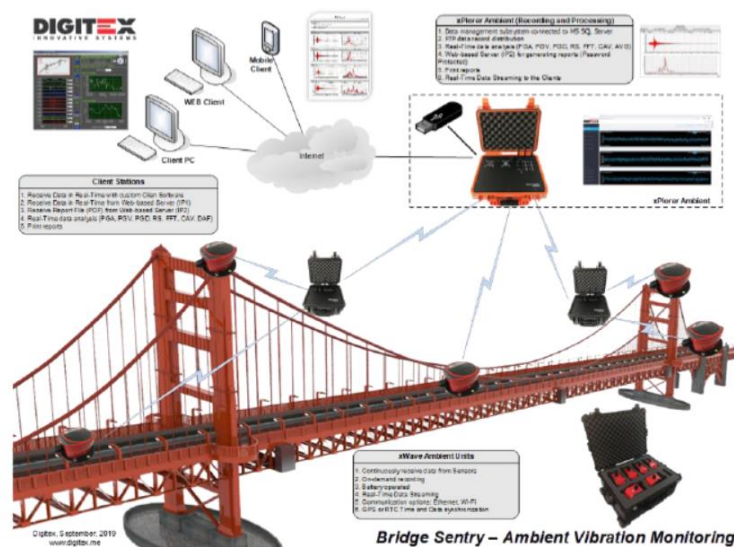
- Qty.1 xPlover, central acquisition unit.
- Qty.5 xWave units - total of 15 channels of acceleration installed on different locations of the structure for monitoring vibration
- Qty.1 xSense units – total of 5 channels for measuring voltage-based sensors.
- Qty.2 xNet unit – total of 2 units for expanding the network coverage on the structure that is being measured.

Figure 1. Sentry System Architecture [11].

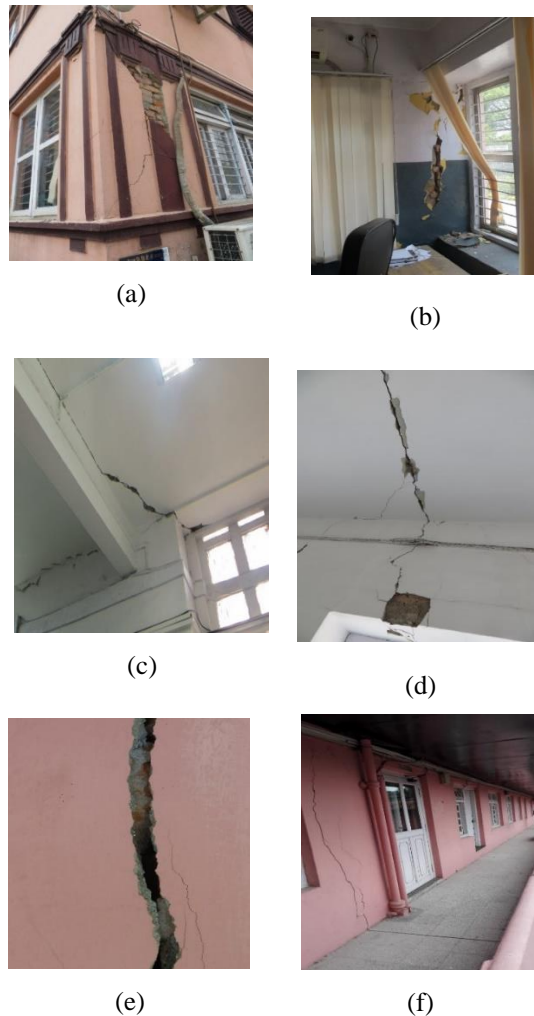
Internal walls have also suffered minor to moderate cracks at different locations. At few locations, there is very deep cracks in the slab which needs serious attention. Slab at these portions have gone cracking wider than 10 mm and reinforcements have buckled. The damage picture due to Gorkha Earthquake are shown below in Fig. 2.

Figure 2. a) Heavy vertical crack in the pier; b) Vertical crack in the pier; c) Deep crack in the first floor slab;d) Crack in the slab; e) Crack width of about 20 mm in the wall; f)Vertical crack in the Wall

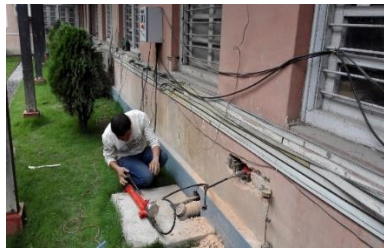
The in-situ shear test is also known as the push test. It provides a direct measurement of the shear resistance of mortar joints in masonry. The test is suitable for masonry that has relatively strong units and weak mortar so that shear cracks form in the typical stair step pattern along mortar joints and the units remain un-cracked. In this type of construction, the shear strength of the mortar joints limits the shear strength of the masonry wall. Five test locations were selected based on internal and external locations. The test was carried out at 3 locations on the ground floor and 2 locations at first floor which is shown in Fig.3a).

Figure 3 a) Conducting In-situ Shear Test on Wall

The test locations were prepared by removing the brick, including the mortar on one side of the brick to be tested. The head joint on the opposite side of the brick to be tested was also removed. This was done with caution that the mortar joint above or below the brick to be tested is not damaged. The hydraulic ram was inserted in the space where the brick was removed. A steel loading block was placed between the ram and the brick to be tested so that the ram will distribute its load over the end face of the brick. The dial gauge was inserted in the space. The brick was then loaded with the ram until the first indication of cracking or movement of the brick. The ram force and associated deflection on the dial gage were recorded. From the observation, final corrected shear strength of brick masonry is obtained as per ASTM standard and IITK- GSDMA Guideline and the corrected minimum shear strength obtained are 0.054 N/mm² and 0.036 N/mm² respectively. The difference in these values from two standards, ASTM[8] and IITK-GSDMA Guideline-EQ06[2], is due to the coefficient of friction between the brick and mortar is assumed as per the site conditions. Being on the conservative side, the value obtained from the GSDMA-EQ6 is used for checking the shear strength capacity.

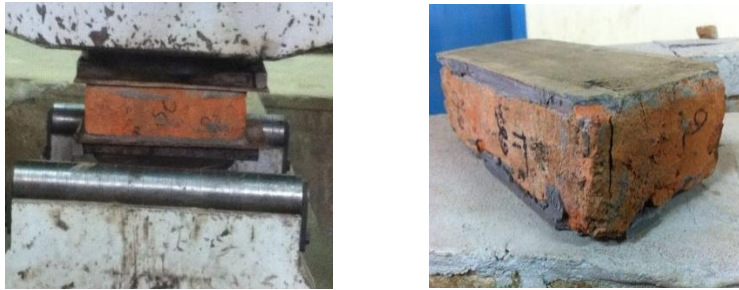
Four brick samples were taken from the building wall and compressive strength and water absorption tests were carried out at Central Material Testing Laboratory (Pulchowk Campus), Institute of Engineering which is shown in Fig.3b). The average breaking strength of the three brick samples tested is was 42.51 kg/cm² (4.17 Mpa) which indicates low strength brick. Water absorption of the three samples are 28.22%, 26.34% and 24.6%. As per the Nepal National Building Code (NBC 109), a first-class hand-made brick shall not absorb more water than 25% of its weight. The brick falls to lower category of second class [9].

Figure 3 b) Compressive Strength Test of Brick Unit performed at CMTL

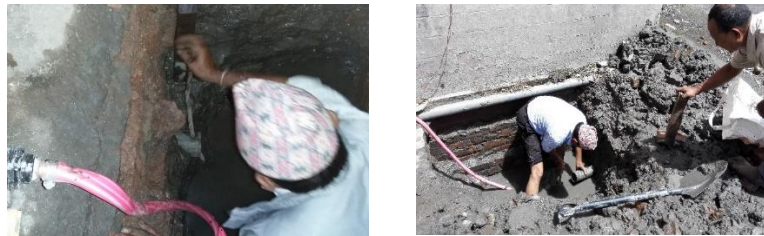
Soil samples were taken from two locations, ground excavated for foundation exploration (at the premise of Supreme Court building) to determine the shear strength of soil which is shown in Fig.3c). The cohesion (c) and angle of friction (ϕ) of the soil below 1m from the existing ground level is found in the range of 0.1 to 0.13 kg/cm² and 24.130 to 27.140.

Figure 3 c) Soil Sampling for direct shear test of soil

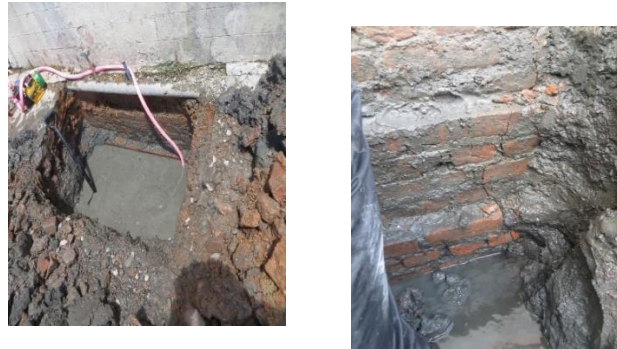
Figure 3 e) Foundation Investigation

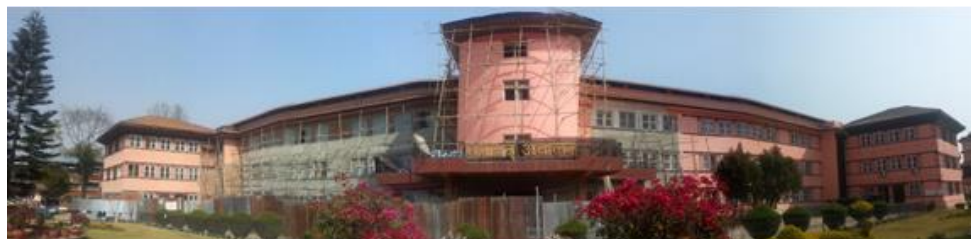
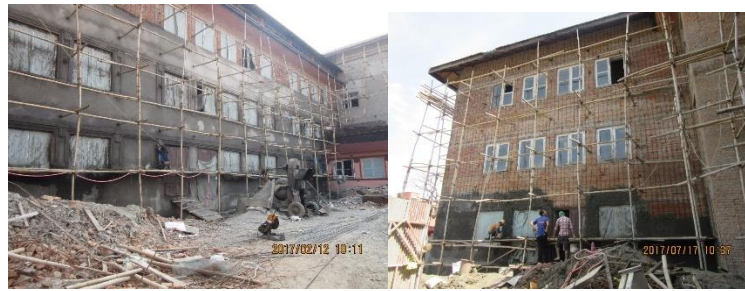
Implementation of this building was carried out which above given options. Removal of plaster in required locations, dismantling of brick work, bar mesh splint and bandage on inner and bar mesh jacketing on outer walls, micro concreting, curing, plastering were done. Few photographs of accomplished retrofit work are presented in the Fig.6 below.

Figure 6 Implementation of Retrofit Option

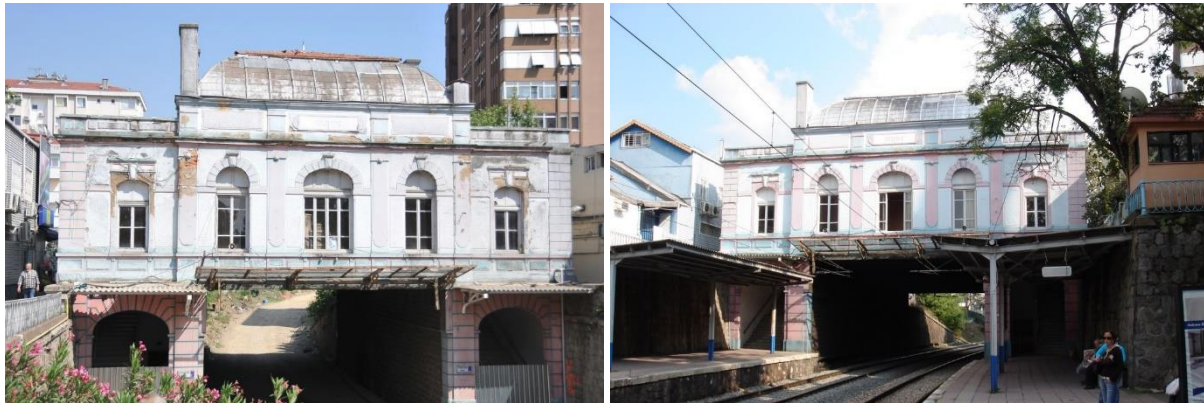
The ground level walls are brick masonry spanning from floor to the roof. All of the walls have been plastered. Walls thickness is around 700 mm at platform level and 400 mm at ground floor. All interior walls are also brick masonry with 300 mm thickness. These masonry walls carry the grey vault having a raised section at the middle of the structure. At both sides of the vault, gable roofs are constructed. During the assessment works conducted to determine the as built state of the building, no reinforced concrete elements were observed.

Figure 8. *Recent Photographs of the Station Before Strengthening*

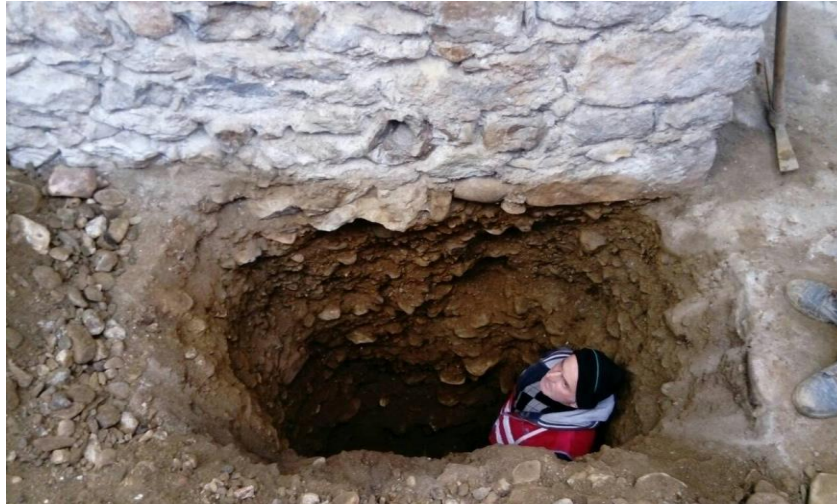
For the structural analysis purposes, additional research was carried out to determine the foundation depth. The tower is founded on a sloping terrain, so the southern side is at an elevation of +0.00 m, while the elevation of the northern part is at an elevation of -2.00 m. From the investigation probe along the northeast corner of the building, the identification of the foundation was carried out (Fig. 3). The foundation is constructed of a solid stone masonry in lime mortar without extension up to elevation -4.00 m and it is a continuation of the stone masonry above the ground level.

Figure 3. An exploratory borehole along the northeast corner of the tower

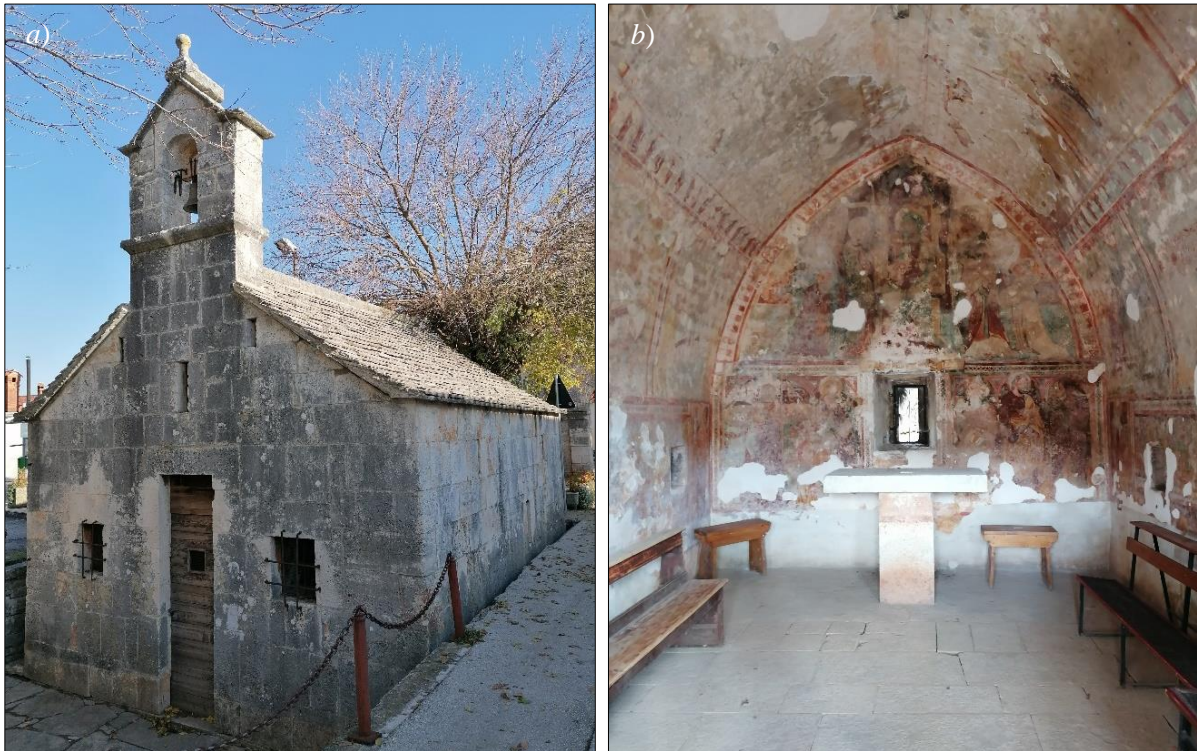
The walls are made of regular square stone blocks in lime mortar with very thin joints (not plastered on the outside). The thickness of the walls is 75-80 cm. On each façade a small narrow window is present; the front western façade also contains two square windows and a bell gable. Roof is covered with slate tiles (Fig. 1).

Figure 1. St. Anthony church in Barban: a) front view; b) Interior view.

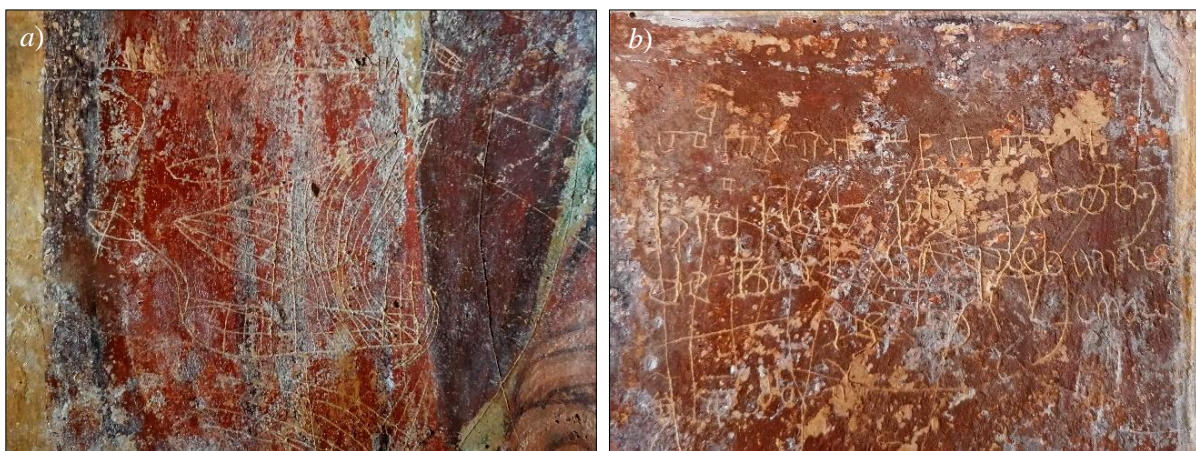
Figure 3. a) Drawing of a ship; b) Glagolitic graffiti.

At the beginning of the 15th century its interior was painted with 15 scenes from the legend of St. Anthony the Abbot, the patron saint of the church, shown in two opposite bands on the north and the south wall. The western and the eastern walls were also painted with depiction of the Virgin Mary with the Child and images of various saints important to the local community. On all surfaces of the preserved wall paintings we can find incised numerous Glagolitic graffiti, depictions of architecture (fortified towns, bell towers and churches), figural drawings, depictions of ships and stylized ornaments (Fig. 3). The time of painting can be determined by the oldest graffiti, dated before 1429 [4].
