2nd Croatian Conference on Earthquake Engineering

Conference Proceedings

2nd Croatian Conference on Earthquake Engineering – 2CroCEE

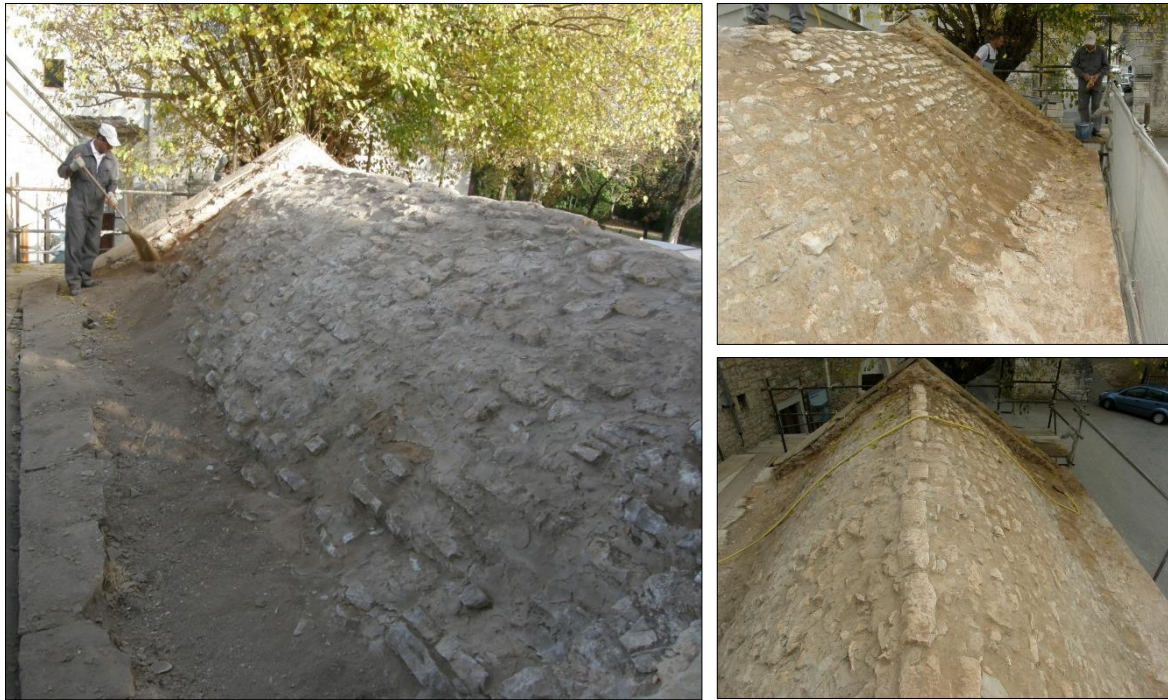
Figure 4. Extrados of the vault during the replacement of the roof tiles in 2008 [6].

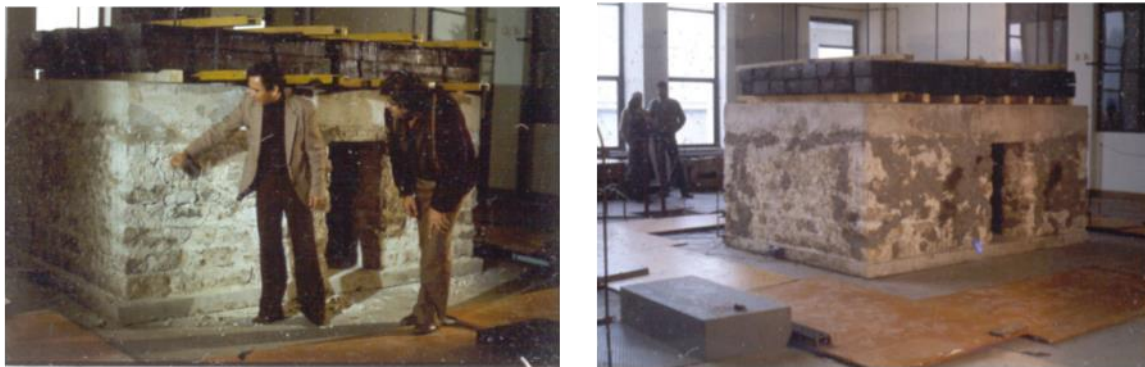
Figure 1. Original and repaired model of a typical masonry building in Budva

structural units and then the methodology for structural retrofitting was determined based on detailed studies of structural characteristics, the damage level, the built-in materials, the foundation conditions as well as local seismicity. Since the injection was the most frequently applied method, for its testing and verification a 1:2 scaled model of a typical single-story building was constructed of the same original stones and mortar and tested on the IZIIS' seismic shaking table applying the 1979 Petrovac earthquake. After testing and occurring of diagonal cracks, the model was repaired by injection and tested again, in which case the model suffered less damage, (Fig. 1). Using the acquired knowledge on the technique application, the consumption of material and the effect of applied injection, more than three hundred buildings within the old towns along Mediterranean coast have been repaired at the same time, including structural repair, repair of facade walls and the interior of each individual building, [3].

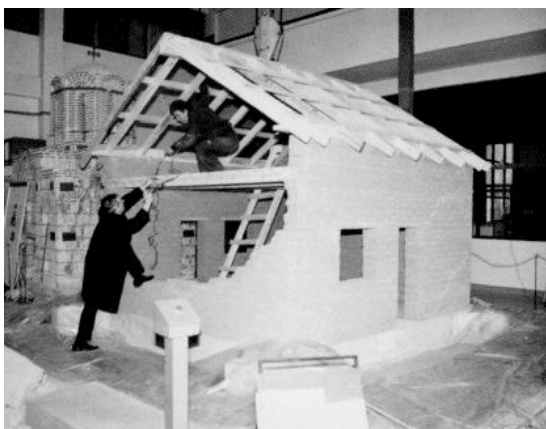
Unretrofitted Adobe Model -UAB

The first model was a control model while second was retrofitted with a combination of horizontal and vertical straps, center cores, and partial plywood diaphragms. The applied retrofitting proved very effective in improving stability and preventing collapse, (Fig. 2). Based on all the results and the GCI' Engineering Guidelines a number of historic adobes structures in south California were seismically upgraded applying this experimentally verified methodology, [5].

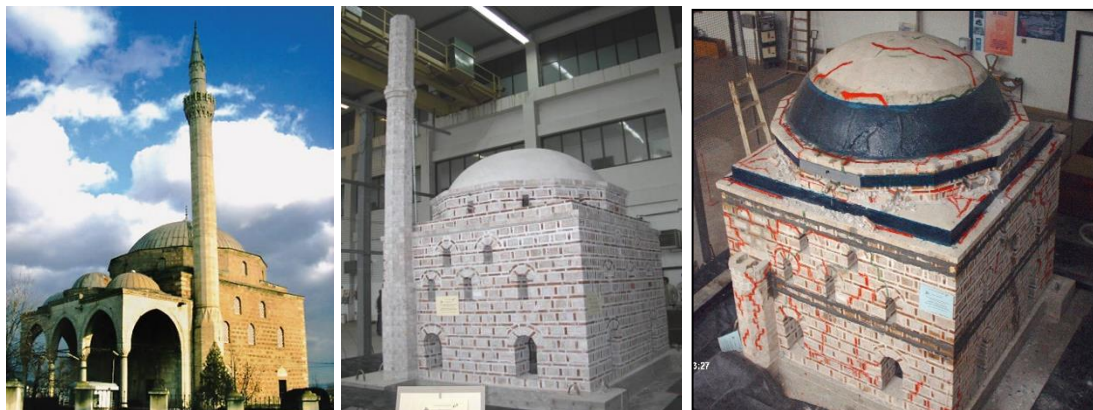
Figure 4. Mustafa Pasha Mosque: prototype (left), 1:6 scaled model (middle), phase 3 – damages (right)

Experimental investigation was performed in three main phases: (1) testing of the original model under low intensity level, with the aim of provoking damage to the minaret only; (2) testing of the model with strengthened minaret, with the aim of provoking its collapse and damage to the mosque, and (3) testing of the strengthened mosque model until reaching heavy damage. The applied strengthening solution, consisting of formation of a horizontal belt course around the bearing walls by CFRP rods as well as around the tambour and at the base of the dome by CFRP wrap, has significantly improved the seismic resistance of the monument, [8].

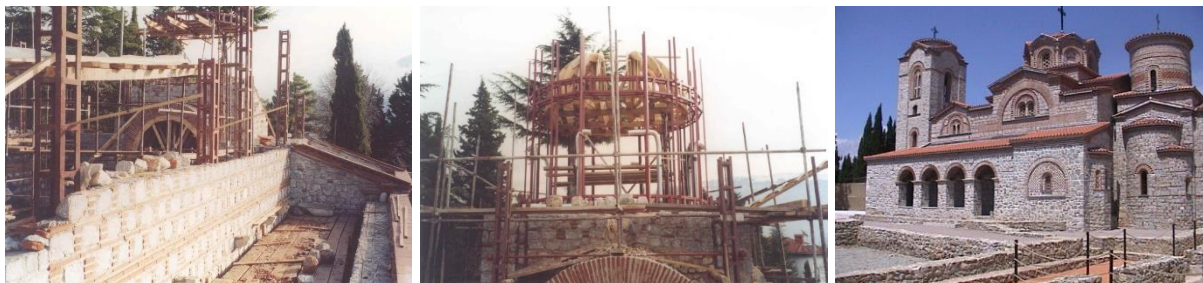
Figure 5. St. Panteleymon church: during reconstruction, (left, middle), rebuilt church (right)

In the process of conservation and rebuilding of the St. Panteleymon Church in Ohrid, having in mind the importance and specific nature of the structure representing a historic monument classified in the first category, it was necessary to design a building structure that will satisfy the stability conditions in the process of application of the conservation principles regarding shape, system, and materials, [9]. The principal structural system of the church consists of massive stone and brick masonry in lime mortar. Seismic strengthening was provided in accordance with the previously developed and verified methodology for Byzantine churches, (chapter 3.2). i.e. the horizontal and vertical steel ties were proportioned and a solution for consolidation of the foundation was given. The church was reconstructed in the course of 2001, (Fig. 5).

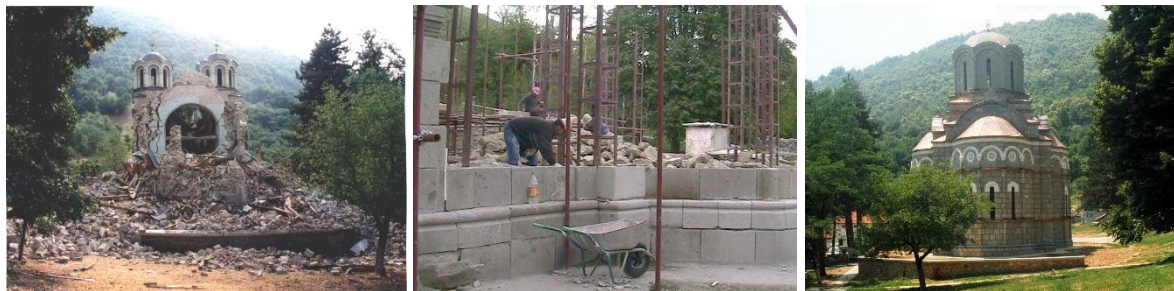
Figure 6. St. Athanasius church: after detonation, (left) during reconstruction, (middle), rebuilt church (right)

The solution for repair and structural strengthening of damaged existing part of the structure anticipates injection of all the cracks and incorporation of horizontal and vertical RC strengthening elements on certain levels. For the demolished part of the structure, a concept of complete reconstruction by maximum possible use of selected material has been adopted, whereat elements for structural strengthening for providing the designed level of seismic safety have also been anticipated: (i) RC belt course below the floor level, in the existing foundation walls, for anchoring the vertical strengthening elements, (ii) vertical strengthening steel elements at the ends of the massive walls and around openings, (iii) vertical strengthening steel elements into the tambour columns, (iv) horizontal steel elements along

the walls, in the base of the tambour and the dome. Due to the different treatment of the structural units constituting the integral structure, an expansion joint between them is anticipated to be constructed.

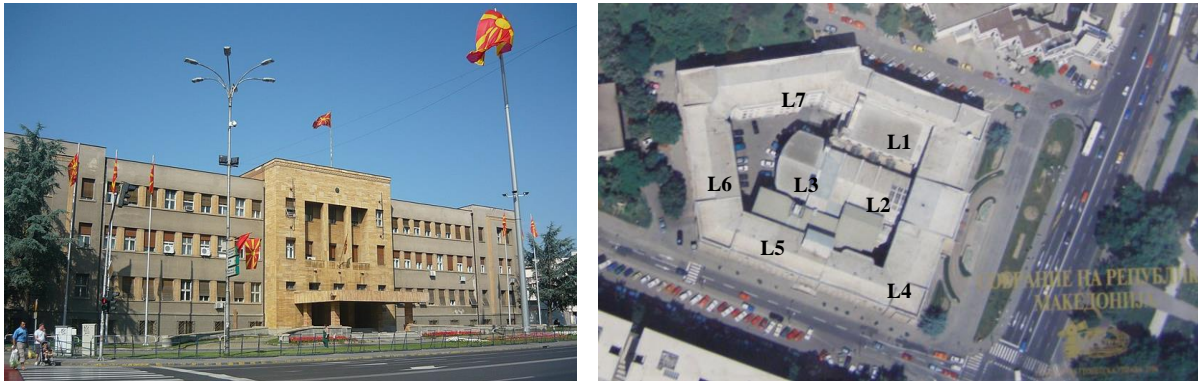
Figure 8. Parliament of Republic of North Macedonia (north facade – left, aerial view – right)

The Parliament Building of the Republic of North Macedonia was more than 70 years old, (Fig.8). As a historic building, it is protected by the Law on Protection of Cultural Heritage. Throughout its existence, a lot of changes, enlargements, adaptations, damaging during 1963 Skopje earthquake as well as post-earthquake repair and strengthening of this building have been done. Within the project on *Enlargement, Building of Another Storey and Adaptation of the Building*, the necessity for increasing the seismic safety of main structural system has been defined, [12].

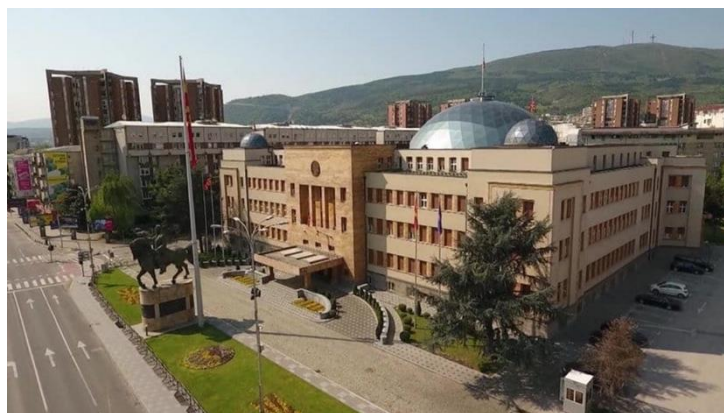
Figure 12. The Parliament building after seismic retrofitting, adaptation and building of another storey

The process of strengthening while continuously functioning of the Parliament, was carried out quite successfully despite number of limitations in the period 2010-2014, (Fig. 11, 12).

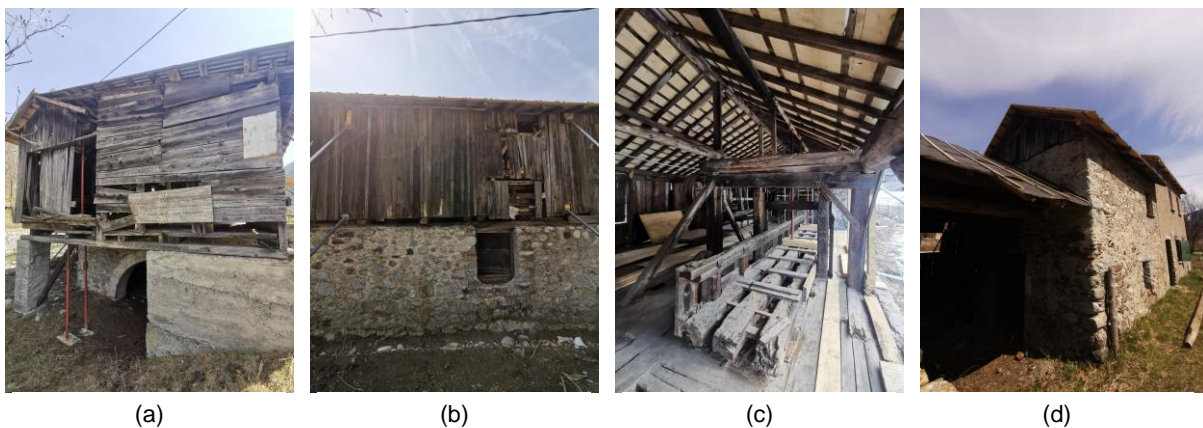
Figure 5. Front (a), side (b), and interior (c) views of portion A of the sawmill; view of portion B (d).

The main vulnerabilities that were found, were also related to the poor state of the building. Firstly, the whole portion A presented insufficient load-carrying capacity of the wooden columns, with the existing structure able to sustain static actions only because of provisional strengthening members. All wooden floors and roofs were not in good state, and also very undersized for the future increased design loads (snow, wind and crowd). Furthermore, local cracks were detected in the masonry walls of building portions A and B. Finally, all horizontal structural elements were not able to create an effective diaphragmatic and dissipative action against seismic loads, and joints between floors and walls were absent. Therefore, similarly to the church of Ceto, wood-based retrofitting systems were applied for this building as well.

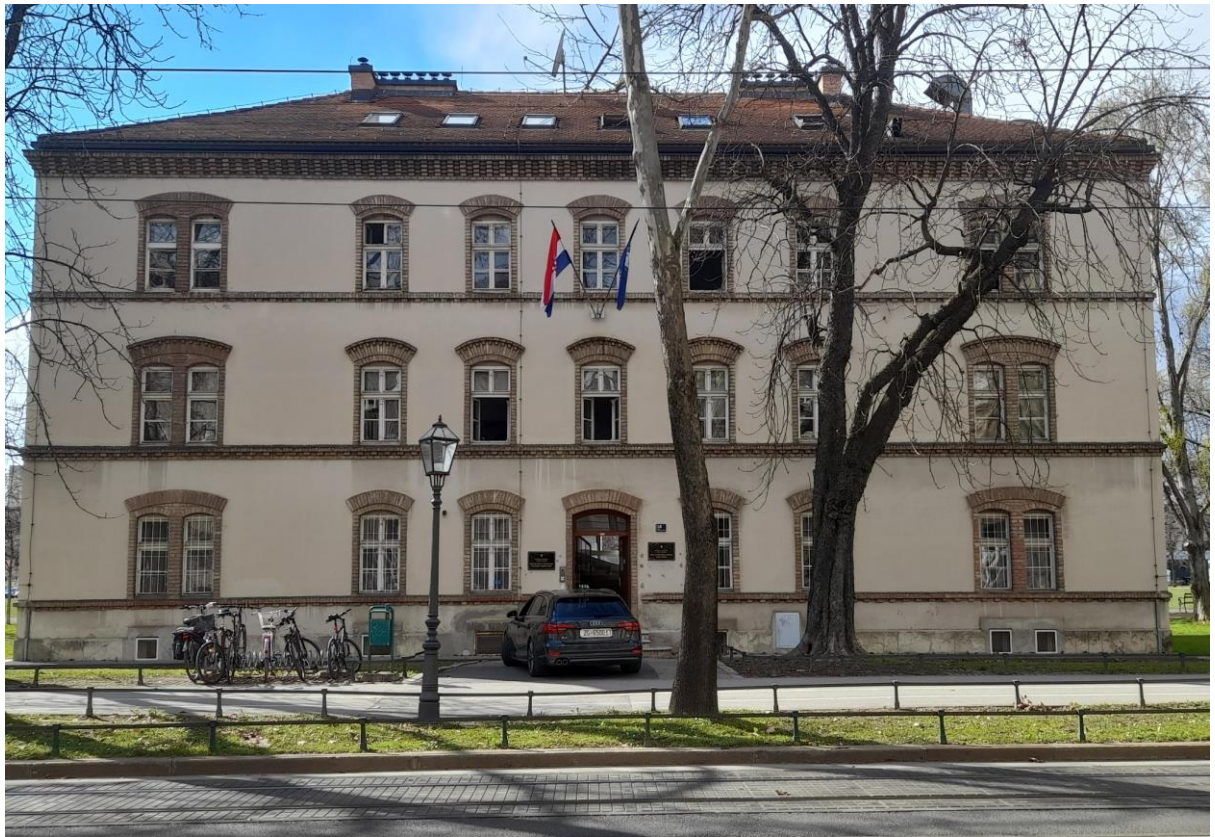
Figure 1. Case study building

The case study building is a public-purpose building with a rectangular floor plan of 25.18 m × 11.42 m and a height of approximately 15.50 m. The building has five floors, and all are used as office space. The building has undergone minor changes in the original geometry and space over time and has been properly maintained. More information about the building can be found in the paper by Milić et al. [6].

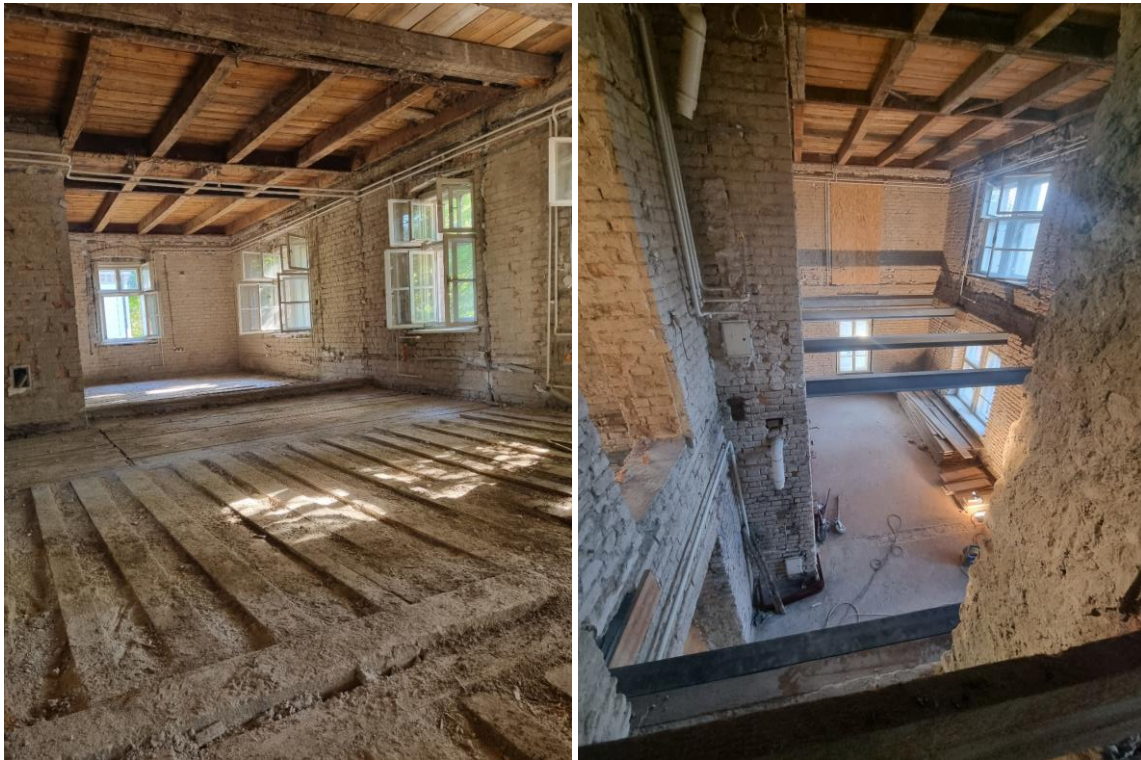
Figure 8. Plaster removal and preparations for strengthening

The renovation of the building started in June 2022. The plaster was removed from all the elements (Figure 8), and the masonry joints were cleaned. A new stiff diaphragm is placed (Figure 8).

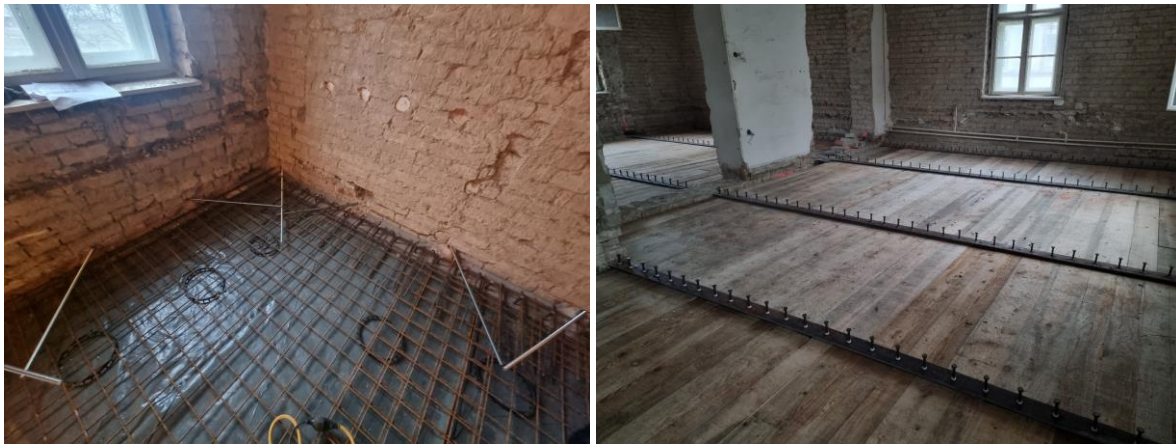
Figure 9. New stiff diaphragm

New rigid diaphragms have replaced existing flexible diaphragms as steel-concrete composite structures, which have been proven with high resistance to seismic and cyclic loading [20] and to secure evenly distribution story shear and torsional moment (Figure 9). On top of the concrete architectural floor, layers are planned to be installed: topping slab with sound insulation, PE foil, cement screed, and finishing skin. During the construction work, it was revealed that some of the elements were not in the right place or not built in a predicted manner, so it was essential to have construction administration included all the time. For example, it was noted that existing steel members were not where they were supposed to be, nor did the number of steel members match the previous design, so it was crucial to have designers involved in the construction so the site would not be paused.

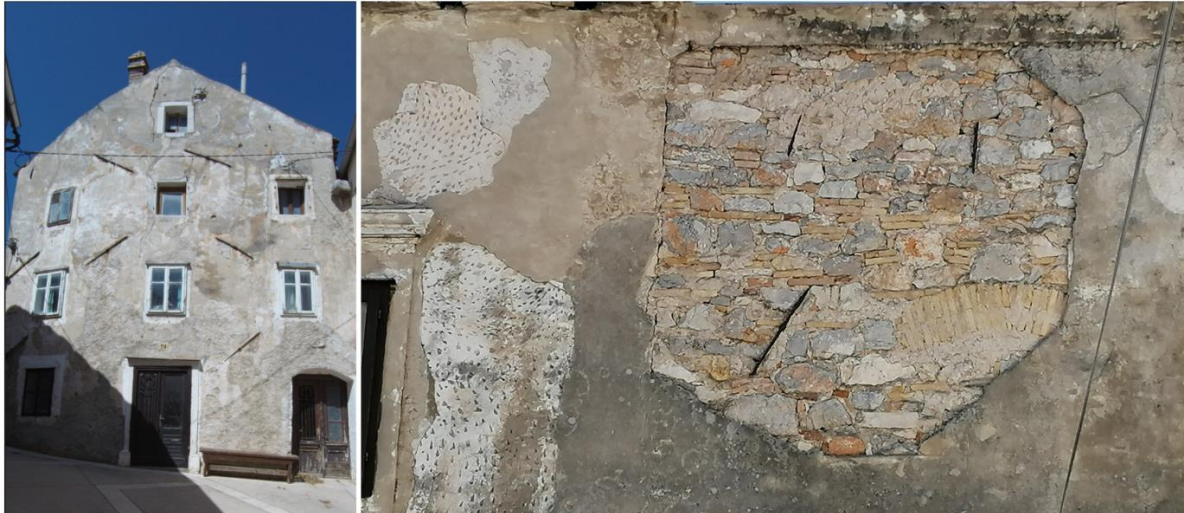
Figure 6. Tie rods visible on the facade of the building (left) and inside the section of the Wall (right)

is necessary to further research this area. The connection between the timber floor structure and the stone masonry wall is of great importance considering the behavior of the structure during earthquakes. One of the structural details that are characteristic of almost every old stone masonry building are the tie rods, which are shown in Figure 6. The ties were made of wrought iron.

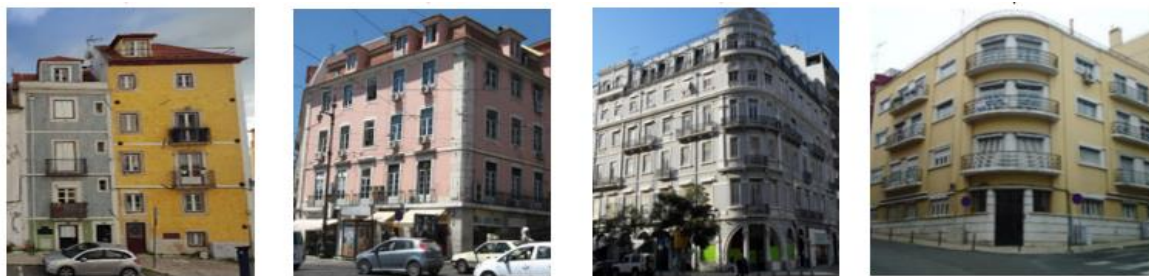
Figure 1 Main features of old masonry buildings

Four typologies of masonry buildings are typically identified in the urban centers of Portugal (Figure 1.): “Pre-Pombalino” (before 1755), “Pombalino” (1755 to 1870), “Gaioleiro” (1870 to 1930) and “Placa” (1930 to 1960). The “Pre Pombalino” buildings, constructed before the 1755 earthquake, are recognized by their irregular geometry, reduced dimensions, narrow facades, high density of walls and few openings to the exterior. They usually are four stories high and are constituted by poor-quality masonry walls supporting the timber floors. The “Pombalino” buildings emerged after the Lisbon earthquake and are particularly known by the improvements in the anti-seismic conception in that period. They usually have up to five stories high and regular geometry. This typology was standard in the building construction practice for more than one century. On the other hand, the “Gaioleiro” buildings represent a downgrade when compared to the previous typology, with the adoption of more simplified construction techniques and the use of low-quality materials which was promoted by the rapid expansion of the urban centers and the housing demand. This typology is significantly more vulnerable, from a seismic point of view, compared with the previous one. Finally, “Placa” buildings emerged before the enforcement of the first seismic-code in 1958 and introduced the use of lightly reinforced concrete slabs at the floors level. The high mass of the RC slabs and the low strength capacity of the load bearing walls to horizontal forces results in an unsatisfactory structural seismic performance. The main characteristics of these typologies are briefly described in Figure 1.

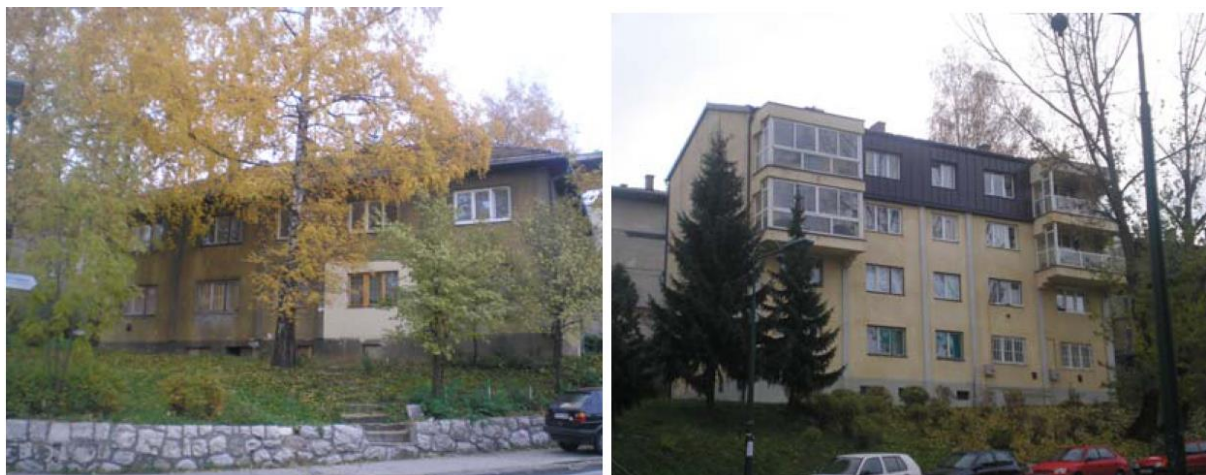
Figure 1. Masonry building before reconstruction (left), after reconstruction (right).

There are at least two motives for the research presented in this paper. First, during the two previous decades it has become a common practice to upgrade the existing multi-story masonry buildings for one or two new floors. One example is showed on figure 1, presented the former existing masonry building and the upgraded one, situated in the vicinity of the Faculty of Civil Engineering in Sarajevo. Second, a large number of masonry buildings in our country were built before the introduction of the first seismic codes. These buildings don't fulfill most of design requirements set by modern seismic regulations. However, the experiences gained during past earthquakes in the region of the South-East Europe showed us that the existing masonry buildings possess higher resistance than one might conclude from the everyday engineering analysis. It is obvious that the masonry structure should be modelled as a whole.

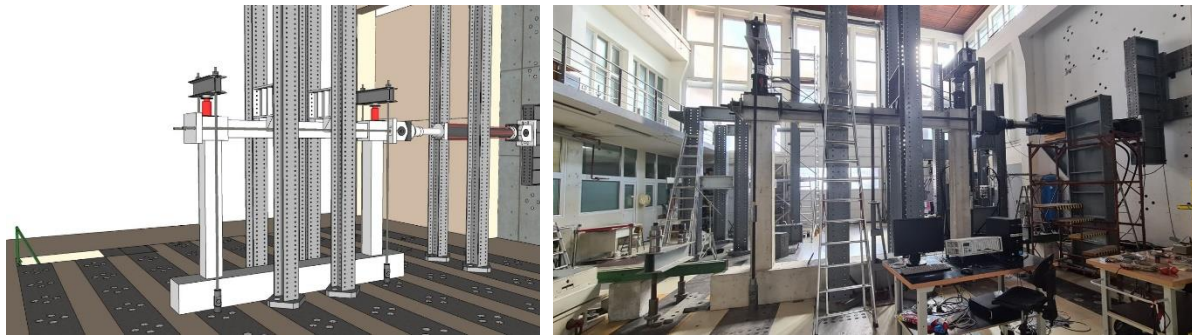
Figure 4. a) Scheme for frame testing; b) testing of frames

The testing setup was prepared in Laboratory in ZAG Ljubljana for cycle tests on reinforced concrete frames consisted of a rigid testing floor with a modular system of steel structural parts and a 6 x 7 m huge reaction wall, both of which have a load-carrying capability of 1000 kN/m² and were spaced apart by a distance of 7 metres. The specimen was fastened to the testing floor using a structure of steel beams and rods that were positioned at both the beginning and the end of the foundation block for the frame. The vertical load of 300 kN on each concrete column was applied by a system consisting of two vertical rods M42, a short beam, and a hydraulic servo-controlled actuator with a capacity of 600 kN. There was a distance of 3.6 metres between the centre lines of the two vertical systems.

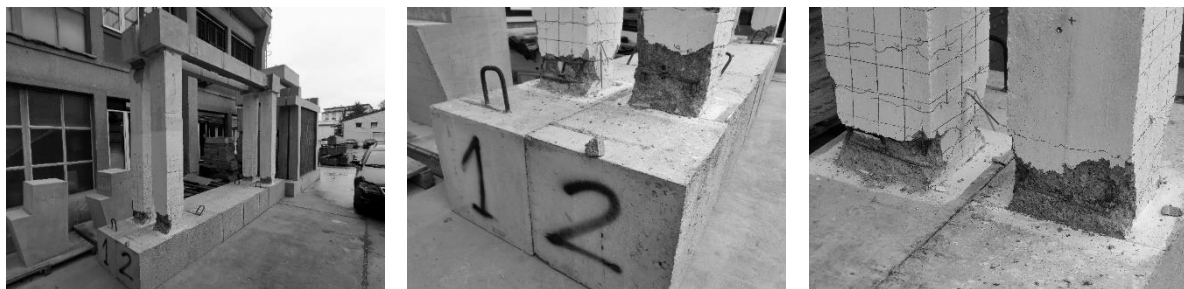
Figure 8. Crack propagation and damage in frames

When the frames were inspected after tests have been finished (Fig. 8), the discrepancies become considerably more apparent. That was done by characterising the damage in terms of the location and size of the plastic joints, as well as the position and width of any cracks that have been formed. When compared to frame REF, frames R10 and R15 had less damage (a smaller region of the plastic joint), less falling off of the protective layer, and in the end, there was no breakdown of the reinforcement in the case of the frames with the rubber particles.

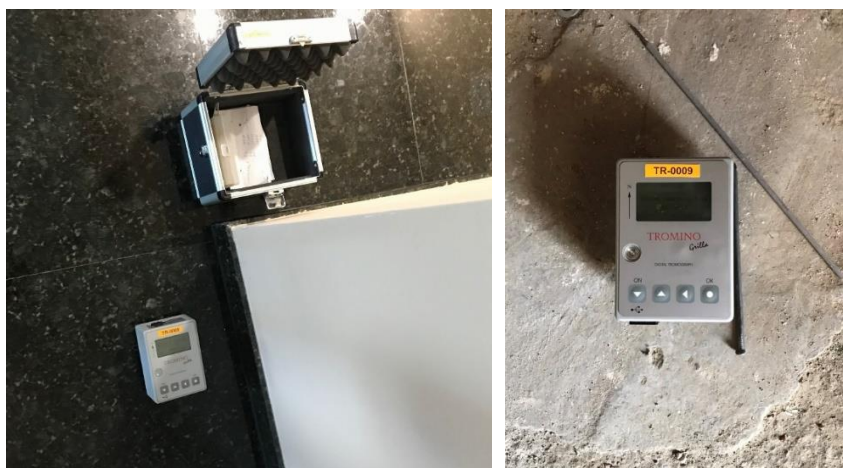
Fig. 1. Some photos from the performed measurements with TROMINO instrument

The measurements were performed with a portable TROMINO® velocimeter (<https://moho.world/en/tromino/>) from the first generation (Fig. 1) with measurement duration of 10 minutes and certain pre-defined parameters as given in Tab. 1.

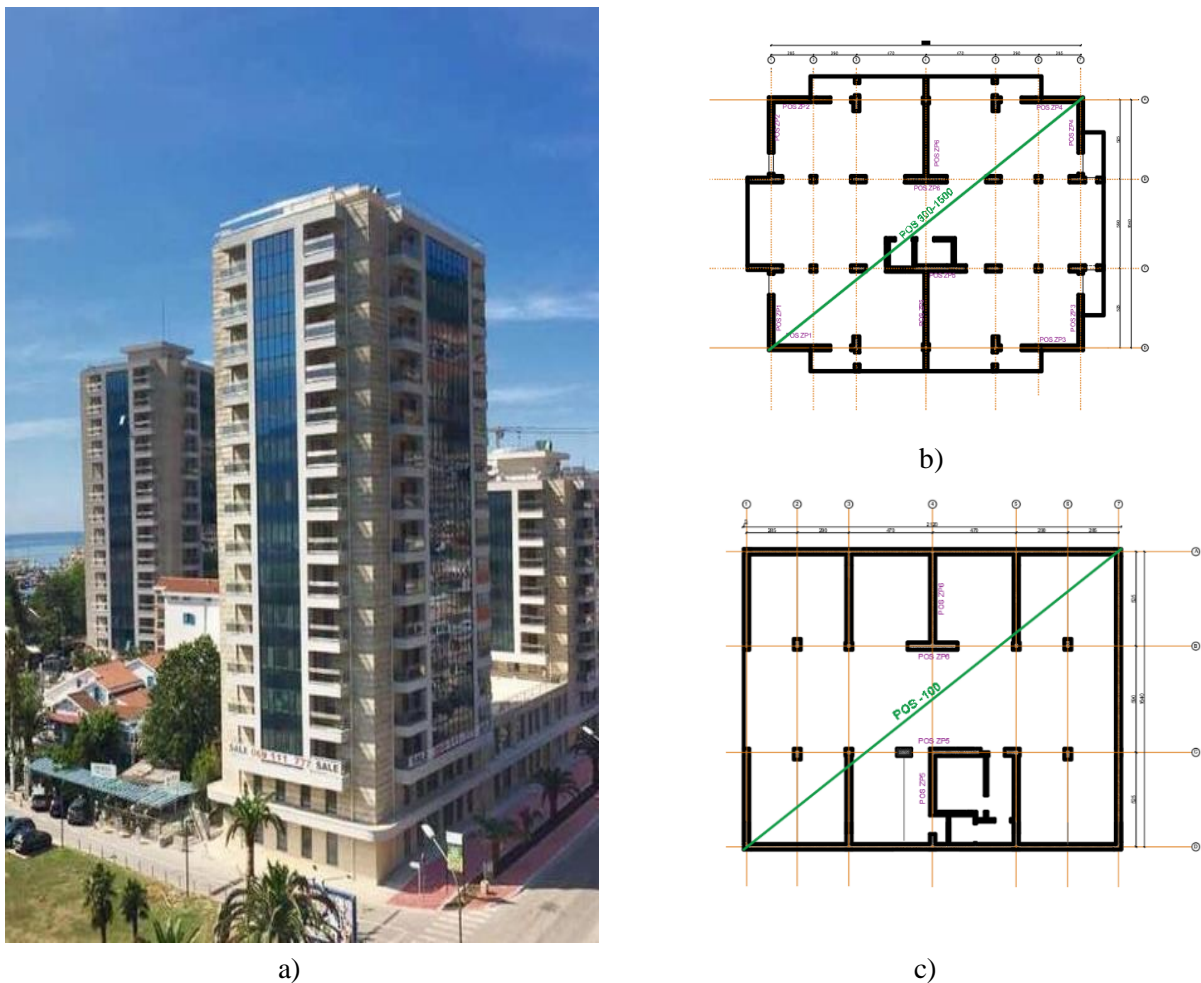
Figure 1. a) existing RC high-rise building; b) floor plan for floors above ground level; c) floor plan for floors below ground level.

The building consists of 19 storeys, i.e., two underground garage storeys, a basement, ground level, a mezzanine, thirteen residential floors and a roof. MEST EN 1998-1 [8] provides that in the location of Budva, earthquakes with a return period of 475 years have a peak horizontal acceleration of 0.34g, while earthquakes with a return period of 95 years have a peak horizontal acceleration of 0.15g. The height of the building is 55.9m, out of which 13.4m is below ground level. Non-structural walls are made out of bricks and gypsum boards. Plans of the characteristic floor below and above ground level are shown in Fig. 1b and Fig. 1c. The thicknesses of the designed walls are 20cm, 25cm, 30cm and 40cm. Structural elements are founded in the foundation slab, which thickness is 120cm. Frames have negligible stiffness compared to walls, which makes the structural system of the building a system with ductile walls. The ductility class is medium (DCM). All slabs have a thickness of 15cm. Walls ZP1, ZP2, ZP3 and ZP4, are passing all floors consistently from garage walls up to the roof, while ZP5 and ZP6 are passing all floors from the foundation slab up to the roof.

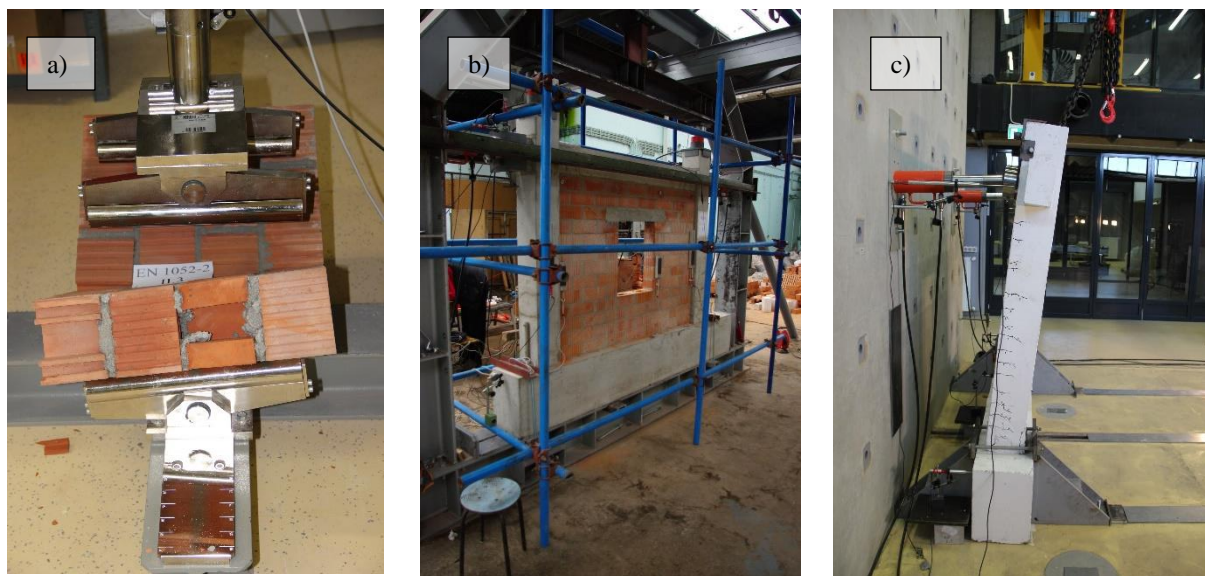
Figure 1. Experimental tests. a) OoP bend test on masonry infill wall [10]. b) IP cyclic, quasi-static test on frames with and without masonry infill walls and openings [11]. c) IP cyclic, quasi-static test on frames with and without masonry infill walls and openings [7]

Based on the OoP wall bend experiments that were done with the load parallel and perpendicular to the bedjoints (Fig. Figure 1a) and by the IP (Fig. Figure 1b) and OoP (Fig. Figure 1c) cyclic, quasi-static tests, computational models were developed and calibrated against them [12]. The computational models were developed using a FEM 3D micromodel approach via Atena Engineering 3D [13] software with manually edited *input* files.

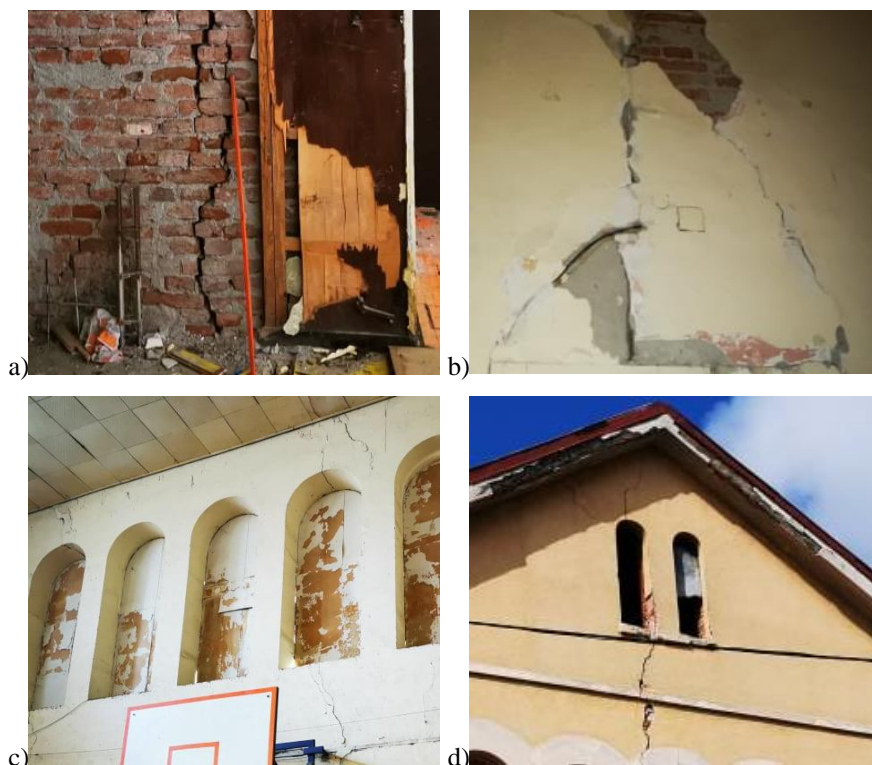
Figure 4. a), b), c), d) Severe cracks on the load-bearing wall elements

During the inspection, significant damage was observed on the load-bearing wall elements, manifested with large cracks on the walls. Heavy damage was observed also in the roof - wooden structure and ribbed reinforced slab, in the annex ground floor structures. (Fig. 4) After the visual inspection it was concluded that, in order to bring the building in functional condition, it is necessary to make a repair and strengthening.

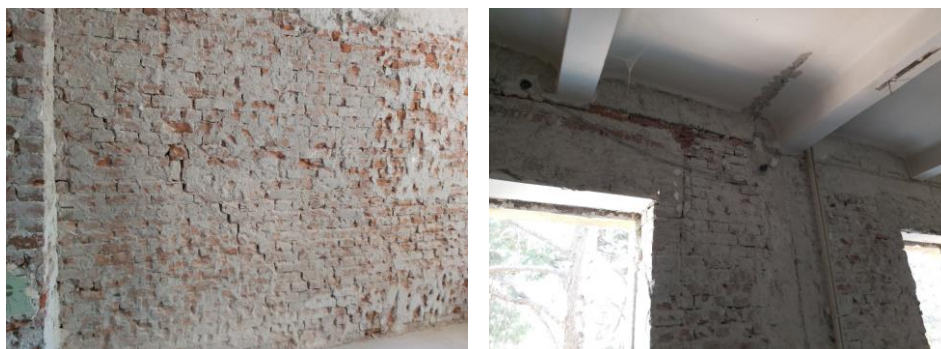
Figure 3. Cracks in masonry walls

Structural and non-structural damages were observed due to the inappropriate foundation and maintenance of the building, which have increased during the exploitation period and seismic actions (Fig. 2, Fig. 3).

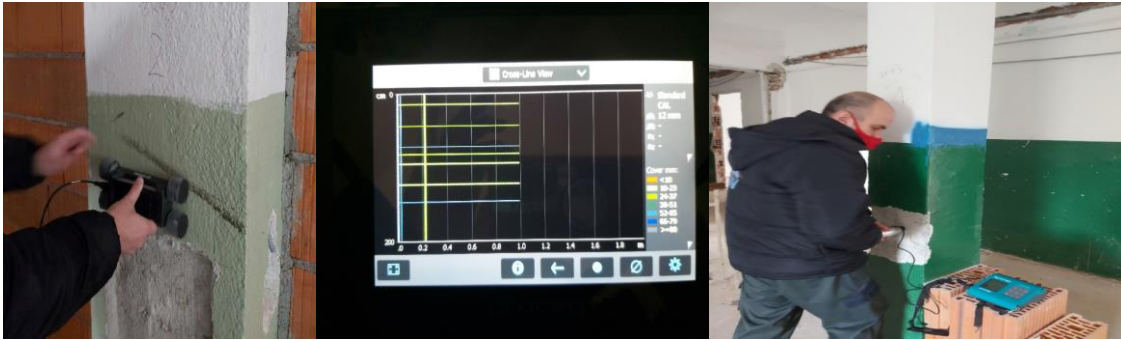
Figure 4. Non-destructive tests

In order to define the stability of the building, non-destructive tests (Fig. 4) were applied[1] for definition the material characteristics, further used in numerical analysis.

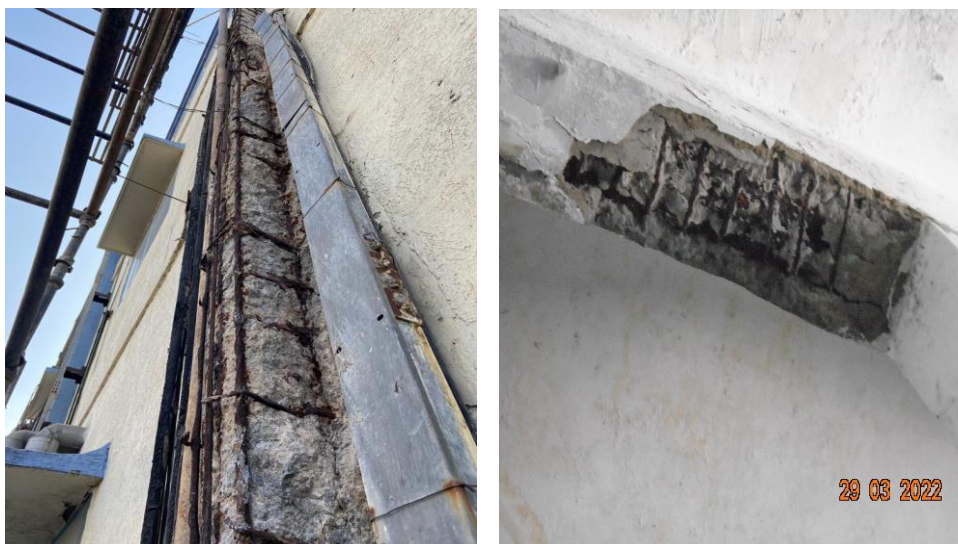
The existing condition of the structure is shown in the below figure 4. The results of the Non-destructive testing using rebound hammer, ultra-sonic pulse velocity and Core cutting are presented in Table 1 of appendix for reference.

Figure 4: Existing condition of Columns and Beams

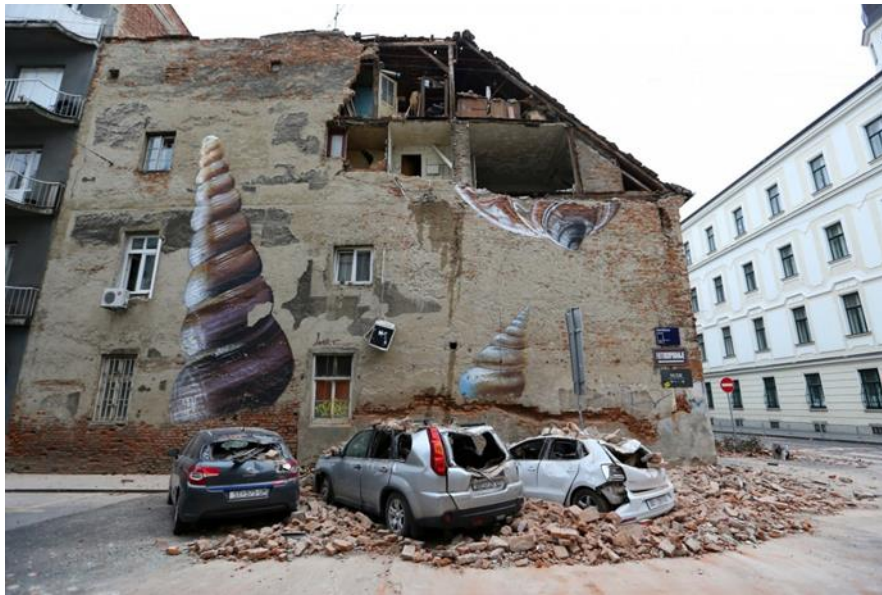
Hairline cracks and other minor damage can occur to masonry facades as a result of earthquakes. Although the aesthetics of the building will be compromised, such damage does not usually pose an imminent hazard. However, major damage, such as the partial or total collapse of a façade, creates greater risks and hazards for occupants attempting to escape and for emergency services trying to access a building. As well as the imminent danger from falling masonry, important access routes in and around the building may be blocked. Damage to facades and falling stones is evident in post-earthquake photographs from Christchurch (2011) and Zagreb (2020), see Figure 1.

Figure 1. Masonry façade damage – Zagreb 2020 (Photo credit REUTERS/Antonio Bronic).

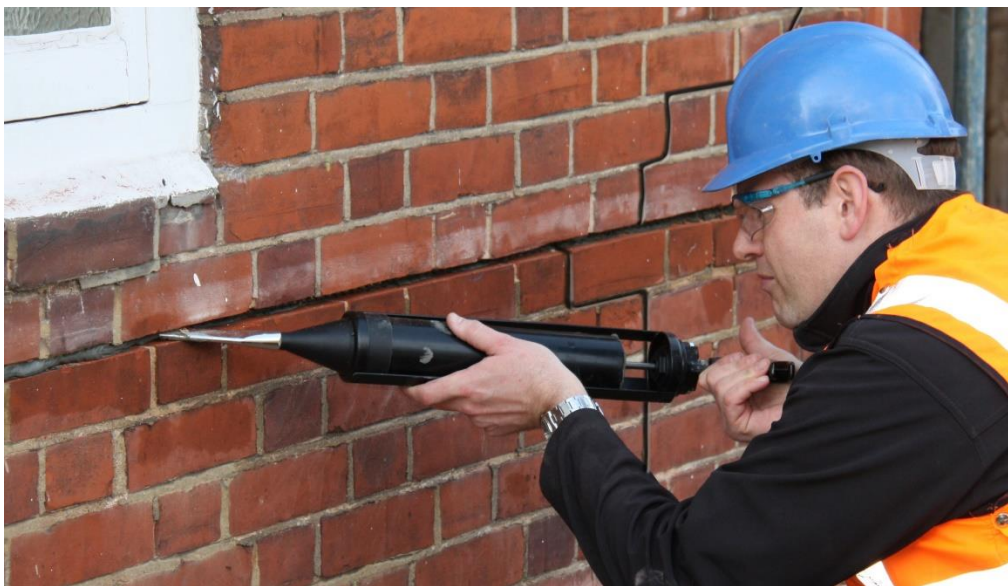
One method of repairing cracked masonry is to insert long twisted (helical) stainless steel bars into horizontal mortar joints and grout them in place (see Figure 3). The helical bars and thixotropic cementitious grout bond tightly to the existing masonry, redistributing the tensile load down the length of the panel and minimising the occurrence of cracks. With careful consideration of the mortar to be used in the grouting process, façades can be repaired technique in a very aesthetically sympathetic manner.

Figure 3. Thixotropic cementitious grout applied to a horizontal slot in preparation for insertion of helical bar.

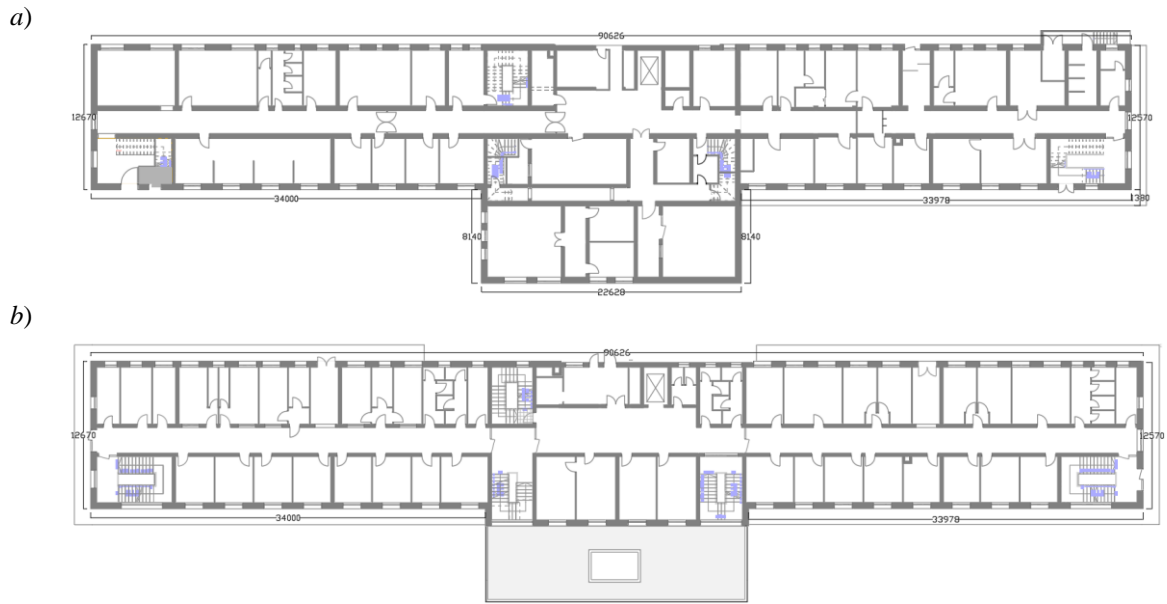
Figure 1. Design of the old building: a) Basement story, ground story; b) First story, second story.

The plan view of the old existing building is shown in Fig. 1, while Figs. 2 and 3 show some photos of damage after the earthquake, prior to and after the mortar layer was removed. Before removing the mortar, vertical cracks, tending diagonally, can be seen, and they were temporarily closed until the building was completely repaired. After the mortar was removed, diagonal cracks can be seen.

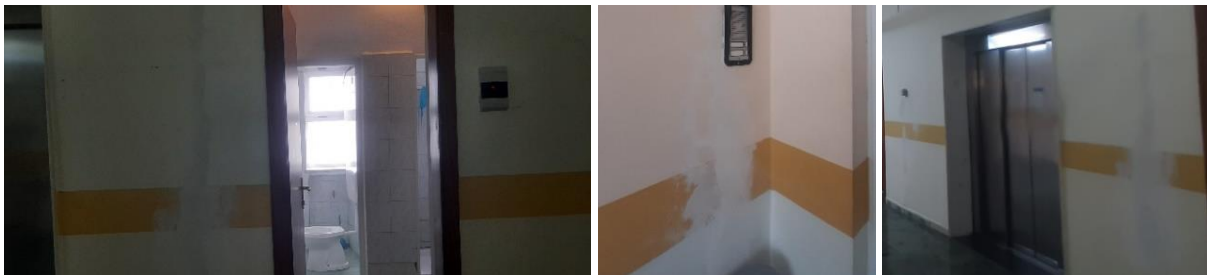
Figure 2. Cracks in the wall from the earthquake in 2019 Tirana, Albania.

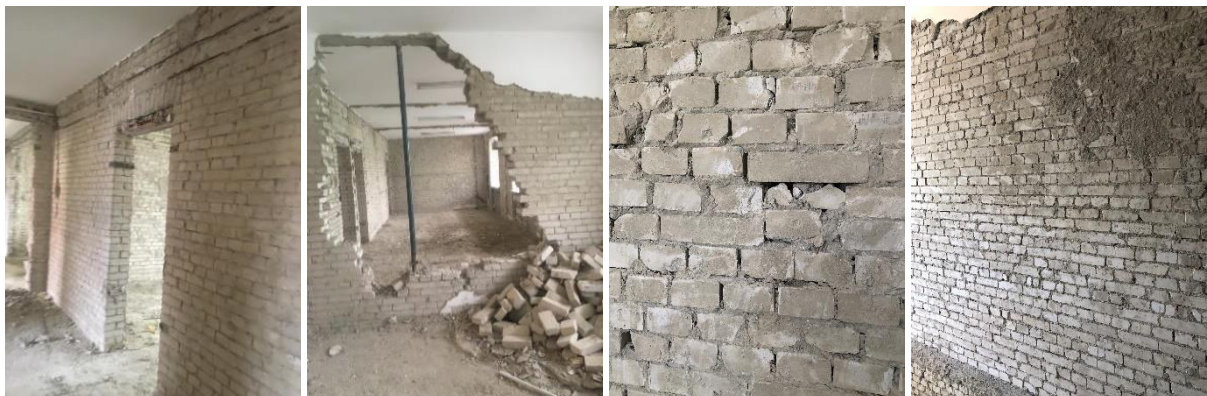
Figure 3. Wall after demolishing mortar.

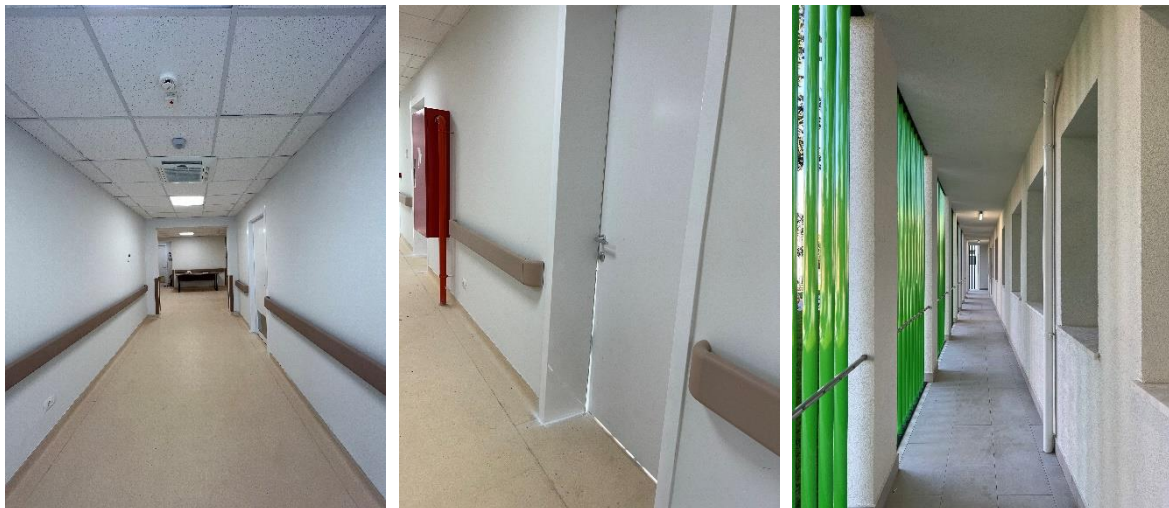
Figure 5. Renovated building.

During the renovation, it was taken as a basis that the materials that will be used in the floor and the tertiary or dividing walls should have a lighter specific weight. Partition walls are taken from Knauf walls, and now we have a floor load reduction of $g=2.80\text{ kN/m}^2$ on floors and of $g=1.50\text{ kN/m}^2$ on the roof. The other walls were not damaged, they were only reinforced with two layers of compressed or cast plaster with a thickness of $t=25\text{ mm}$, class C-25/30. Fig. 4 shows the renovation design plans with the walls' changes. Fig. 5 illustrates the renovation execution of the building which is the subject of the analysis.

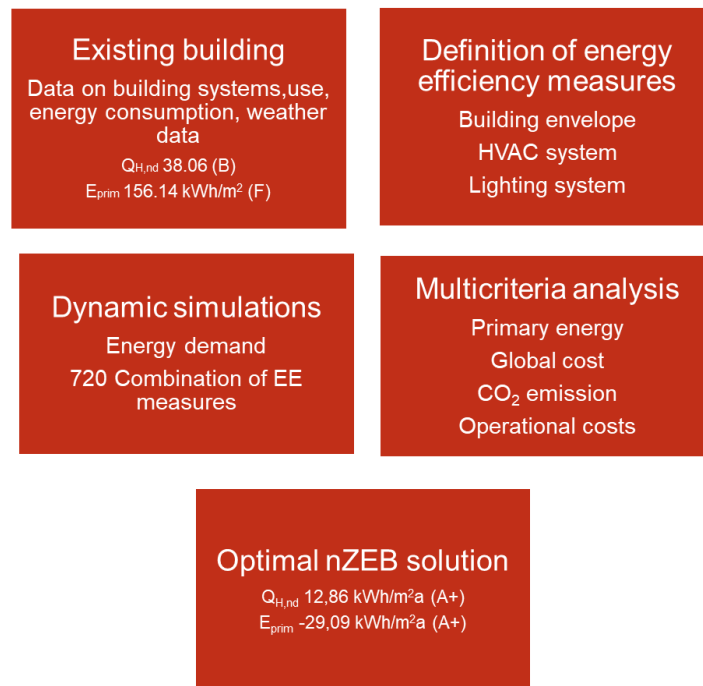
Figure 2 Methodology for selection of optimal nZEB solution

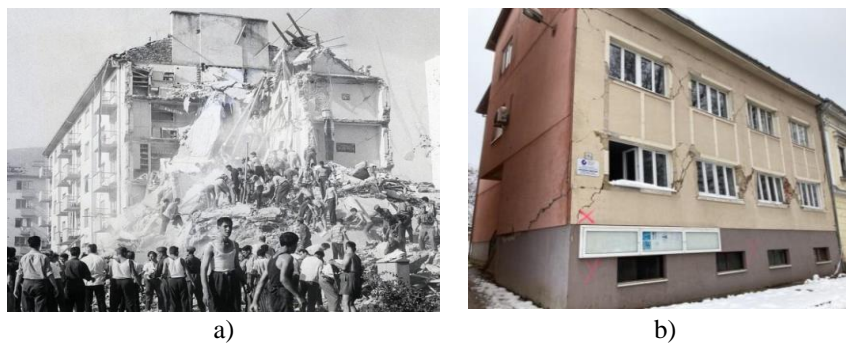
Figure 2. Performance of URM multi-family residential buildings in past earthquakes in the region: a) a collapsed building due to the 1963 Skopje earthquake (credit: Z. Milutinović) and b) a damaged building due to the 2020 Petrinja earthquake (credit: SUZI-SAE).

Buildings of this typology were exposed to several damaging earthquakes in the region, including the 1963 Skopje, North Macedonia earthquake (M 6.0) (Fig. 2a), the 2010 Kraljevo, Serbia earthquake (Mw 5.5), and the 2020 Petrinja, Croatia earthquake (M 6.4) (Fig. 2b) [4, 5]. The buildings of this type which performed poorly in the 1963 Skopje earthquake were designed according to standardized designs, with load-bearing walls provided only in one horizontal direction (longitudinal or transverse) [6].
