2nd Croatian Conference on Earthquake Engineering

Conference Proceedings

2nd Croatian Conference on Earthquake Engineering – 2CroCEE

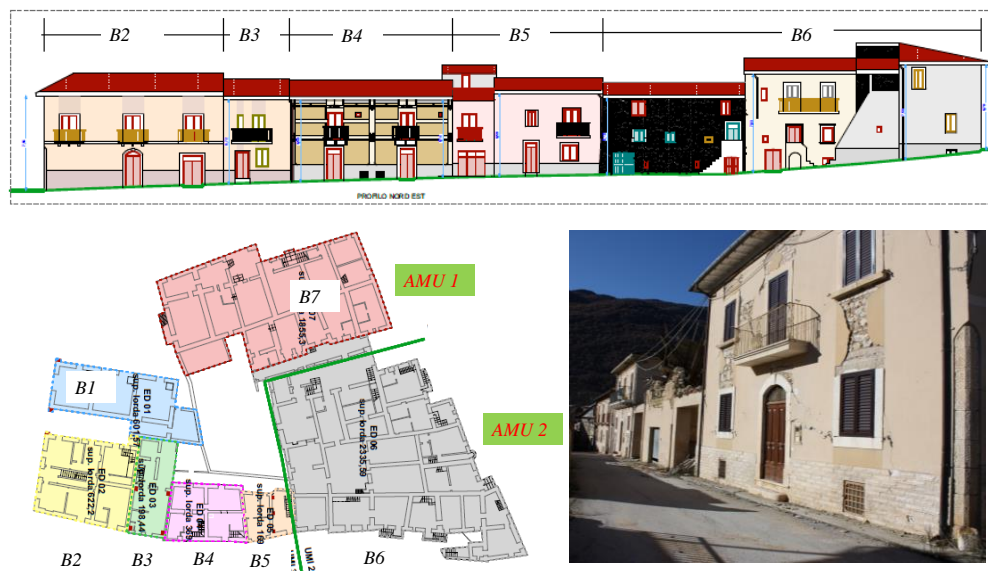
Figure 1. Building Aggregate and sub-units.

A new reconstruction model defined on the basis of new procedures was necessary in order to deal with the reconstruction of old masonry building aggregates (i.e. groups of masonry buildings to form complex building agglomerates) with a cultural and architectural heritage value. In this case, the reconstruction model refers to: a) Building Aggregates (namely BA); b) a portion of the BA with homogeneous characteristics, Aggregate Minimum Unit (namely AMU), see Figure 1 (e.g. the aggregate depicted in such figure is analysed by means of two applications related to AMU). The application for funding related to BA or AMU contains data related to one or more buildings (B) which consist of one or more dwellings.

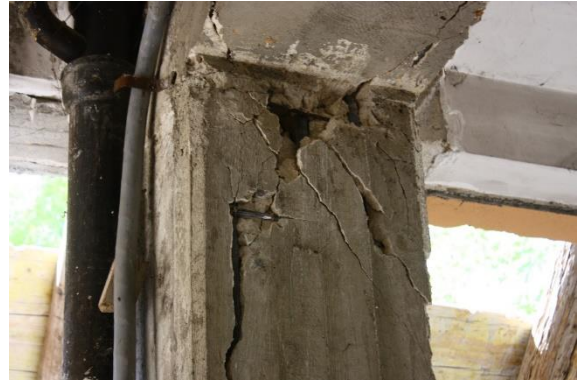
b) Brittle fracture in a pillar

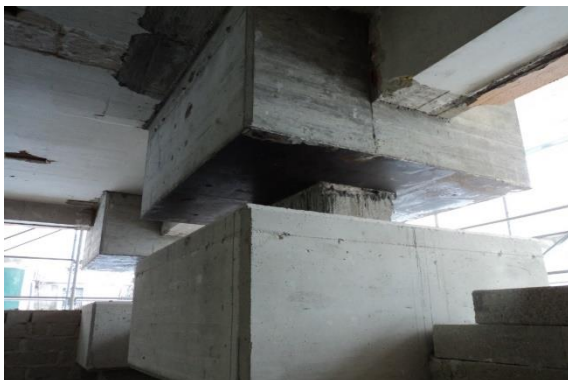
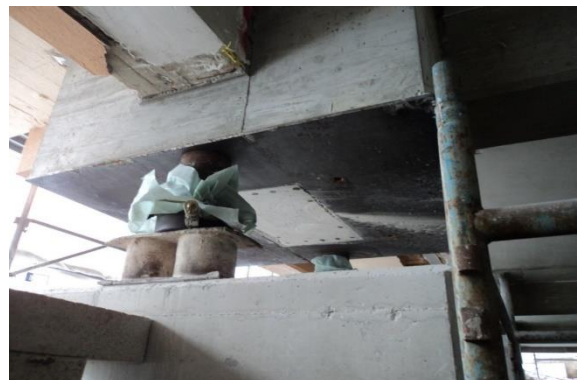
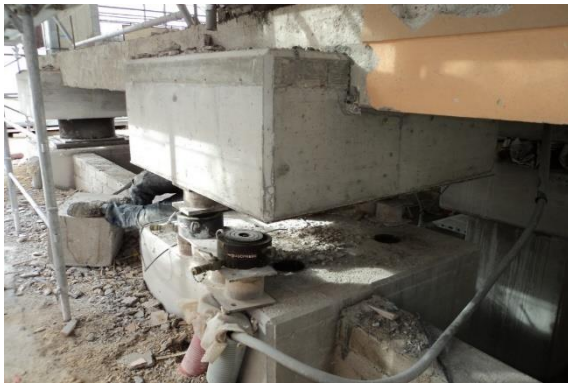
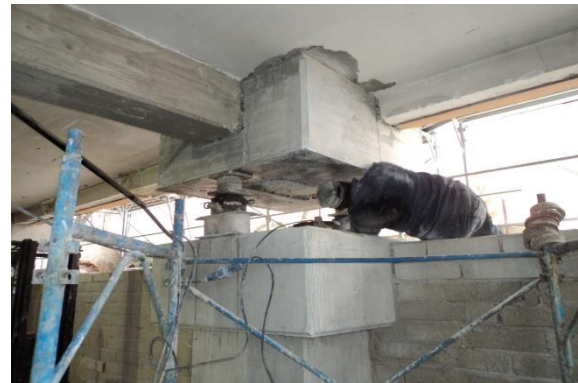
Figure 5. a) Strengthening of a pillar

b) Cutting a pillar for isolator insertion

Figure 5. a) Strengthening and cutting the top of a pillar

b) Control of the cutting of a pillar

By cutting pillar top edge, after reinforcing foundation and pillar lower part, 32 elastomeric isolators and sliders have been positioned. The HDRBs are 9 FIP SI-S 700/200 and 10 SI-S 800/200, and the sliding devices area 13 FIP VM 250/700/100. In fig. 5 the insertion of an isolator in the top of the pillar is shown.

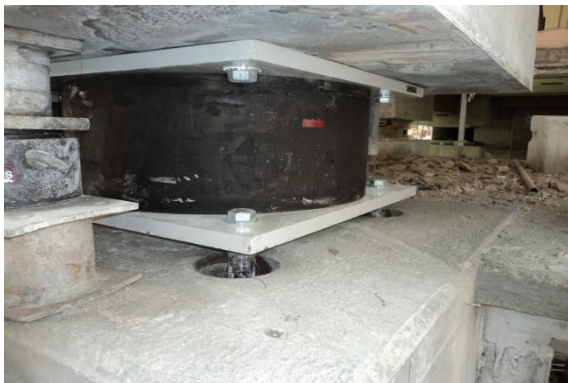
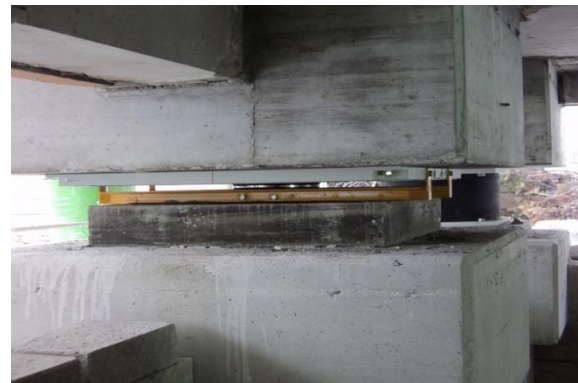
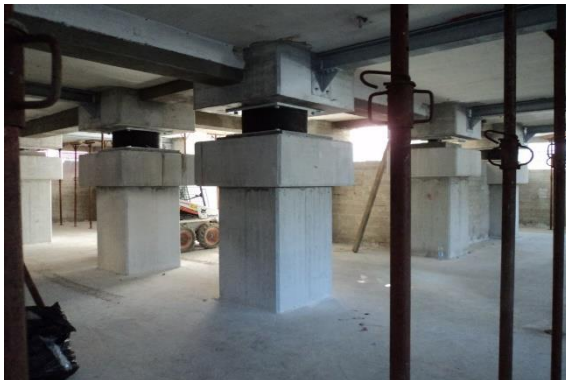
Figure 6. a) Insertion of an elastomeric HDRB SI-S 800

b) Insertion of a slider Vm 250/700/700

Figure 6. a, b) Level 0 with all isolators at the top of strengthened pillars

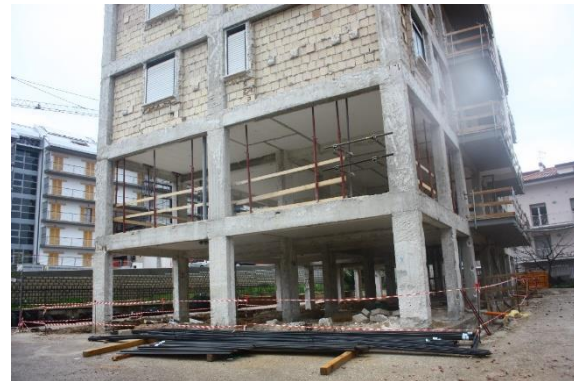
b) damage end demolition of the infills

The damage caused by the 2009 earthquake in the building infills determined the need to completely demolish all the infills at the first two levels, and partially at superior levels (Fig. 8).

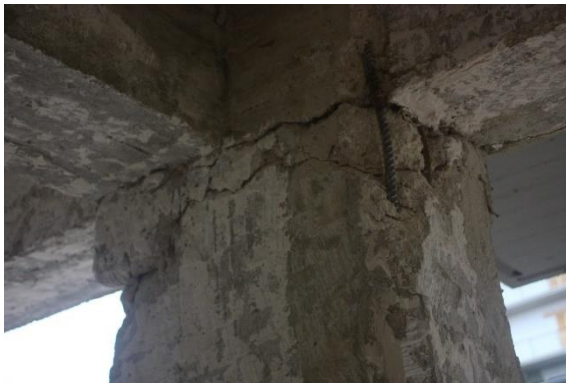
Figure 9. a) Brittle fracture in the top of a pillar

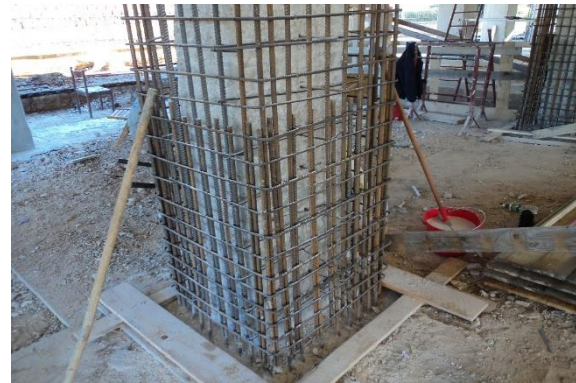
b) Increase of section and reinforcement bar in a pillar

In order to strengthen the structure, an enlarged concrete section with new reinforcement bars were set up in all the pillars (Fig. 9 b).

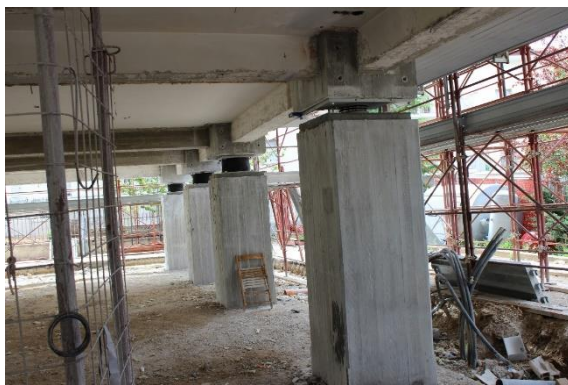
Figure 10. a) HDRB and sliding devices at top of pillar

The building has been retrofitted with sixteen SI-N 450/126 high damping rubber isolators and eight sliding devices VM 250/250. It's worth noticing the position of sliding devices in correspondence of the staircase, (Fig. 11b) where they have been placed at a different height with respect the isolation level. The area of this retrofitted building is quite different from the preceding one, and is located near an active fault which caused several strong earthquakes in the past. The area has some resonances caused by the fault proximity. Also, this structure has been completely designed according to Italian code for new structures.

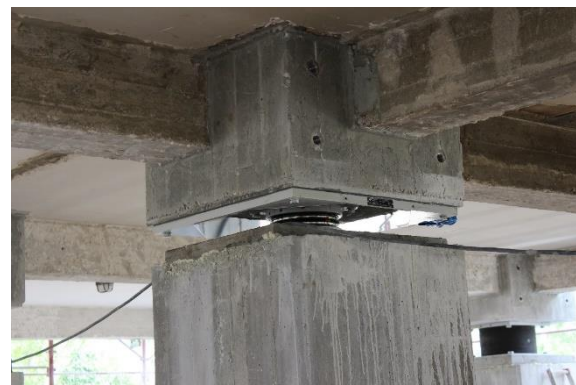
b) Sliding device at top of a pillar

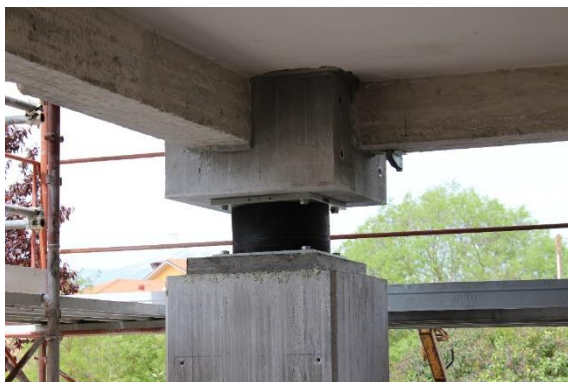
Figure 11. a) HDRB rubber isolator SI/N 450/126

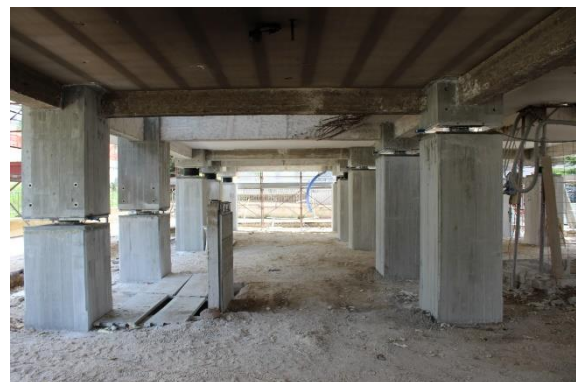
b) Sliding device in correspondence of the staircase

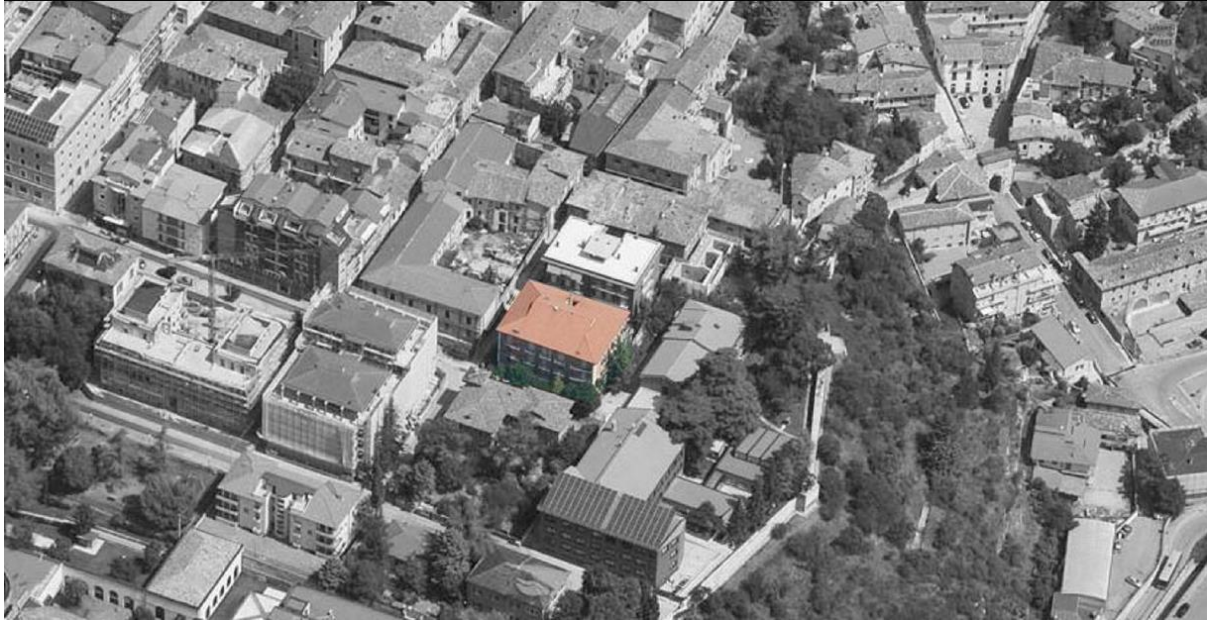
Figure 12. Isolated building in the centre of the city of L'Aquila, where secondary amplification effects occur at low frequencies.

The maximum seismic performance for this building has been gained by seismic isolation, but, according to the shown amplification effect (fig. 3), an accurately seismic design has been performed to take into account the probable high displacement during earthquakes in this area.

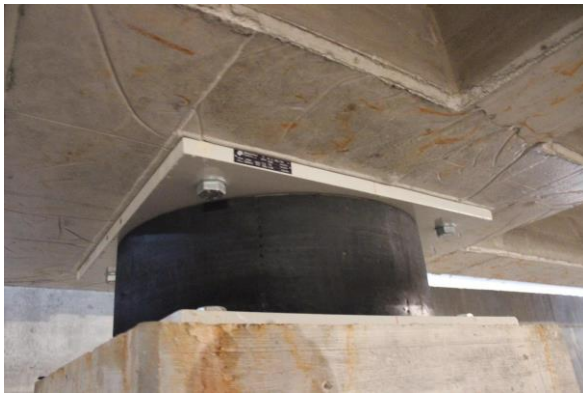
Figure 14. a) HDRB isolator SI-S 800/160

The isolation system has been designed in order to take into account not only the structure typology, but also the soil – structure interaction, in particular the secondary resonance at low frequencies which are typical of the centre of the city (Fig. 3). In particular (Figs. 14, 15), seismic movement joints have been designed to permit large displacement of the superstructure.

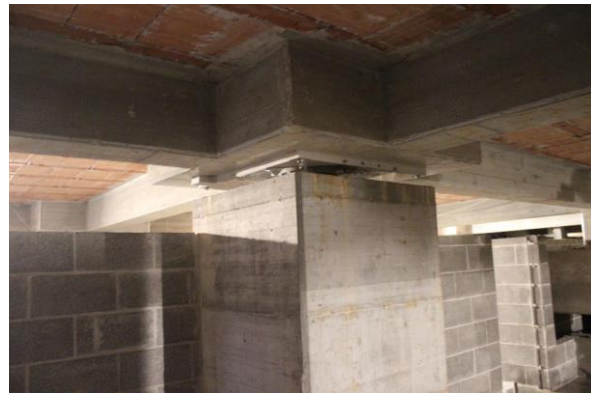
b) sliding device VM 300/600/600

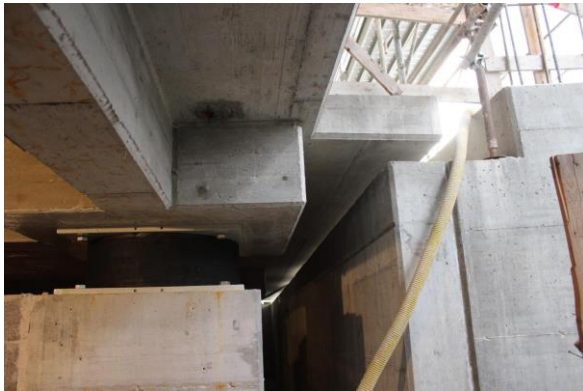
Figure 15. a) HDRB isolator with external seismic joint

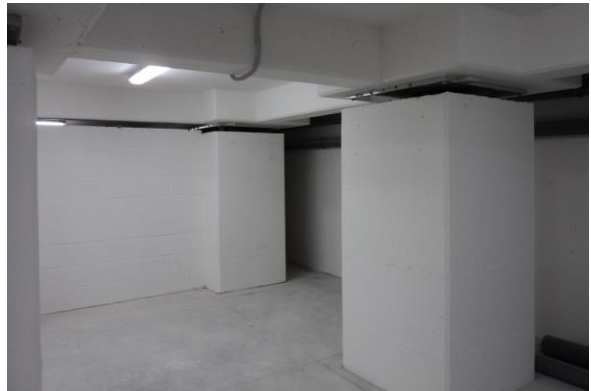
b) Horizontal joint with superstructure

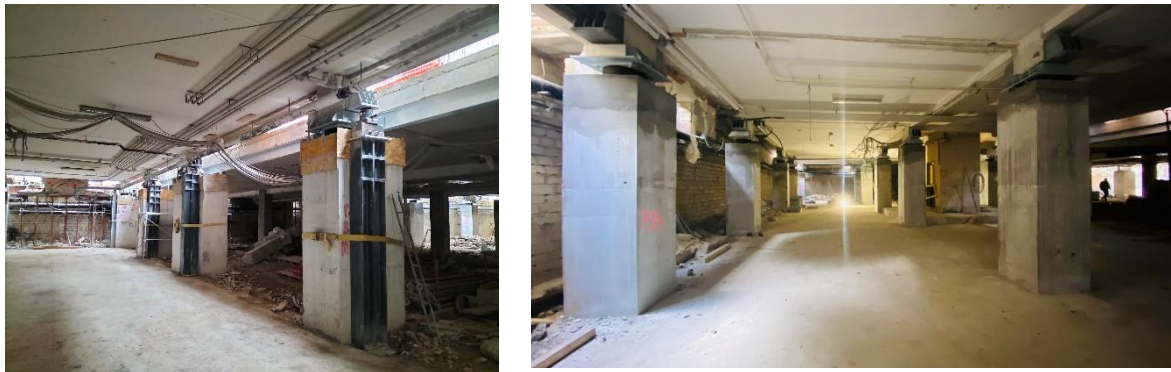
Figure 5. Crefel Building: two phases of the installation of the isolators.

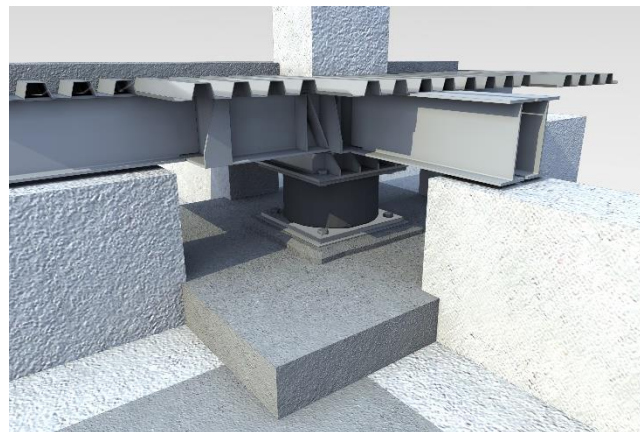
10) completion of new ground floor.

Figure 9. Steps for isolators installation in Building in via Di Vincenzo 23 (Case Study 2).

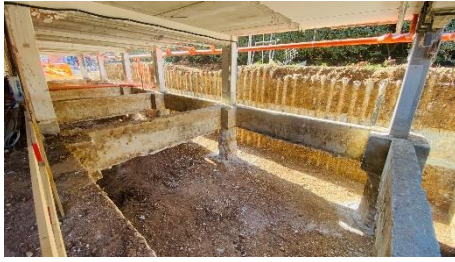
1) excavation below the existing foundation beams;

Figure 14. Steps for isolators installation in Building in via Di Vincenzo 23 A.

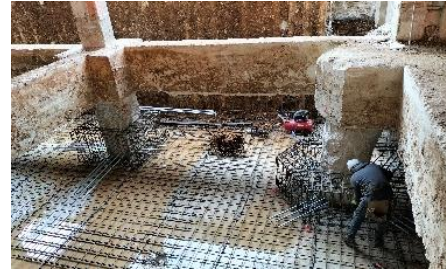
2) placing reinforcement for the new structure (plinths and foundation slab);

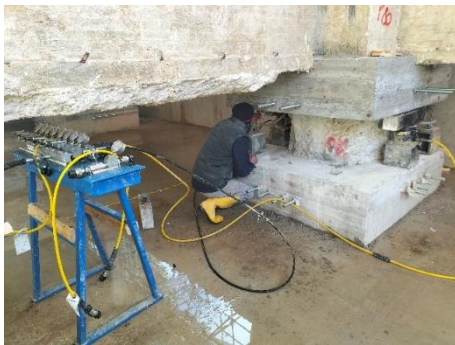
5) placing of hydraulic jacks and displacement transducers;

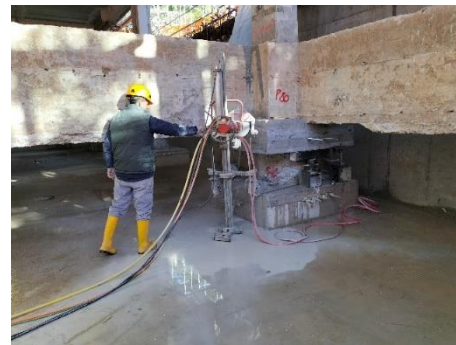
6) cutting the top of the pile with diamond wire;

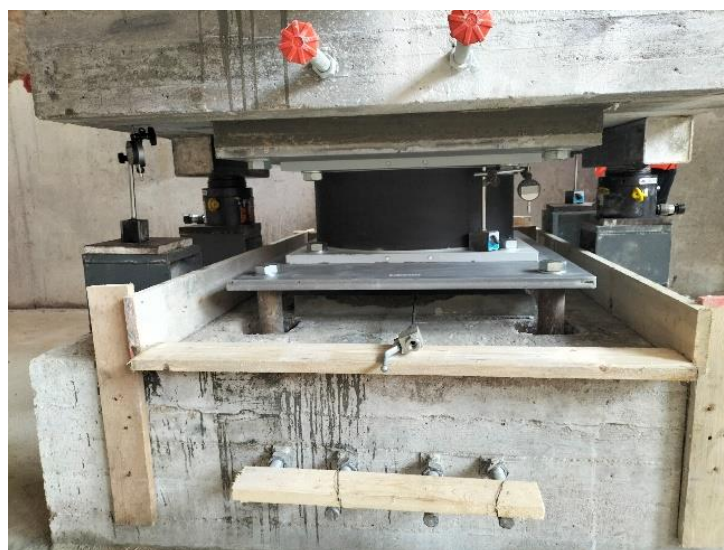
7) the isolator during installation: non-returnable flat jack has been already injected, while bottom anchorage grouting is not yet carried out.

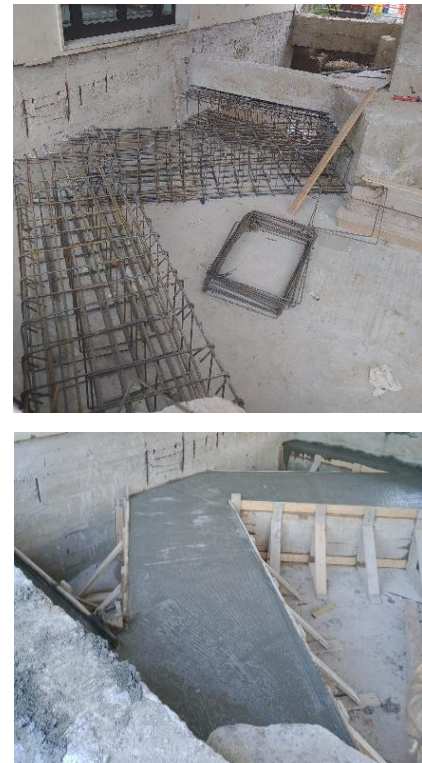
Figure 13: Detail of connecting beams realized among the foundation

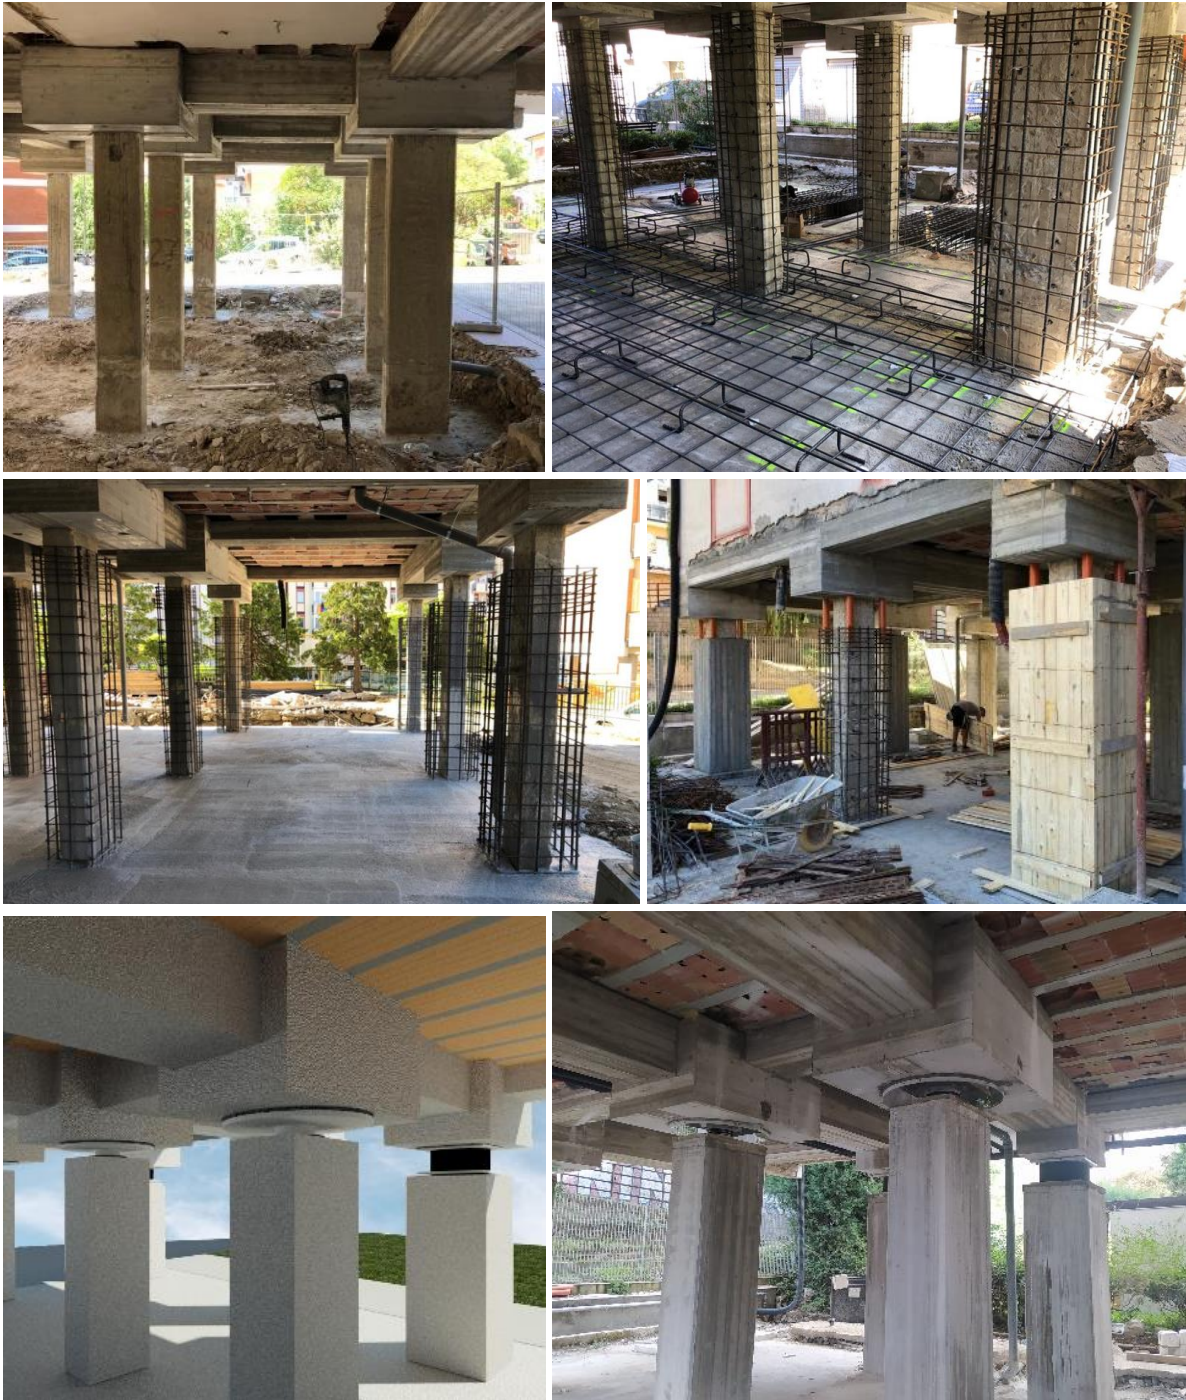
Figure 17: Details of the interventions realized

composed by new RC beams, jacketing of existing beams, and new steel beams, the latter inserted between the unconnected columns. The new steel beams may not be too high because of the installations, that are very close to the floor intrados. In order to quantify these additional internal forces numerical simulations have been conducted, reproducing the structural joints geometry including beams, columns and caps (Figure 15). Figure 16 compares the columns base rotations without and with the grid floor along the two directions at the Life Safety Limit State. It is easy to note that the grid added reduces the rotations of some columns and, consequently, the internal action born due to the second-order effects. Finally, Figure 17 reports some pictures of the intervention realized for installing the isolation system.

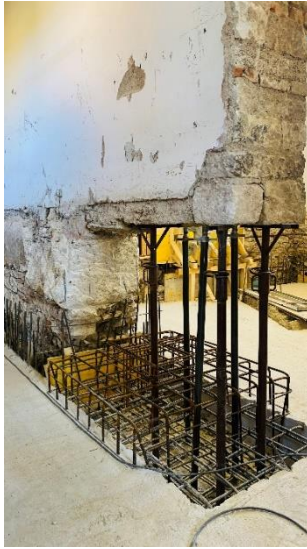
a) Demolition of existing foundation, new foundation reinforcement and support of masonry wall with props

Figure 14. Base isolation construction phases.

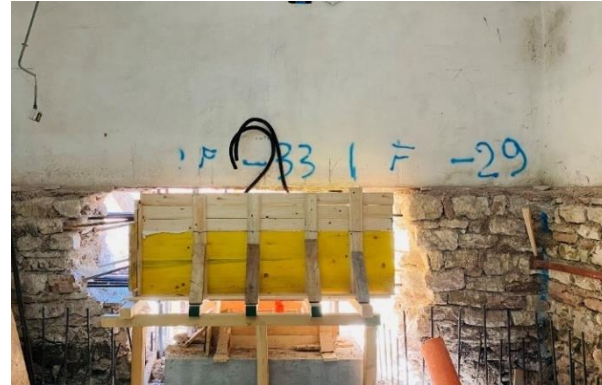
b) Formwork for concrete casting of upper curb beams

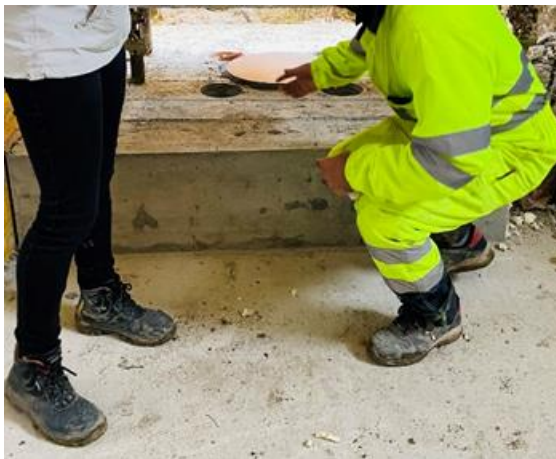
c) Installation of flat jack

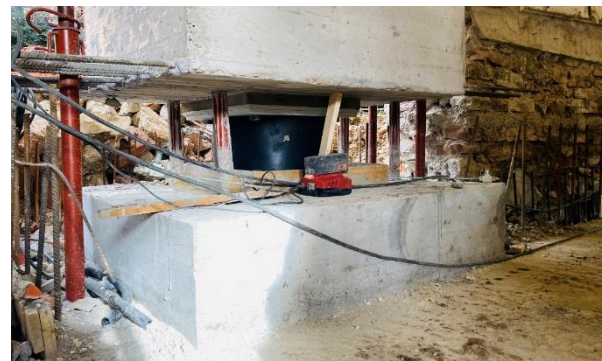
d) Installation of isolator

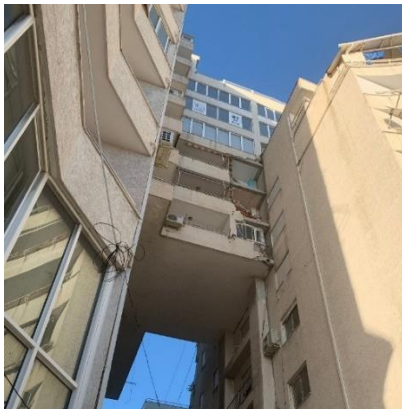
Figure 1. Collapse of the facade walls in the "connecting bridge" area

This volume added to the form of the bridge is partly supported on two columns attached to the facade of the first building but not connected to it and not far from it (on the right) and partly emerges as a cantilevered volume on the last three floors of it, on the terrace of the existing building.

Due to the irregular configuration in plan, the added mass on the upper floors of the second building and the irregular and large-amplitude seismic waves, two effects were produced: the buildings collided with each other in the joint area and the cantilever volume has increased the height of the center of mass of the second building and has had the effect of increasing its behavior as an inverted pendulum. As a result, parts of walls have fallen from the facade. Fig. 1.

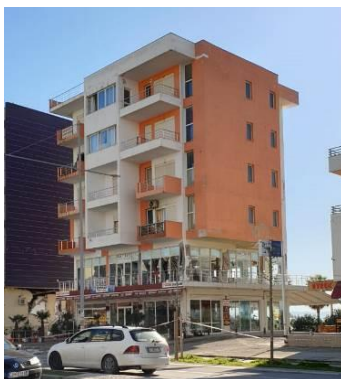
Figure 3. Non-uniform distribution of non-structural components

The building in Figure 3, with 6 floors and a reinforced concrete supporting structure, built during 2008-2010, is one of many buildings with the same irregularities in their configuration. The building's volatility has been high, among other issues, due to the following factors: low stiffness on the first two floors; low stiffness in twisting and irregular distribution of structural elements in the added mass of upper floors and non-uniform distribution of non-structural elements, with added mass on upper floors.

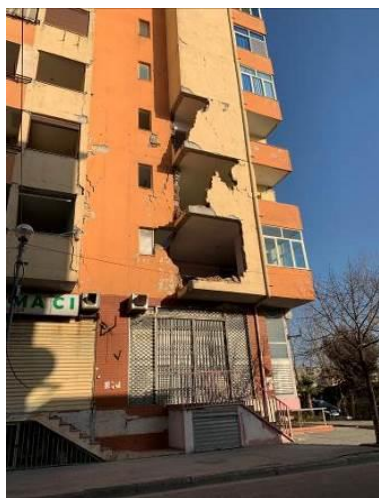
Figure 6. Walls collapse in the cantilever volumes

Due to the simultaneous oscillation in the vertical and horizontal direction, the cantilever volumes are in a delicate situation of balance. In the cases shown in Fig. 6 and Fig. 7, this state of the cantilever volumes is also accompanied by the lack of implementation of technical details to properly connect the walls at the ends of the cantilevers. As a result, the walls of the facade on several floors of the cantilevered volume have collapsed, exactly at the outer corners of the cantilevers.

The main cause of this damage model is the deviation from the anti-seismic design conditions, due to the irregular volume configuration with the cantilevers and the added weight of the walls in them, because the architect has chosen to treat the cantilever as a volume attached to the rest of the facade.

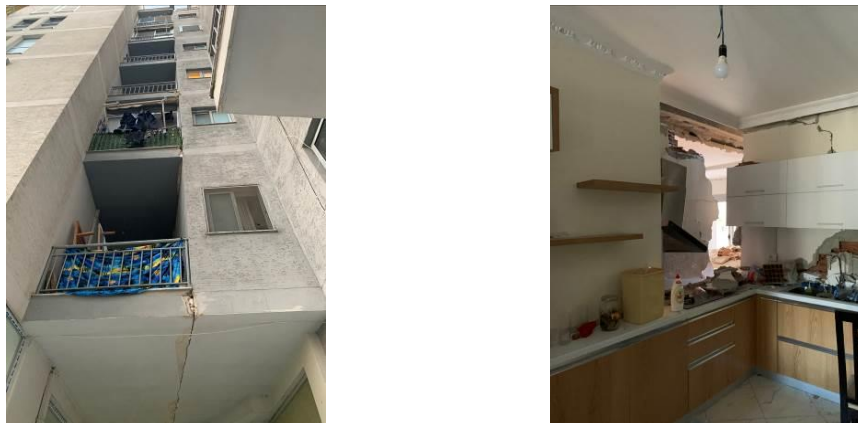
Figure 8. Damage caused during the collision in the joint position

Generally, buildings that are separated by an anti-seismic joint have suffered damage in the joint area, generally due to the collision of the buildings during the seismic action. In all these cases, it is understood that their cause is the incorrect dimensioning of the joint. The case of Fig. 8, shows the breaking of the wall up to its separation (also due to the inertial forces caused by the collision of the supporting structures of the buildings). Another consequence of this cause is the damage to the neighboring buildings on the upper floors due to the collision with the greater displacement of the top floors and their uneven swaying.

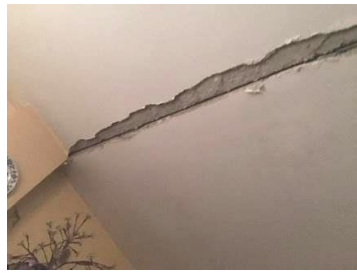
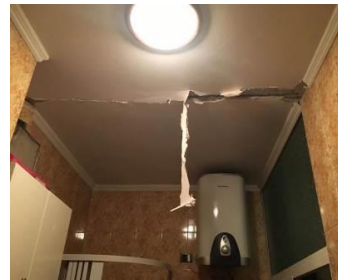
Figure 9. Interior view from an apartment in Tirana. Source: Marin Zaimi

A visit to the damaged buildings was necessary after the earthquake of November 26, 2019, in order to point out the phenomenon of organizing the same functional space of the apartment over the anti-seismic joint. The photos in Fig. 9, were made in the same apartment in a multi-storey residential building built before 2000 in the center of the Albanian capital. Proving whether this choice was design avoidance during implementation was not possible, but the fact shows that the housing unit falls on the seismic joint. This either shows unfair solutions of the architect, for the above mentioned, or shows a complete lack of cooperation and coordination of the design work between the architect and the structural engineer. This must be a widespread phenomenon because the same situation of the extension of the same residential apartment over the seismic joint of 2 neighboring buildings was also found in a building in the city of Durrës. Fig. 10.

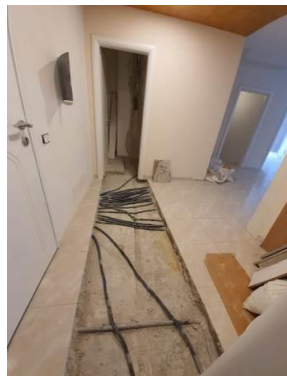
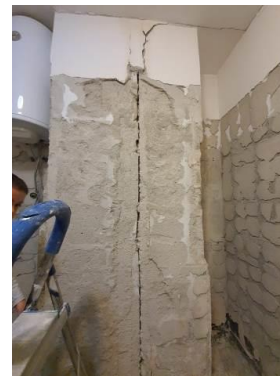
Figure 10. Interior view from an apartment in Durrës city. Source: Entela Kapllani

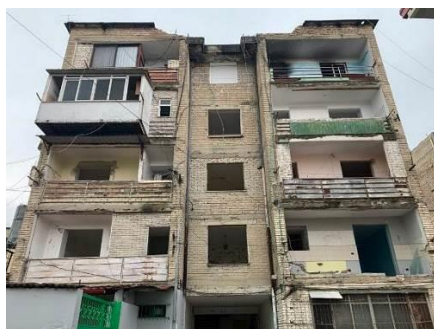
During the earthquake of November 26, 2019, there were cases of terrace parapets falling for various reasons. In Fig. 11, the case of a building whose parapet collapsed due to non-implementation of the technical detail of the brick parapet reinforcement and the thickness of the terrace layers. During the seismic event, a 20 years old girl lost her life, struck in the head by a piece of parapet going out of the building, although the building itself did not sustain significant damage.

Figure 11. Collapsed brick parapet. 1970s construction building

Gable walls and the parapets of balconies and terraces, which tend to overturn in an earthquake, should not be built out of masonry construction. They are to be made of reinforced concrete in order not to be separated from the structure. The damage of gable wall may be prevented by placing it between the frames. [13] A solution to the reinforcement of the brick parapet is given in Fig. 12.

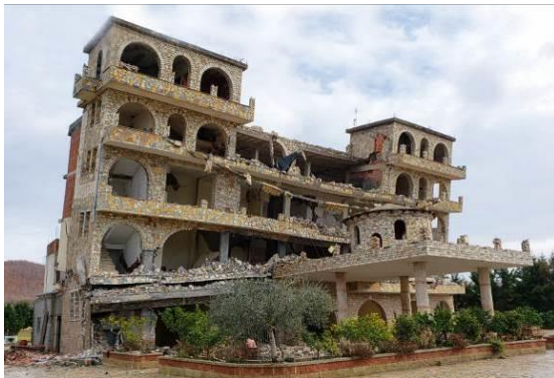
In the first case, not only the detachment of the stone slabs from the facade occurred, but also the structural damage of the columns in the facade covered with stones, because during the seismic event they could not withstand the increased stress as a result of the unforeseen weight of the natural stones on the facade. The destruction of the building was identified as a consequence of the deviation from the design during implementation and the loading of the structure with a weight outside of the design. In other cases of cladding facades with natural stone tiles with mortar adhesion, their detachment from the facade has also occurred.

Figure 13. Cladding with natural stone

Hence, chemical connections, such as mortar, are inconvenient, which are also prohibited in western countries prone to earthquakes. Instead of chemical connections, mechanical connections such as cramp anchorage with proper details and intervals are appropriate to be used. [9]

According to KTP-N.2-1989, Chapter 3, Point 3.4.2, the plates used for covering external walls with a surface area greater than 0.1 m^2 ... are anchored to the walls with the help of metal ties.

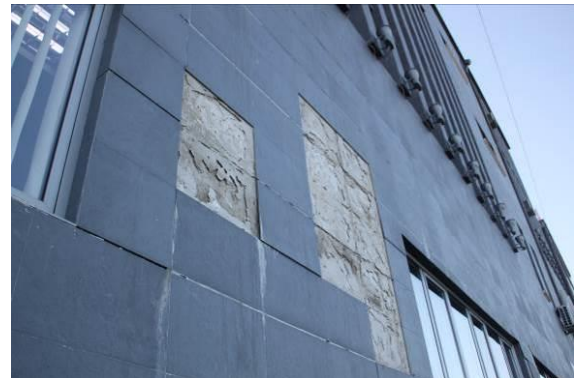
In the second case, the ceramic tiles were detached from the facade due to their gluing assembly with mortar on the exterior facade. However, the adherence, breaking and tensile strength of the mortar are restrictive. The consecutive drift movement due to earthquake forces between stories makes the mortar exceed its strength and makes the finishes separate from the walls due to properties of mortar in between. [13]

Figure 14. Cladding with ceramic tiles

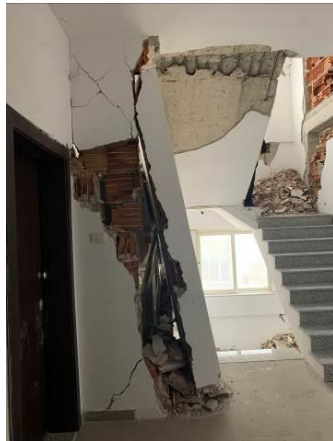
Stairs and corridors provide exits from the building. In many cases of high-rise buildings in the Durrës area, the damage to the stairs itself, accompanied by the fall of parts from the damaged surrounding walls of the stairwells, which have occupied the bases and landings of the stairs, making it even more

Figure 15. Damaged stair ramps

One of the solutions is to design fixed bearing from one corner of the staircase to the frame and unrestrained bearings from the other corners. Another solution is to separate the staircase as a separate building block with seismic joints. Hence, the staircases and the corridors of them should be surrounded by shear walls in order to form cores. [9]

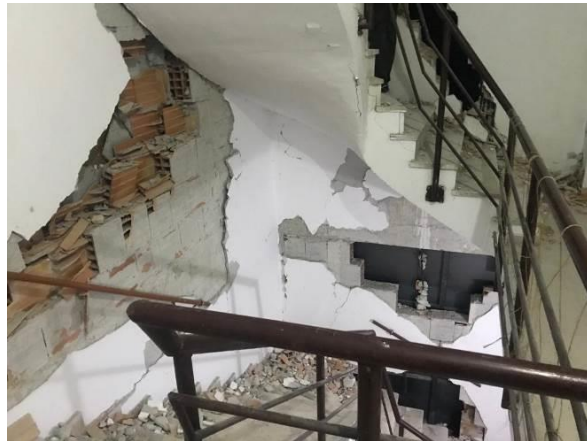
difficult to move residents during and after the seismic event. As the panic grew during the descent to quickly leave the building, many people fell and suffered physical injuries. Fig. 15, shows cases of inerts falling down stairs.

Figure 16. Inerts fallen down stairs.

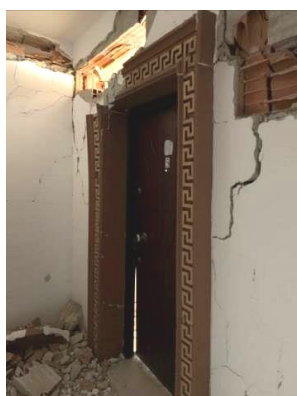
Also, due to the deformation of the walls, the door frames have suffered deformations, especially those of the outer doors of the apartments, which have blocked the opening. As a result, residents experience increased panic due to the inability to immediately leave the building during and after the seismic event and also to enter the apartment after the seismic event in the case that they went to the apartment after the earthquake. In Fig. 17, shows door with damaged lock to enable opening.

Figure 17. Exterior door with damaged lock

When the walls surrounding the doors and windows are subject to their deformation or blocking, then the solution is: appropriate framing of the cracks in the walls with reinforced concrete and the plastering of the walls is accompanied by galvanized steel mesh, as shown in Fig. 18, and Fig. 19.

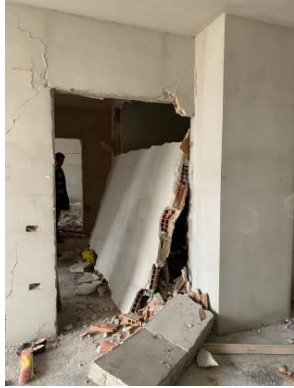
Figure 20. Collapse of the partition wall

given in Fig. 20. Usually, rigid partitions need to be anchored top and bottom to provide lateral support or stability, against toppling. To avoid stiffening the structure, upper anchors must accommodate both in-plane and vertical movement. [16]

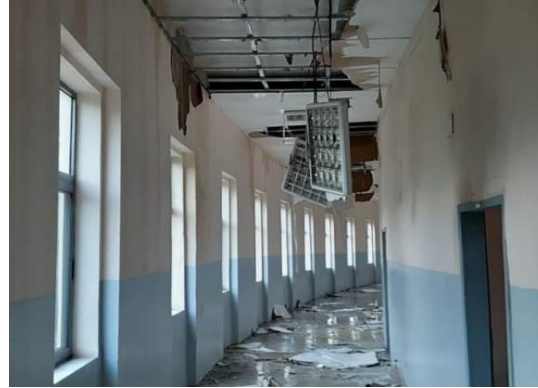
Figure 21. Collapse of suspended ceiling and light fixtures during the earthquake of September 21th, 2019. Faculty of Geology and Mining. PUT. Tirana. Source: <http://redaktori.net/?p=17147>

Since suspended ceiling often falls during earthquake, Figure 21, connections with the suspended members must be properly designed. As the suspended ceiling is subjected to horizontal movement due to seismic forces, a gap should be made at the perimeter of it in order to prevent the ceiling pounding to the walls. The suspension system for the ceiling should also minimize vertical motion in relation to the structure. [10]

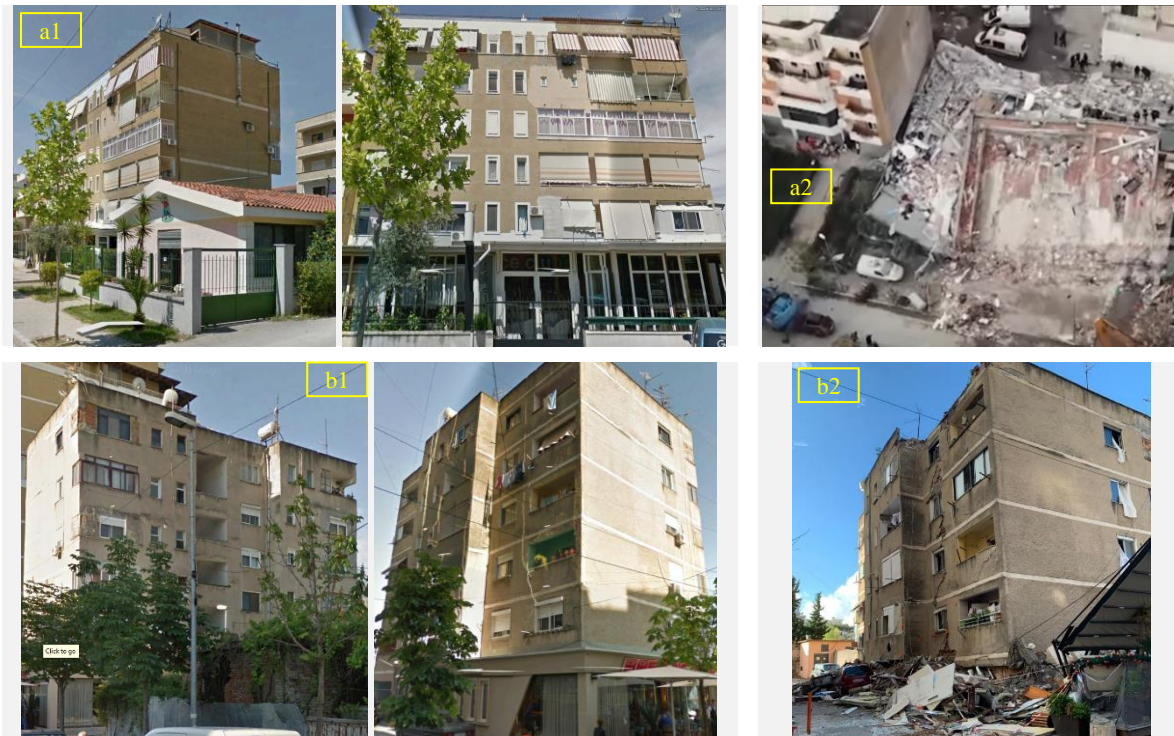
Fig. 10. Two cast-in-place M-RC 82/2 Model collapsed buildings: a-) pancake mechanism; b-) “soft story” mechanism

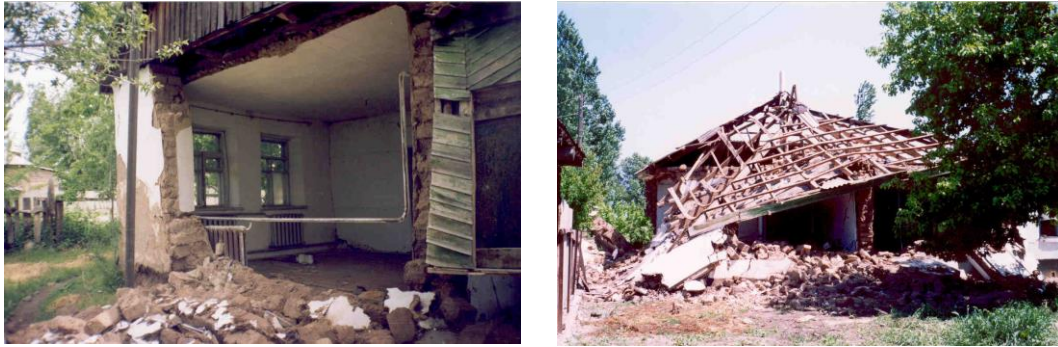
With an earthquake intensity of 5-6 points, there was serious damage. Almost all houses with adobe masonry walls were damaged at least 2 degrees during the earthquake. Approximately 50% of these houses were damaged from 2 to 3 degrees, and some - 4 and 5 degrees (complete collapse). Damage to adobe houses (see Fig. 4).

Fig. 4. Destruction of adobe houses as a result of the earthquake on May 23, 2003

Such serious damage to residential buildings with an earthquake intensity of 5-7 points is explained by the low strength of adobe blocks used in construction. The average compressive strength of adobe samples was 3 kg/cm².

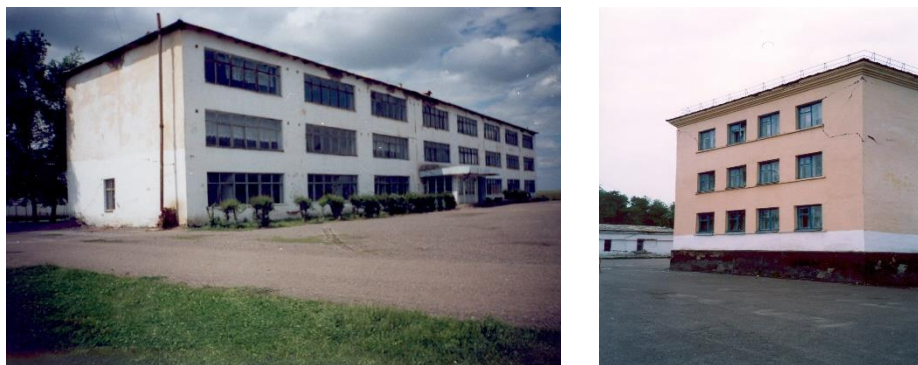
Five schools are made with load-bearing brick walls of complex construction (see Fig.7).

Fig. 7. General view of schools with load-bearing brick walls of complex construction

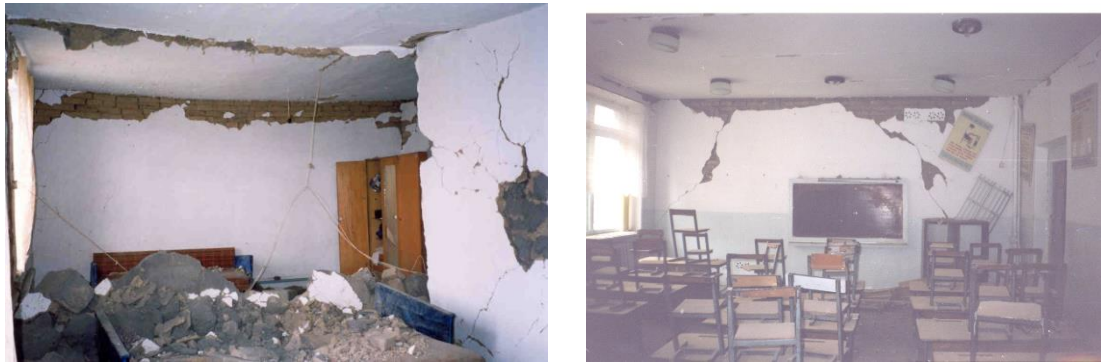
Within two weeks after the earthquake, the KazNISSA Institute conducted a detailed survey and developed project documentation to strengthen 15 school buildings. The survey showed that buildings with load-bearing brick walls received severe damage during an earthquake with an intensity of 7 points (see Figure 8). Buildings damaged from 3 to 4 degrees are recommended for demolition. Buildings that have received damage from 2 to 3 degrees are recommended for strengthening.

Fig. 8. Damage to schools with load-bearing brick walls.

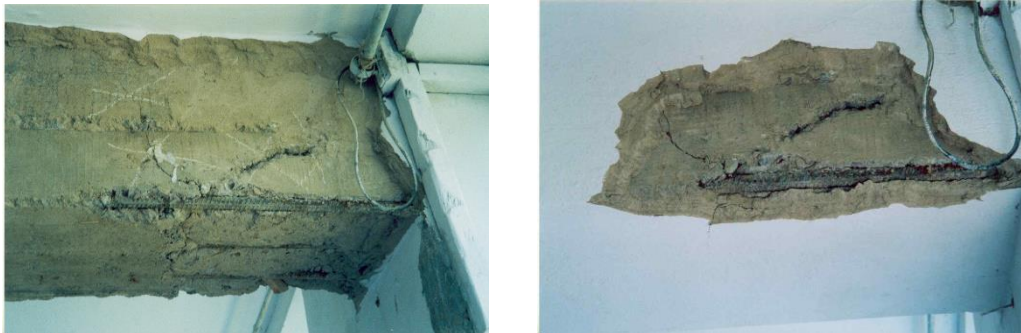
The school building in the village of Zhaksylyk with monolithic reinforced concrete frames with external brick walls. The structures of the monolithic reinforced concrete frame were severely damaged at an earthquake intensity of 6 points due to the extremely poor quality of construction (see Fig. 9).

Fig. 9. Damage to the reinforced concrete crossbar in the School building

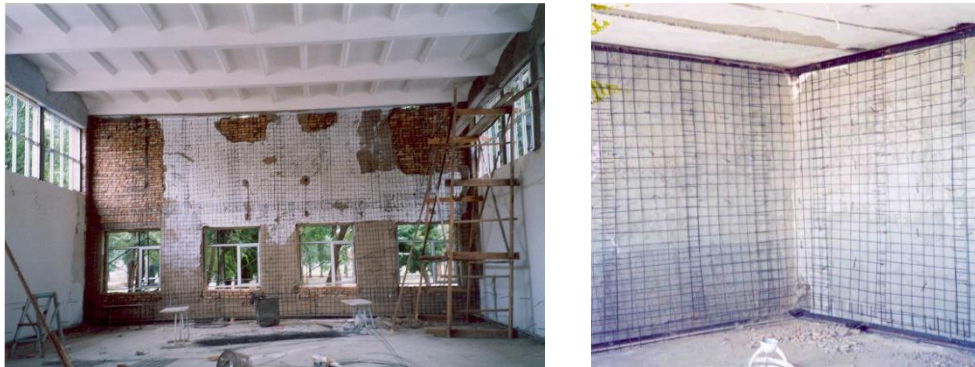
The periods of natural oscillations of buildings with brick walls before amplification were equal, about 0.45 seconds, after amplification decreased, to 0.24 seconds. Accordingly, the rigidity of buildings after reinforcement increased 3 times.

Fig. 10. Reinforcement of brick walls with reinforcement grids

In order to make the proposed reinforcement method effective, instrumental studies of the dynamic characteristics (periods and forms of natural oscillations, logarithmic decrements) of school buildings before and after reinforcement were carried out.

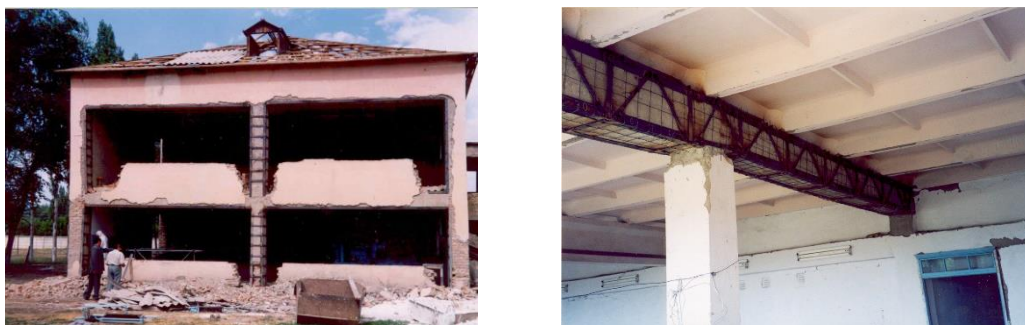
Brick walls and partitions received serious damage, which absorbed the bulk of the seismic load, which saved the building from collapse. It is recommended to strengthen the buildings: a) strengthen the columns of the transverse frames of the frame with clips made of steel corners; b) strengthen the crossbars of the frames by increasing the compressed zones of the crossbar, with the device in the upper zone of additional reinforcing rods and grids (see Fig. 11).

Fig. 11. Reinforcement of columns and beams with steel clips

Dynamic tests showed that the periods of natural oscillations of frame buildings before amplification were about 0.34 seconds, and after amplification about 0.2 seconds. The rigidity of the building after reinforcement increased by an average of 3 times compared to the rigidity before reinforcement [5].

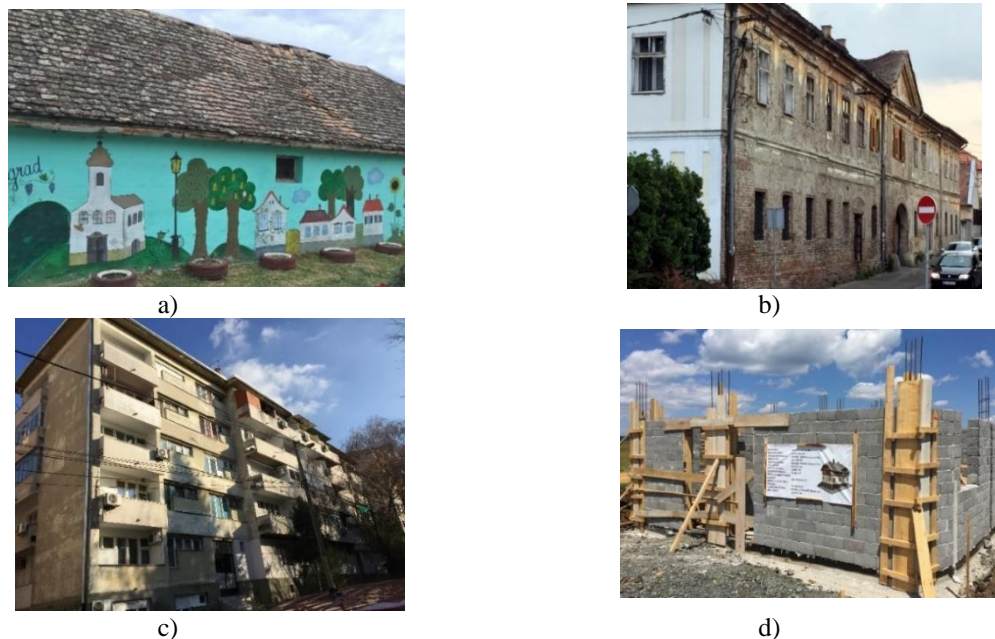
Figure 2. Examples of masonry building typologies from Serbia: a) M1- a single-family building in Irig (Vojvodina); b) M2 – an early 20th century URM building in Zemun; c) M3-M – an apartment building in Belgrade; d) M4- a single-family house under construction, Zlatibor.

Buildings classified as M1 and M2 typologies have wooden floors which act as flexible diaphragms, and they were predominantly used in Serbia until the end of WWI. Floor systems in buildings classified as M3 or M4 typologies can be treated as rigid diaphragms, but there are a few types, depending on the construction period. The application of ribbed RC floors started at the beginning of the 20th century. A semi-prefabricated ribbed RC floor system (Herbst), consisting of 25 cm deep prefabricated RC ribs and a cast-in-situ concrete layer, was practiced until the end of WWII. Avramenko is another semi-prefabricated floor system that has been used since the 1930s. A shift towards semi-prefabricated concrete and clay floor system happened during the mid-1960s. For example, LMT (light prefabricated floor) is a semi-prefabricated floor system consisting of cast-in-situ RC joists placed between masonry elements. Since mid-20th century, solid RC slabs have been used in multi-story masonry and RC buildings. Examples of masonry building typologies are presented in Fig. 2, and a brief description of each typology is presented in this section.

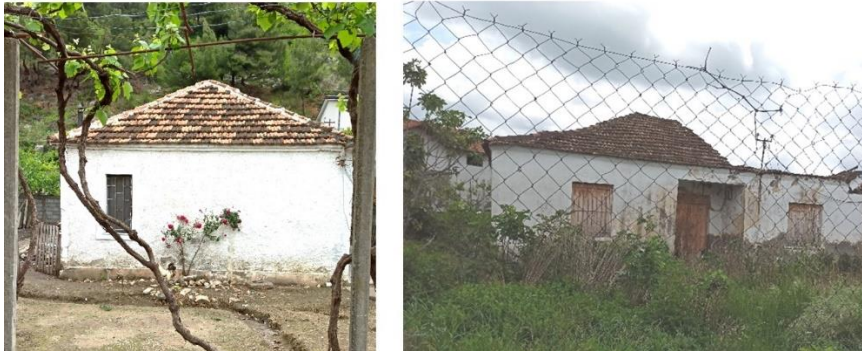
In terms of the building age the buildings constructed from 1945 up to 1960 were mostly low-rise masonry buildings, with only few buildings using concrete or steel.

Figure 4. Examples of buildings built in the 1945-1960 period

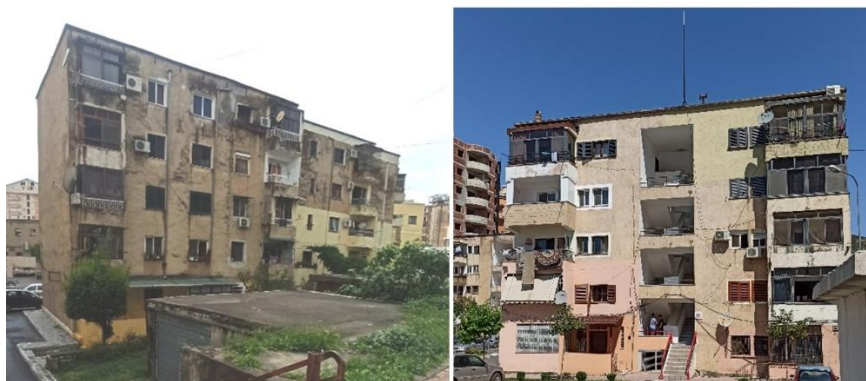
From 1960 up to 1979 some changes were made due to some important seismic events. The quality of materials improved, some additional structural elements were added to the masonry buildings. Prefabricated buildings were added as a new typology to be used for residential and industrial use.

Figure 5. Examples of buildings built in the 1960-1979 period
