2nd Croatian Conference on Earthquake Engineering

Conference Proceedings

2nd Croatian Conference on Earthquake Engineering – 2CroCEE

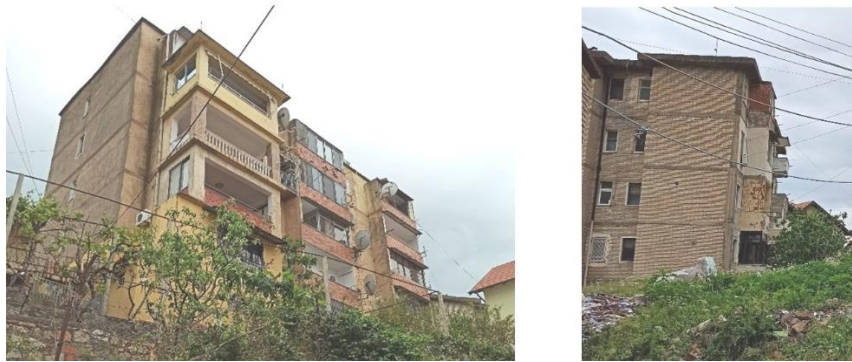
The 1979-1990 period was characterized by additional improvement in materials and construction technologies which resulted in improved building response to seismic actions. Vertical and horizontal confining elements were added in masonry buildings.

Figure 6. Examples of buildings built in the 1979-1990 period

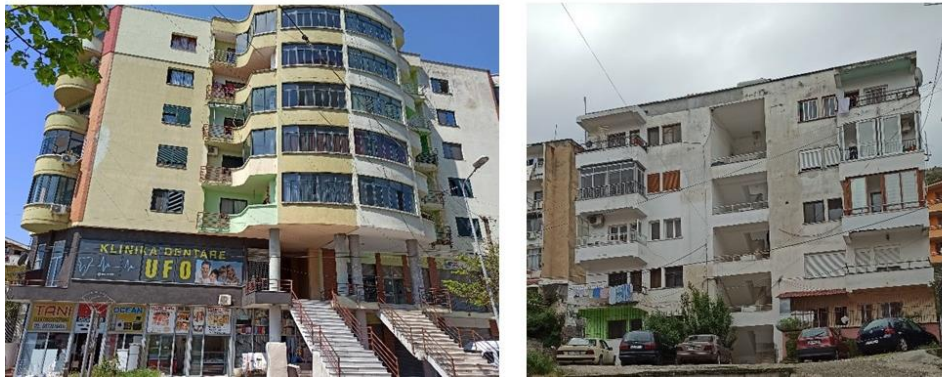
During the period, from 1990-2000 a considerable number of high-rise buildings were built and reinforced concrete technology was more widely used than masonry construction.

Figure 7. Examples of buildings built in the 1990-2000 period

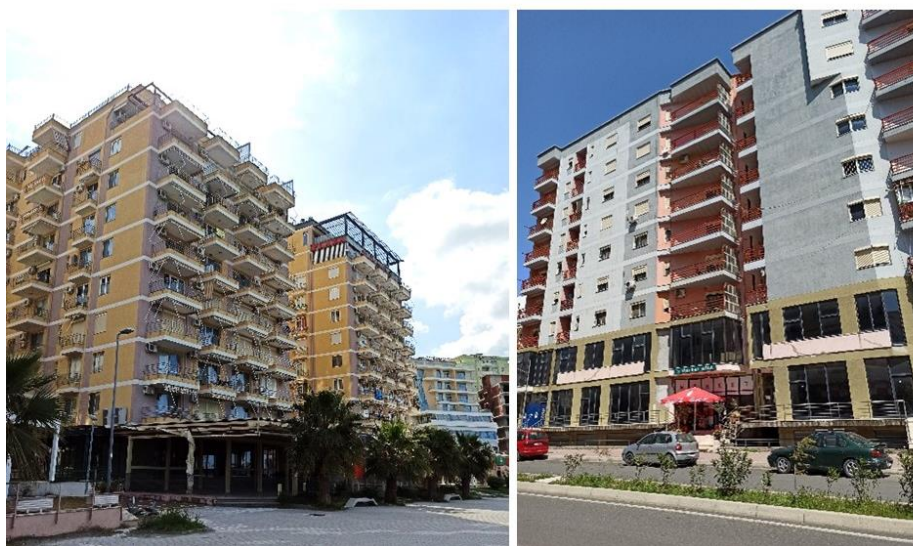
From 2000 up to present important developments were made in construction technologies and the way buildings were designed taking into account the need for the implementation of Eurocodes. RC frame systems, shear walls and dual systems were widely used to construct high-rise buildings.

Figure 8. Examples of buildings built after 2000
